**LIMITED OCCURRENCE INVESTIGATION REPORT – FINAL**

<b>Reference Number</b>	CA18/3/2/1451						
<b>Classification</b>	Serious Incident	<b>Date</b>	22 May 2024	<b>Time</b>	0840Z		
<b>Type of Operation</b>	Training (Part 141)						
<b>Location</b>							
<b>Place of Departure</b>	Ermelo Aerodrome (FAEO), Mpumalanga Province		<b>Place of Intended Landing</b>	Ermelo Aerodrome (FAEO), Mpumalanga Province			
<b>Place of Occurrence</b>	Runway 31 at Ermelo Aerodrome (FAEO), Mpumalanga Province						
<b>GPS Co-ordinates</b>	<b>Latitude</b>	26°29'42.95" S	<b>Longitude</b>	029°58'47.98" E	<b>Elevation</b>	5 795ft	
<b>Aircraft Information</b>							
<b>Registration</b>	ZS-FOW						
<b>Make; Model; S/N</b>	Piper Aircraft Corporation; PA-28-235 (Serial Number: 28-11150)						
<b>Damage to Aircraft</b>	Minor		<b>Total Airframe Hours</b>	4 328.2			
<b>Pilot-in-command</b>							
<b>Licence Type</b>	Student Pilot Licence (SPL)		<b>Gender</b>	Male		<b>Age</b>	42
<b>Licence Valid</b>	Yes	<b>Total Hours</b>	49.6		<b>Total Hours on Type</b>	17.7

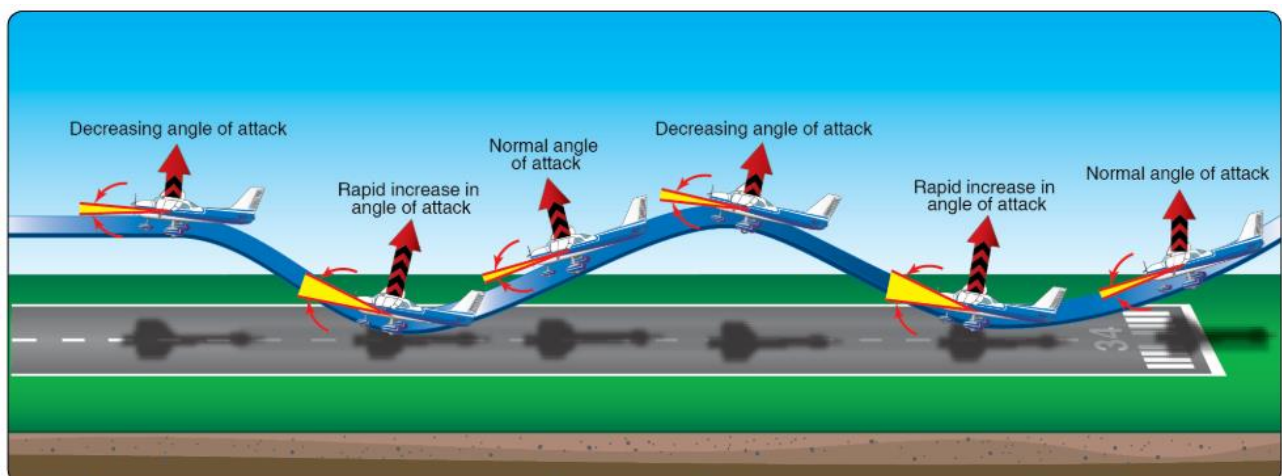
*Porpoising In a bounced landing that is improperly recovered, the airplane comes in nose first, initiating a series of motions imitating the jumps and dives of a porpoise. The improper airplane attitude at touchdown may be caused by inattention, not knowing where the ground is, miss-trimming, or forcing the airplane onto the runway.*

*Ground effect decreases elevator control effectiveness and increases the effort required to raise the nose. Not enough elevator or stabilator trim can result in a nose low contact with the runway and a porpoise develops.*
