LIMITED OCCURRENCE INVESTIGATION REPORT – FINAL

Reference Number		CA18/3/2/1459					
Classification		Date		Time			
Type of Operation	Private (Part 91)						
Location							
Place of Departure	Springs Airfield (FASI), Gauteng Province		Place of Intended Landing	Bethlehem Aerodrome (FABM), Free State Province			
Place of Occurrence	3.7 kilometres north-east of Reitz Airfield (FARZ), Free State Province						
GPS Co-ordinates	Latitude	27°45'32.51"S	Longitude	28°23'49.90"E	Elevation	5 275ft	
Aircraft Information							
Registration	ZS-WHV						
Make; Model; S/N	Piper Aircraft Corporation; PA-28-180 (Serial Number: 28-1019)						
Damage to Aircraft	None			Total Aircraft Hours	8165.09		
Pilot-in-command							
Licence Type	Commercial Pilot Licence (CPL)		Gender	Female	Age	21	
Licence Valid	Yes	Total Hours	367.1	Total Hours on Type	125		
Total Hours 30 Days	22.2		Total Flying on Type Past 90 Days	75.4			
People On-board	1+1	Injuries	0	Fatalities	0	Other (on the ground)	0

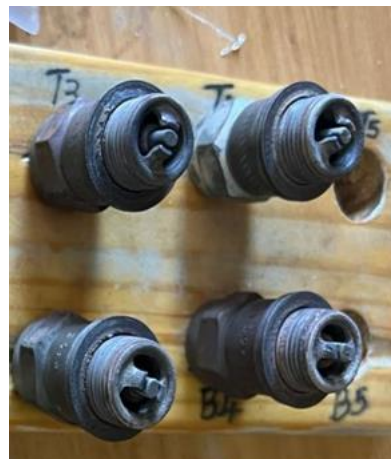
Figure 6: Greyish deposits.

- 6) The engine was equipped with eight spark plugs, four of which were contaminated; this reduced engine performance. The other four spark plugs were in good condition. The affected spark plugs were caused by the worn-out oil control rings.

- 7) The worn-out oil control rings caused excessive oil on cylinder walls which led to the fouling of the spark plugs with oil and carbon deposits. This resulted in reduced engine performance.
