AIRCRAFT SERIOUS INCIDENT REPORT AND EXECUTIVE SUMMARY

Reference:		CA18/3/2/1460	
Aircraft Registration	ZS-ZWY	Date of Serious Incident	27 October 2024		Time of Serious Incident	1058Z	
Type of Aircraft	Boeing 737-800		Type of Operation		Air Transport Operation, Passenger (Part 121)		
Pilot-in-command Licence Type	Airline Transport Licence (ATPL)		Age	34	Licence Valid	Yes	
Pilot-in-command Flying Experience	Total Flying Hours		6 534		Hours on Type	3 400	
Last Point of Departure	Cape Town International Airport (FACT), Western Cape Province						
Next Point of Intended Landing	Lanseria International Airport (FALA), Gauteng Province						
Damage to Aircraft	Minor						
Location of the incident site with reference to easily defined geographical points (GPS readings if possible)							
Runway 07 at Lanseria International Airport (FALA) at Global Positioning System (GPS) co-ordinates determined to be 25°56'22.89" South 027°55'32.07" East, at an elevation of 4521 feet (ft)

Probable Cause

The failure was likely caused by the disintegration of the inner bearing mount due to thermal embrittlement of the base material. This embrittlement resulted from exposure to extreme heat, which was gen

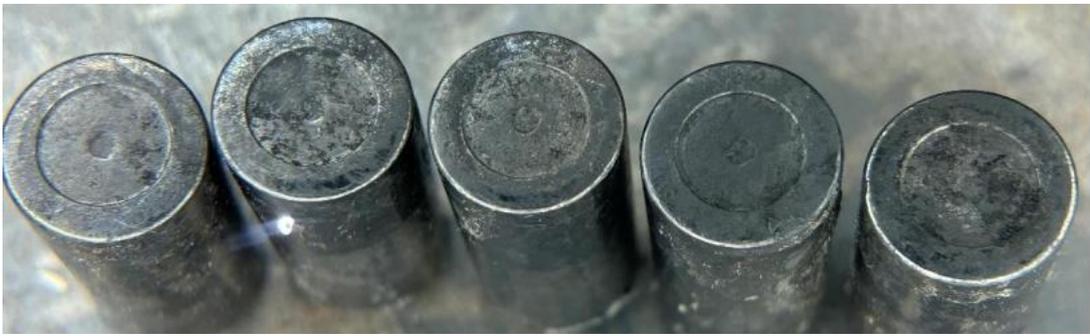
Some roller bodies suffered relatively little damage – other than sliding on the cup race – and the roller large ends were still in good condition. As a result of this, lubrication is not suspected as deficient. See Figures 18 and 19. The roller sliding was a major source of the generated heat.

Figure 19: The top part of the rollers

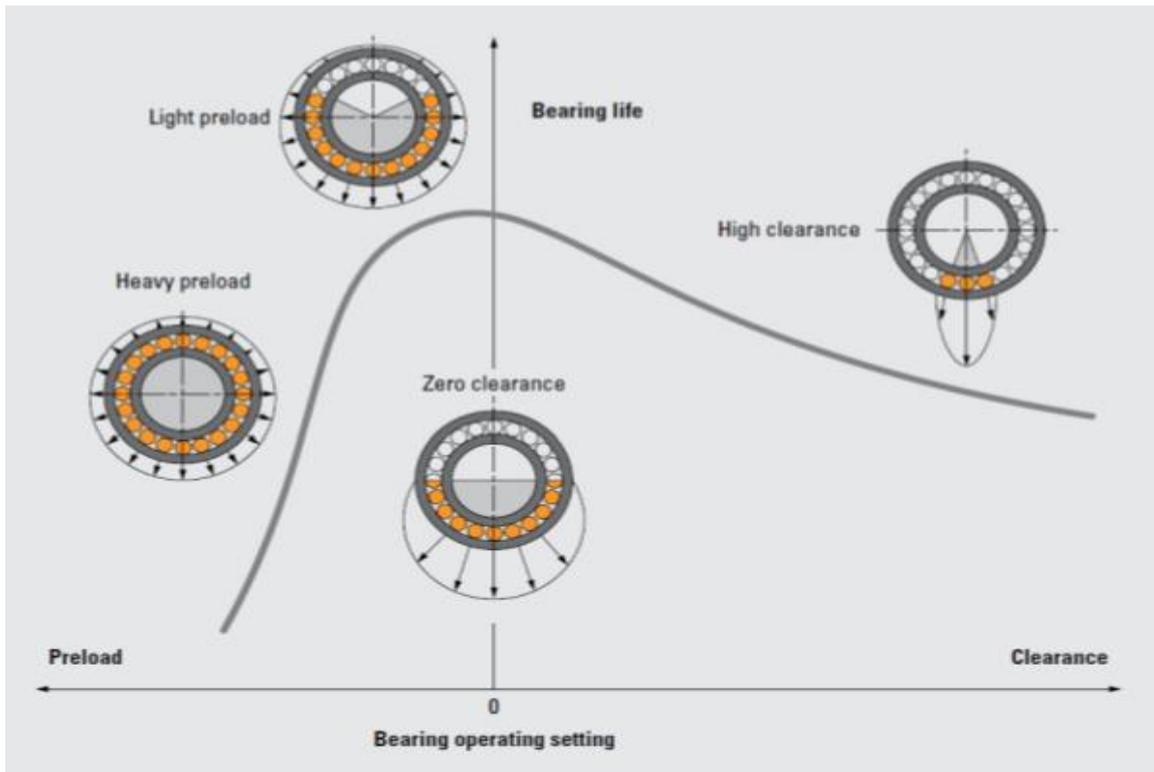
Setting bearing preload is the process of applying a manufacturer specified axial load (force) to a taper roller bearing to reduce or eliminate internal clearance (endplay) between the rollers and bearing races, thereby, ensuring correct operation and maximum bearing life. The installer of the wheel assembly used the Boeing specified method and a calibrated torque wrench to set the Boeing specified preload force. The Bearing Sleeves themselves are inserted into the Hub Bearing bores with an interference fit. It is at this interface that the rotation took place, causing the extreme frictional heating.

Figure 33: Bearing life vs bearing operating setting (preload).
