LIMITED OCCURRENCE INVESTIGATION REPORT – FINAL

Reference Number	CA18/3/2/1464						
Classification	Serious Incident	Date	29 December 2024		Time	1315Z	
Type of Operation	Private (Part 91)						
Location							
Place of Departure	Potchefstroom Aerodrome (FAPS), North West Province		Place of Intended Landing		Beaufort West (FABW) Aerodrome, Western Cape Province		
Place of Occurrence	Runway 26 at Beaufort West Aerodrome (FABW), Western Cape Province						
GPS Co-ordinates	Latitude	32° 18' 00.0" S	Longitude	022° 40' 00.0" E	Elevation	2 932 ft	
Aircraft Information							
Registration	ZS-JLP						
Make; Model; S/N	Piper Aircraft; PA28-180 (S/N:28-7505115)						
Damage to Aircraft	Minor			Total Aircraft Hours	5 867.46		
Pilot-in-command							
Licence Type	Private Pilot Licence (PPL)		Gender	Male		Age	66
Licence Valid	Yes	Total Hours	662.4		Total Hours on Type	23.67	
Total Hours 30 Days	1.8		Total Flying on Type Past 90 Days	5.7			
People On-board	1 + 1	Injuries	0	Fatalities	0	Other (on ground)	0

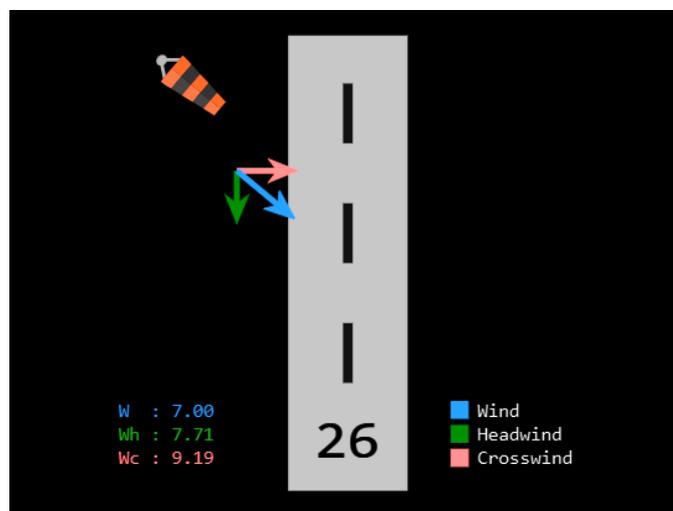
Figure 5: The average wind component on the day of the serious incident. (Source: e6bx.com)

The weather report obtained from the SAWS indicated gusty crosswind conditions at the time of landing which can be attributed as a contributory factor to the accident.

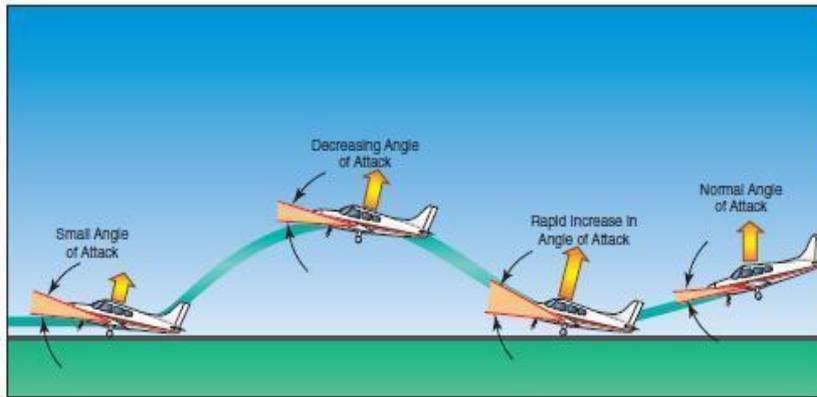
When the airplane contacts the ground with a hard impact as the result of an improper attitude or an excessive rate of sink, it tends to bounce back into the air. Though the airplane's tyres and shock struts provide some springing action, the airplane does not bounce like a rubber ball. Instead, it rebounds into the air because the wing's angle of attack was abruptly increased, producing a sudden addition of lift.

Figure 6: Bouncing during touchdown.

The abrupt change in angle-of-attack is the result of inertia instantly forcing the airplane's tail downward when the main wheels contact the ground sharply. The severity of the bounce depends on the air speed at the moment of contact and the degree to which the angle-of-attack or pitch attitude was increased. Since a bounce occurs when the airplane makes contact with the ground before the proper touchdown attitude is attained, it is almost invariably accompanied by the application of excessive back-elevator pressure. This is usually the result of the pilot realising too late that the airplane is not in the proper attitude and attempting to establish it just as the second touchdown occurs.
