AIRCRAFT SERIOUS INCIDENT REPORT AND EXECUTIVE SUMMARY

Reference:		CA18/3/2/1474	
Aircraft Registration	ZU-JHF	Date of Incident	5 April 2025		Time of Incident	0908Z	
Type of Aircraft	Jabiru J430			Type of Operation	Private (Part 94)		
Pilot-in-command Licence Type	Private Pilot Licence		Age	49	Licence Valid	Yes	
Pilot-in-command Flying Experience	Total Flying Hours			986.3	Hours on Type	353.0	
Last Point of Departure	Heuningberg Farm, Western Cape Province						
Next Point of Intended Landing	Morningstar Aerodrome, Western Cape Province						
Damage to Aircraft	Minor						
Location of the incident site with reference to easily defined geographical points (GPS readings if possible)							
Ploughed field near Riebeek-Kasteel Town (GPS position: 33°24'55.95" South 018°51'26.79" East)							
Meteorological Information	Surface wind: 045°/10kt; temperature: 25°C; dew point: 10°C; visibility: CAVOK						
Number of People On-board	1+1	Number of People Injured	0	Number of People Killed	0	Other (On Ground)	0

Probable Cause/s and/or Contributory Factors							
<p>The pilot executed a forced landing on a ploughed field after engine failure; as a result, the aircraft sustained minor damage. I

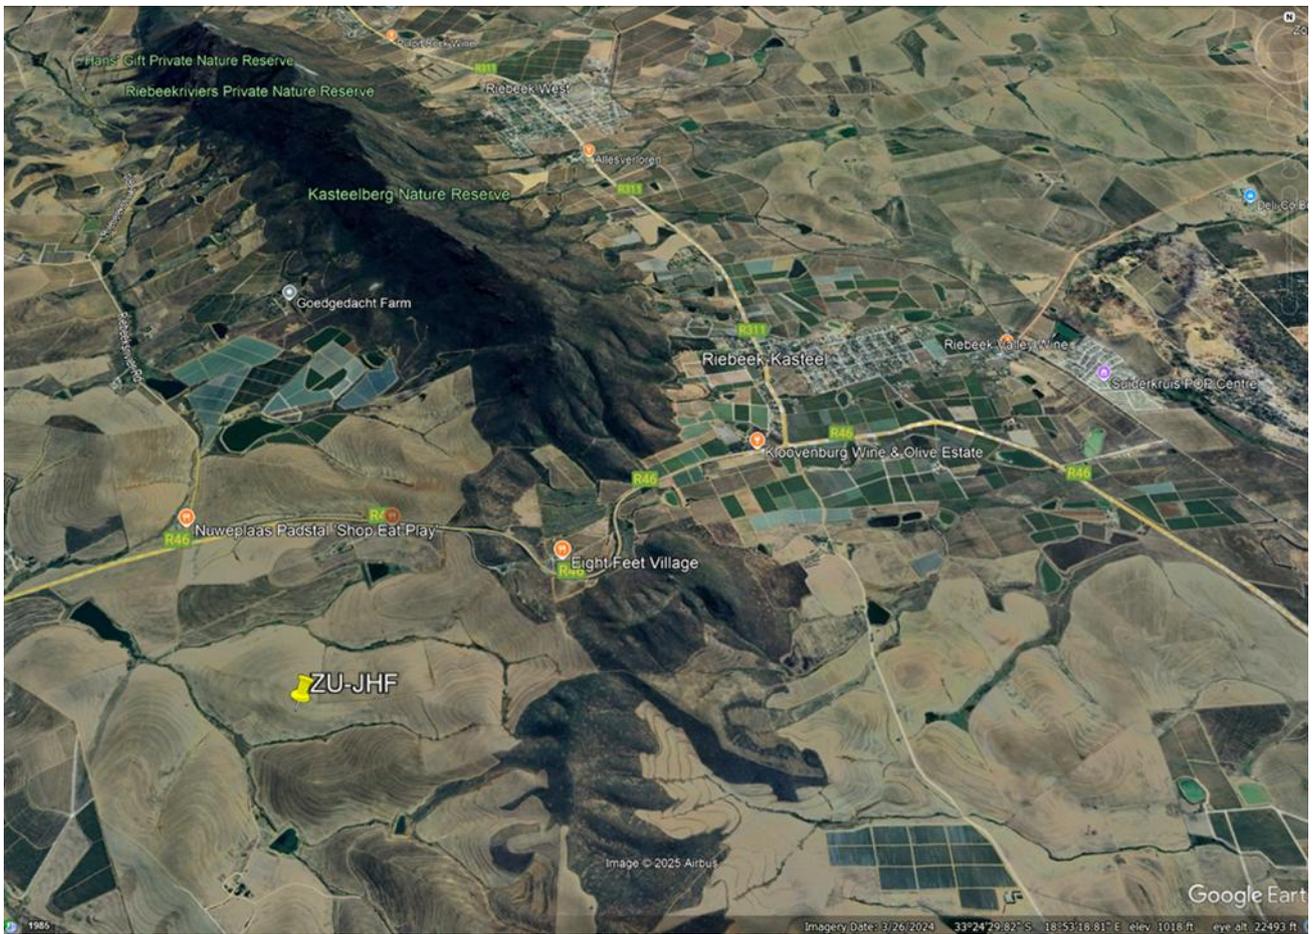
- 1.1.5. The accident occurred during daylight on a wheat field approximately 2.6 nautical miles (nm) south of Riebeeck-Kasteel Town at Global Positioning System (GPS) co-ordinates determined to be 33°24'55.95" South 018°51'26.79" East, at an elevation of 908 ft.

Figure 1: An overview of the serious incident site. (Source: Google Earth)
