LIMITED OCCURRENCE INVESTIGATION REPORT – DRAFT

Reference Number	CA18/3/2/1475						
Classification	Serious Incident	Date	27 April 2025			Time	0558Z
Type of Operation	Training (Part 141)						
Location							
Place of Departure	Cape Winelands Aerodrome (FAWN), Western Cape Province			Place of Intended Landing	Cape Winelands Aerodrome (FAWN), Western Cape Province		
Place of Occurrence	On a farmland, approximately 3 nautical miles (nm) north-east of Cape Winelands Aerodrome						
GPS Co-ordinates	Latitude	33° 45' 34.05" S	Longitude	018° 44' 49.07" E	Elevation	308.4ft	
Aircraft Information							
Registration	ZS-FWR						
Make; Model; S/N	Piper; PA-28-140 Cherokee (Serial Number: 28-25326)						
Damage to Aircraft	None			Total Aircraft Hours	12 730.63		
Pilot-in-command							
Licence Type	Commercial Pilot Licence (CPL)		Gender	Male		Age	28
Licence Valid	Yes	Total Hours	513.7		Total Hours on Type	420.3	
Total Hours 30 Days	57.7		Total Flying on Type Past 90 Days	82.7

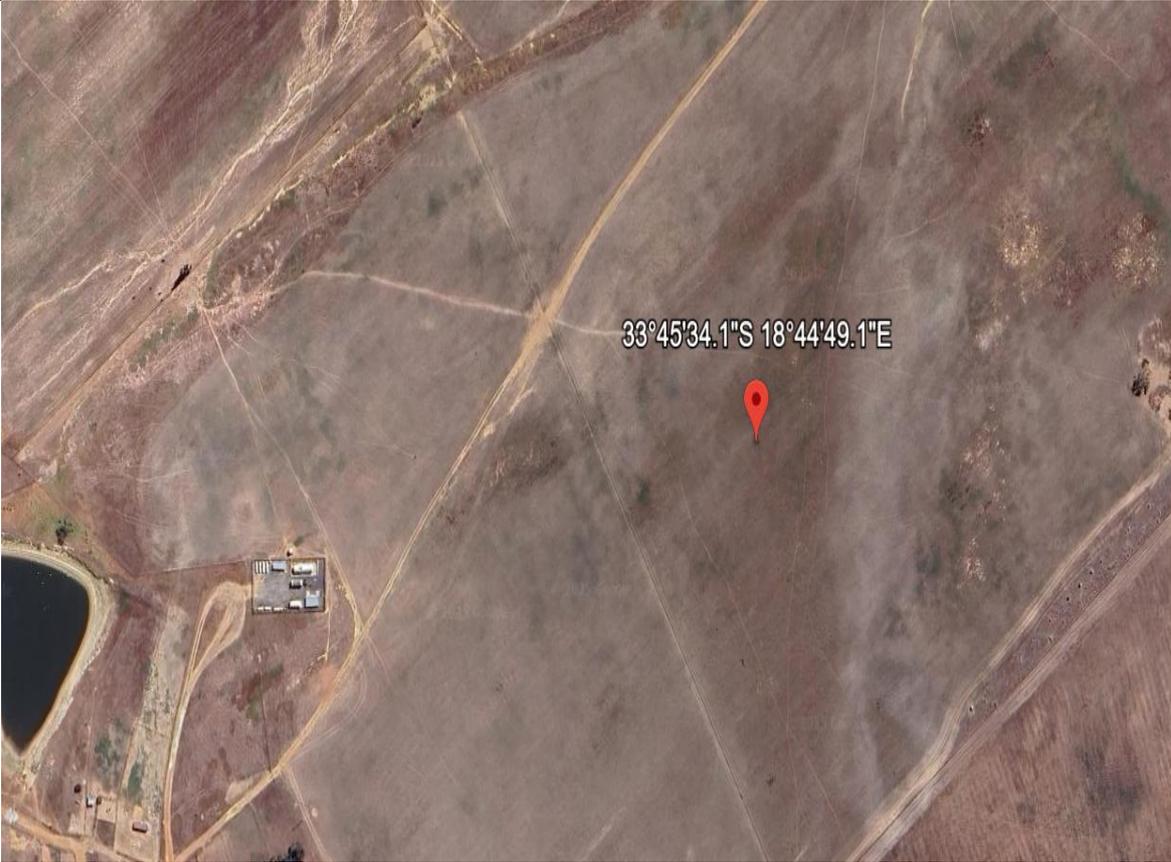
The serious incident occurred during daylight at Global Positioning System (GPS) co-ordinates determined to be 33° 45' 34.05" South 018° 44' 49.07" East, at an elevation of 308.4 feet (ft).

Figure 1: Aerial view of the approximate serious incident site. (Source: Google Earth)
