LIMITED OCCURRENCE INVESTIGATION REPORT – FINAL

Reference Number	CA18/3/2/1478						
Classification	Serious Incident	Date	14 May 2025		Time	0942Z	
Type of Operation	Private (Part 94)						
Location							
Place of Departure	Wings Park Airfield, East London, Eastern Cape Province		Place of Intended Landing		Wings Park Airfield, East London, Eastern Cape Province		
Place of Occurrence	Wings Park Airfield in East London, Eastern Cape Province						
GPS Co-ordinates	Latitude	32°49'.17" S	Longitude	27°50'.18" E	Elevation	1 276ft	
Aircraft Information							
Registration	ZU-FVZ						
Make; Model; S/N	Jabiru Aircraft; J170 (Serial Number: 20)						
Damage to Aircraft	Minor		Total Aircraft Hours	472.5			
Pilot-in-command							
Licence Type	National Pilot Licence (NPL)		Gender	Male		Age	69
Licence Valid	Yes	Total Hours	1369.2		Total Hours on Type	30.2	
Total Hours 30 Days	12		Total Flying on Type Past 90 Days	23.6			
People On-board	1+1	Injuries	0	Fatalities	0	Other (on the ground)	0

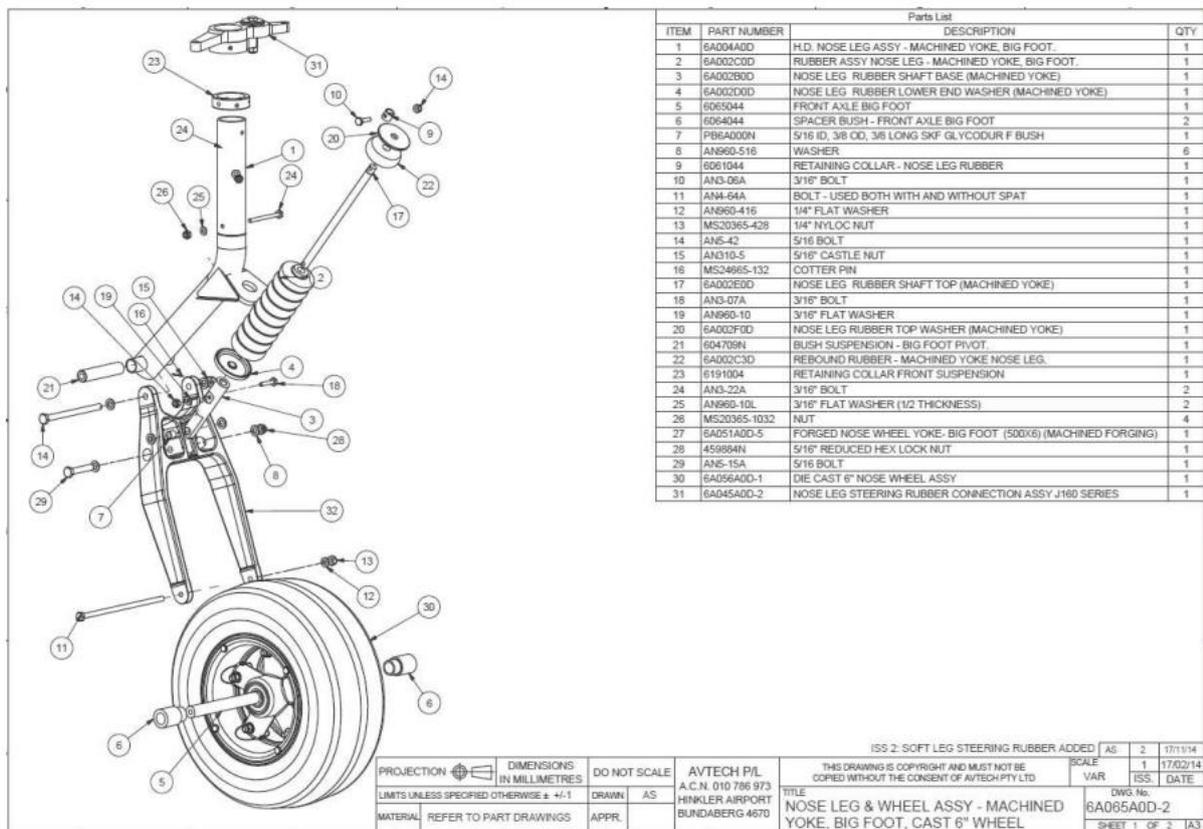
Pre-Paint > Fuselage > Firewall forward > Assemble and fit nose gear.

Jabiru Nose Leg Configuration. (Source: Jabiru J160/170 Constructors Manual)

The Jabiru aircraft has a classic trailing link nose leg design. The main rubber and rebound rubber tend to spring like a trampoline and help soften the rebound of the nose wheel. The trailing link landing gear is best for smooth landings.

The geometry and dimensions of this configuration have been carefully calculated to incorporate centre-of-gravity (COG) ranges, inertia and load analysis, including mass.

Using geometry, the trailing link landing gear takes the upward energy of the wheels contacting the runway and dissipate it through a pivot point, forward of the tyre instead of straight up through a strut. An oleo strut connects the horizontal arm to the vertical arm, soften the oscillations and enabling the gear to compress smoothly.
