LIMITED OCCURRENCE INVESTIGATION REPORT – FINAL

Reference Number	CA18/3/2/1480						
Classification	Serious Incident	Date	23 May 2025		Time	1301Z	
Type of Operation	Training (Part 141)						
Location							
Place of Departure	George Airport (FAGG), Western Cape Province		Place of Intended Landing	Port Alfred Airport (FAPA), Eastern Cape Province			
Place of Occurrence	On a field, 6 nautical miles (nm) south-west of Port Alfred Airport (FAPA), Eastern Cape Province						
GPS Co-ordinates	Latitude	33°35'36.52" S	Longitude	026°45'46.85" E	Elevation	423 feet	
Aircraft Information							
Registration	ZS-FGU						
Make; Model; S/N	Piper; PA-28-140 Cherokee (Serial Number: 28-24070)						
Damage to Aircraft	Minor		Total Aircraft Hours	9 444.4			
Pilot-in-command							
Licence Type	Student Pilot Licence Integrated Course (SPLIC)		Gender	Male		Age	30
Licence Valid	Yes	Total Hours	136.4		Total Hours on Type	21.2	
Total Hours 30 Days	4.6		Total Flying on Type Past 90 Days	15.0

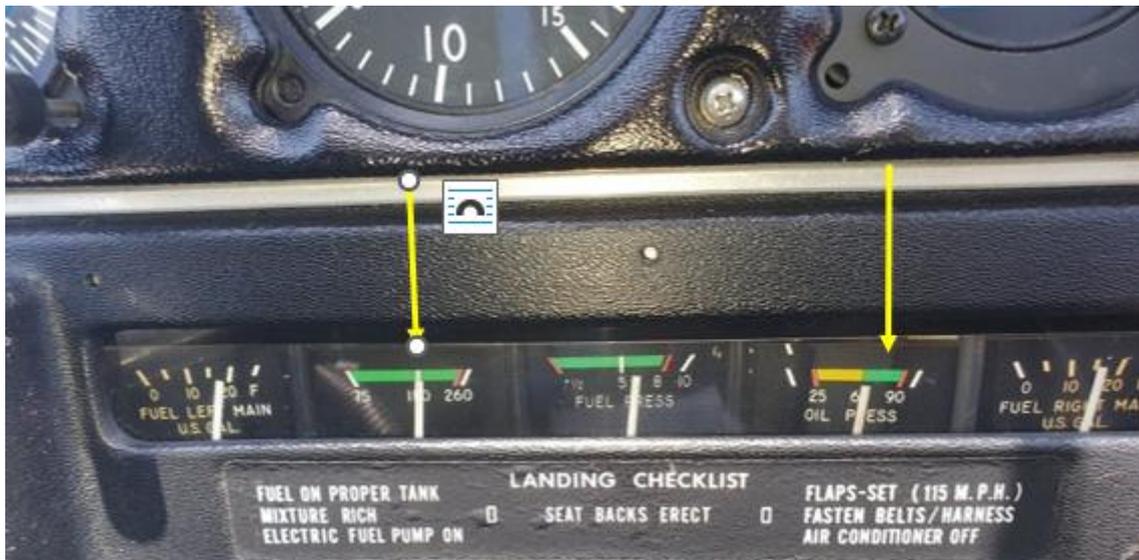
Whilst abeam Plettenberg Bay, the SP noticed that the oil pressure had decayed slightly to between 50 and 60 pounds per square inch (psi); however, the oil temperature remained stable and within limits. During the flight, the SP maintained communication with the aircraft maintenance organisation (AMO) based at FAPA via a cellular phone. After being informed of the situation, the AMO advised the SP to continue with the flight to their facility at FAPA.

Figure 1: Oil temperature and pressure gauges in the Piper PA-28 series.
(Source: Pilot's Operating Handbook)

Upon entering Chief Dawid Stuurman International Airport (FAPE) Special Rules Area (SRA) and whilst abeam Jeffreys Bay, the oil pressure had decayed to between 20 and 30 pounds per square inch (psi), which is in the yellow arc; the oil temperature remained in the green arc. Upon noticing abnormal engine noise and vibration, the SP referred to the Pilot's Operating Handbook (POH) and concluded that the indications were potentially a result of a gauge malfunction. Approximately 8 nautical miles (nm) south-west of Nanaga, the oil pressure decayed to nearly zero; however, the oil temperature still remained within the green arc and there were no other abnormal engine indications. The SP proceeded to prepare for a straight-in approach to land on Runway 10R at FAPA.

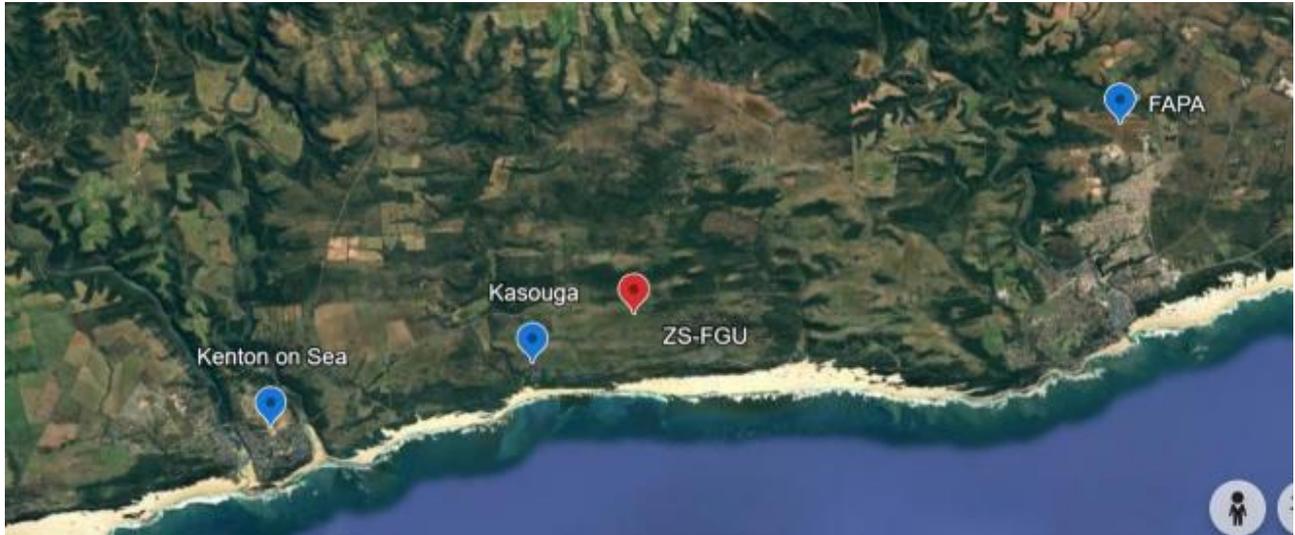
The serious incident occurred during daylight at Global Positioning System (GPS) co-ordinates determined to be 33°35'10.3" South 026°47'58.92" East, at an elevation of 423 feet (ft).

Figure 3: The red pin points to the serious incident. (Source: Google Earth)
