LIMITED OCCURRENCE INVESTIGATION REPORT – FINAL

Reference Number	CA18/3/2/1482						
Classification	Serious Incident	Date	21 May 2025			Time	0515Z
Type of Operation	Private (Part 91)						
Location							
Place of Departure	Newcastle Airfield (FANC), KwaZulu-Natal Province			Place of Intended Landing	New Tempe Airfield (FATP), Free State Province		
Place of Occurrence	Approximately 6 nautical miles south-west of Chelmsford Nature Reserve						
GPS Co-ordinates	Latitude	28° 04' 57.3" S	Longitude	029° 45' 37.6" E	Elevation	4 219 ft	
Aircraft Information							
Registration	ZS-FXT						
Make; Model; S/N	Cessna; Cardinal C177B (Serial Number: 177-01400)						
Damage to Aircraft	None			Total Aircraft Hours	3 553.99		
Pilot-in-command							
Licence Type	Private Pilot Licence (PPL)			Gender	Male		Age 38
Licence Valid	Yes	Total Hours	126.32		Total Hours on Type	123.62	
Total Hours 30 Days	5.43			Total Flying on Type Past 90 Days	7.97		
People On-board	1+1	Injuries	0	Fatalities	0	Other (on ground)	0

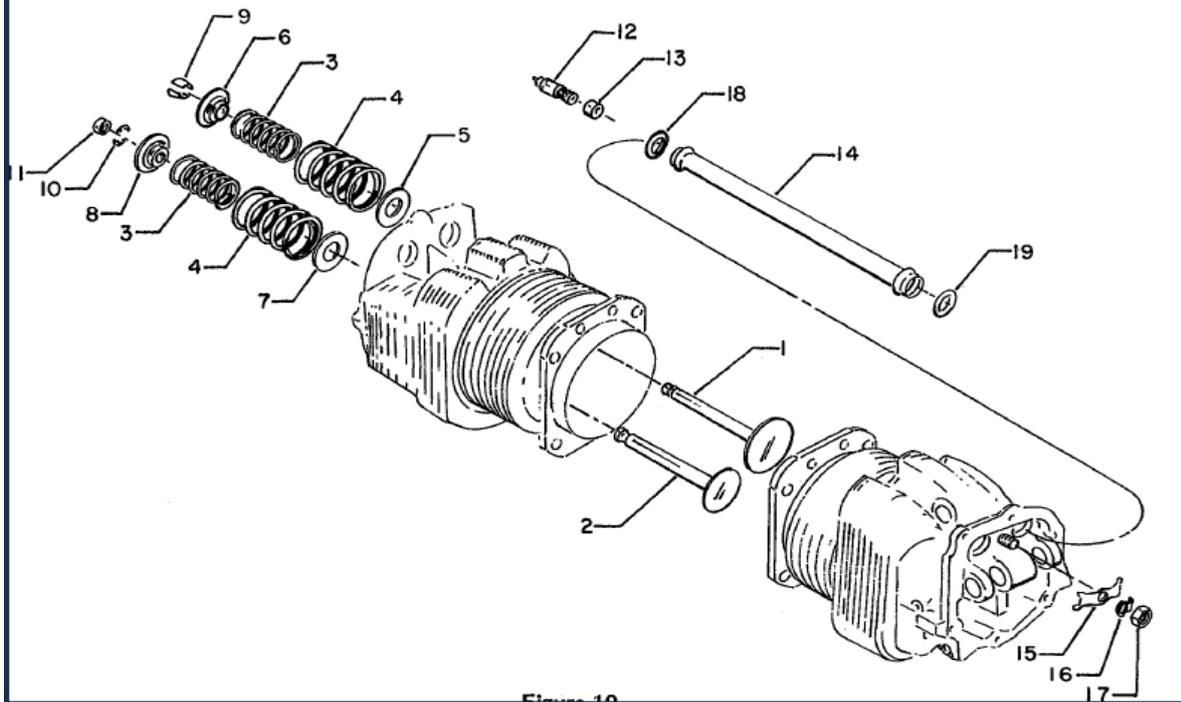
Figure 6 shows the failed components: the damaged exhaust valve rotatory type cap (11), the damaged exhaust valve stem (rotator type) (2), and the failed upper valve spring seat (8).

Figure 7: Exhaust and intake valve schematics.

(3) Using a valve spring compressor (Service Tool No: ST-419), compress the valve spring and place the split keys in the groove around the upper end of the valve stems. Slowly release the pressure on the valve spring compressor and allow the upper spring seat to lock itself in place around the valve keys.

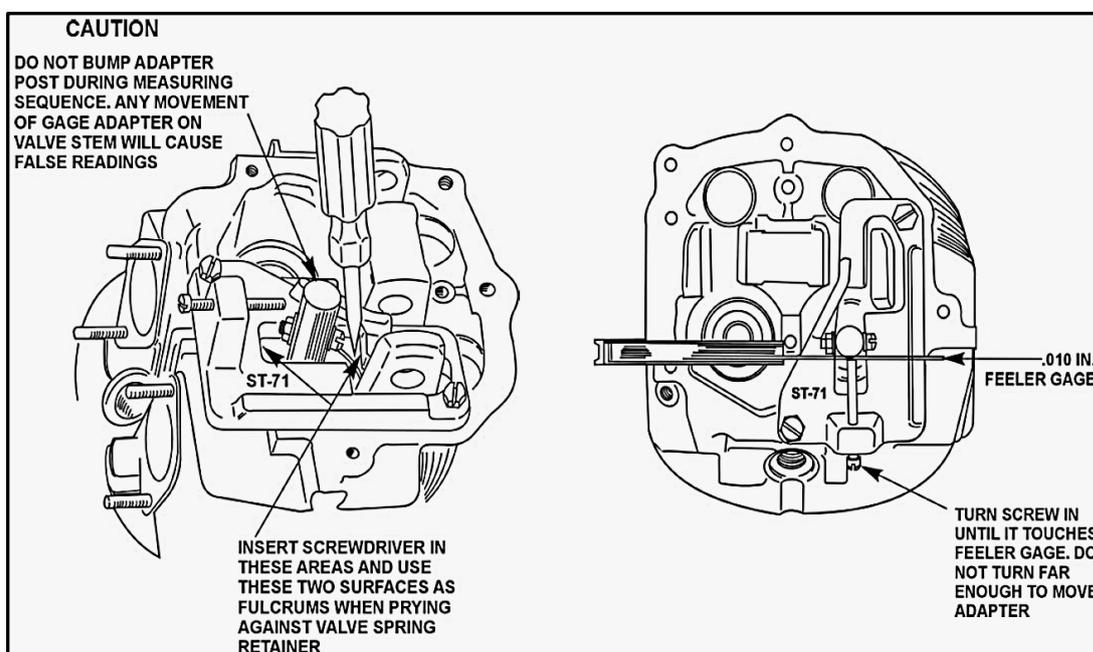
The manufacturer released a Service Bulletin (SB) 388C (388C) dated 22 November 2004, which was supplementary to No.1 SB 388B. The SB outlined a procedure for determining the condition of the exhaust valve guide. The SB further emphasised the compliance time of all engines operating on fixed wings to be at 400 hours intervals or earlier if valve sticking is suspected, until exhaust valve guides are replaced with guides made of improved material.

Figure 8: Exhaust valve guide adjustment.

1. *Remove the rocker cover, pushrods, rocker arm, tappets, etc.*
2. *Install the fixture and adapter post on the valve stem.*
3. *Compress spring, push adapter against retainer.*
4. *Push valve stem laterally via a screwdriver; use feeler gauges to measure movement.*
5. *Acceptable lateral movement depends on guide ID—typically 0.010–0.035". Greater movement guide wear; lesser movement = carbon build-up. Clean or replace the guide accordingly.*
