LIMITED OCCURRENCE INVESTIGATION REPORT – FINAL

Reference Number		CA18/3/2/1488					
Classification	Serious Incident	Date	09 July 2025			Time	1040Z
Type of Operation	Private (Part 94)						
Location							
Place of Departure	Brakpan Airfield (FABB), Gauteng Province		Place of Intended Landing		Brakpan Airfield (FABB), Gauteng Province		
Place of Occurrence	Brakpan Airfield (FABB), Gauteng Province						
GPS Co-ordinates	Latitude	26° 14' 34" S	Longitude	028° 18' 02" E	Elevation	5 356 ft	
Aircraft Information							
Registration	ZU-DLH						
Make; Model; S/N	Cubby; PI X285 (Serial Number: AK 0404)						
Damage to Aircraft	Substantial			Total Aircraft Hours	373.9		
Pilot-in-command							
Licence Type	Airline Transport Pilot Licence (ATPL) (Aeroplane)		Gender	Male		Age	68
Licence Valid	Yes	Total Hours	21000		Total Hours on Type	371.5	
Total Hours 30 Days	2.0		Total Flying on Type Past 90 Days		2.0		
People On-board	1 + 1	Injuries	0	Fatalities	0	Other (on ground)	0

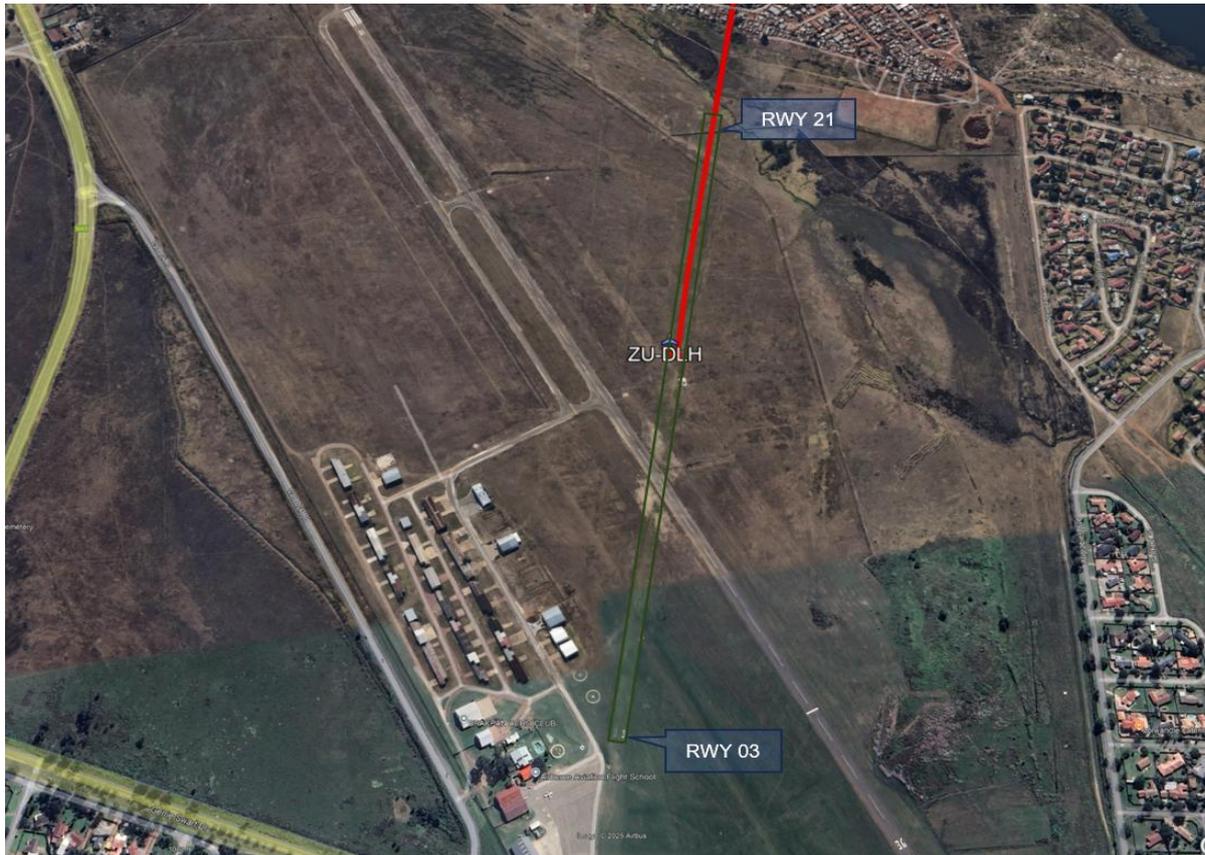
Figure 1: Aerial view of FABB with indications of the grass-covered Runway 21/03. (Source: Google Earth)

The above picture shows an asphalt Runway 18/36. The rectangular green line with the markings indicates the grass-covered Runway 21/03. According to one of the operators at the airfield, Runway 21/03 is an old runway that was not in use until it was revived; after its revival, only 800m of the original length is used.
