**LIMITED OCCURRENCE INVESTIGATION REPORT – FINAL**

<b>Reference Number</b>	CA18/3/2/1499						
<b>Classification</b>	Serious Incident		<b>Date</b>	21 August 2025		<b>Time</b>	0824Z
<b>Type of Operation</b>	Training (Part 141)						
<b>Location</b>							
Place of Departure	Grand Central Airport (FAGC), Gauteng Province		Place of Intended Landing	Grand Central Airport (FAGC), Gauteng Province			
Place of Occurrence	Runway 17 at Grand Central Airport (FAGC)						
GPS Co-ordinates	Latitude	25° 58' 57.28" S	Longitude	028° 8' 16.86" E	Elevation	5 325 ft	
<b>Aircraft Information</b>							
Registration	ZS-EFI						
Make; Model; S/N	Piper Cherokee; PA28-140 (Serial Number: 28-20696)						
Damage to Aircraft	Minor			Total Aircraft Hours	5 579.5		
<b>Pilot-in-command</b>							
Licence Type	Student Pilot Licence (SPL)		Gender	Female		Age	25
Licence Valid	Yes	Total Hours	76.5		Total Hours on Type	64.4	
Total Hours 30 Days	14.4		Total Flying on Type Past 90 Days	39.7

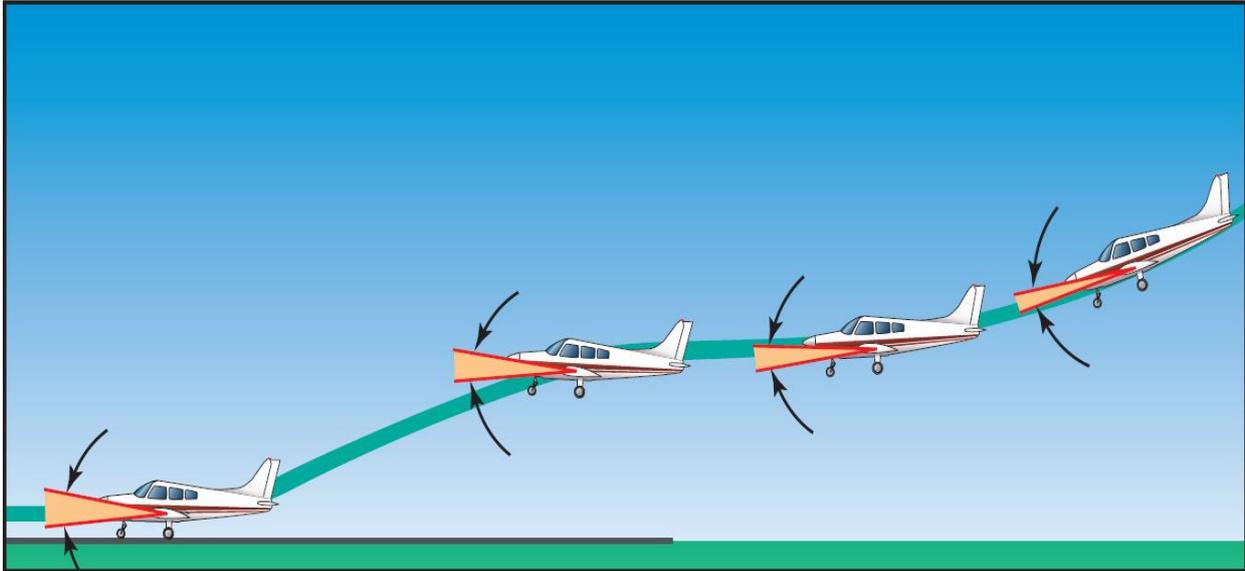
**Illustration 1:** Rounding out too high. (Source: FAA-8083-3A)

*Sometimes when the airplane appears to temporarily stop moving downward, the round out has been made too rapidly and the airplane is flying level, too high above the runway. Continuing the round out would further reduce the airspeed, resulting in an increase in angle-of-attack to the critical angle. This would result in the airplane stalling and dropping hard onto the runway. To prevent this, the pitch attitude should be held constant until the airplane decelerates enough to again start descending. Then the round-out can be continued to establish the proper landing attitude. This procedure should only be used when there is adequate airspeed. It may be necessary to add a slight amount of power to keep the airspeed from decreasing excessively and to avoid losing lift too rapidly. Although back-elevator pressure may be relaxed slightly, the nose should not be lowered any perceptible amount to make the airplane descend when fairly close to the runway unless some power*

is added momentarily. The momentary decrease in lift that would result from lowering the nose and decreasing the angle-of-attack may be so great that the airplane might contact the ground with the nosewheel first, which could collapse. When the proper landing attitude is attained, the airplane is approaching a stall because the airspeed is decreasing and the critical angle-of-attack is being approached, even though the pitch attitude is no longer being increased.
