## LIMITED OCCURRENCE INVESTIGATION REPORT – FINAL

| <b>Reference Number</b> | CA18/3/2/1500 | | | | | | |
| <b>Registration</b> | ZU-WIL | | | | | | |
| <b>Make; Model; S/N</b> | Jabiru J430 (Serial Number: 516) | | | | | | |

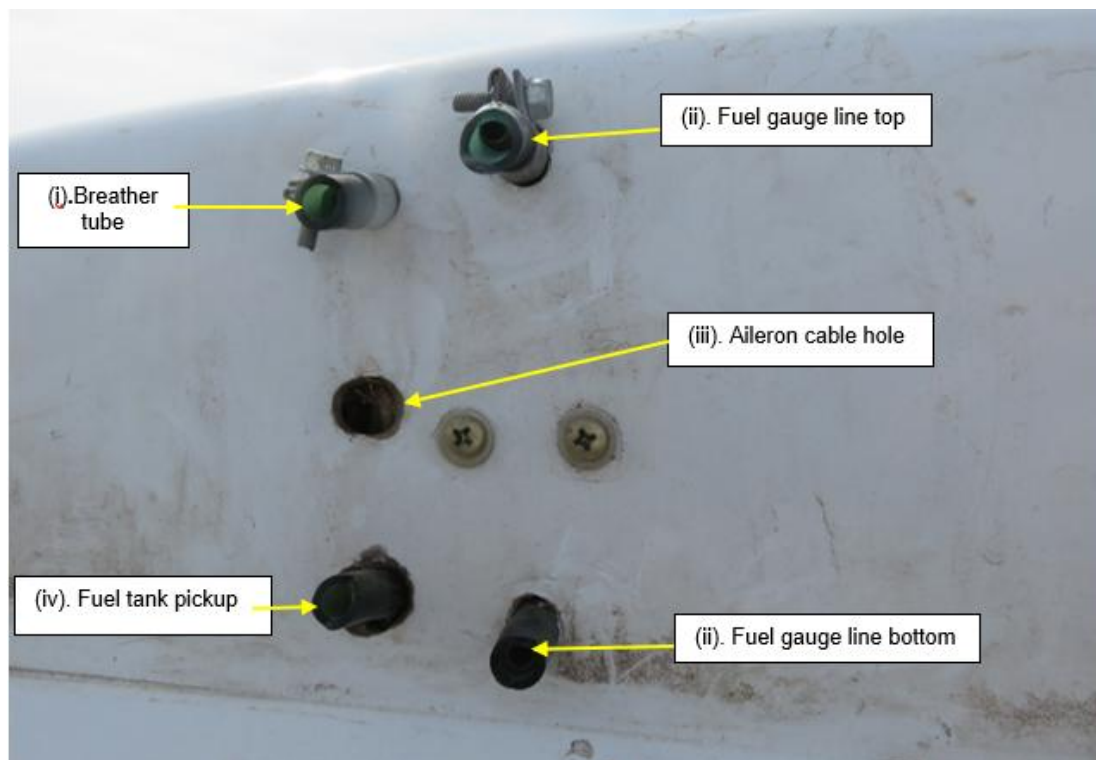
**Figure 7:** The aircraft wing root showing  
 (i) the breather tube, (ii) the two fuel gauge lines.  
 (iii) the aileron cable hole, and (iv) fuel supply line feeding the header tank.

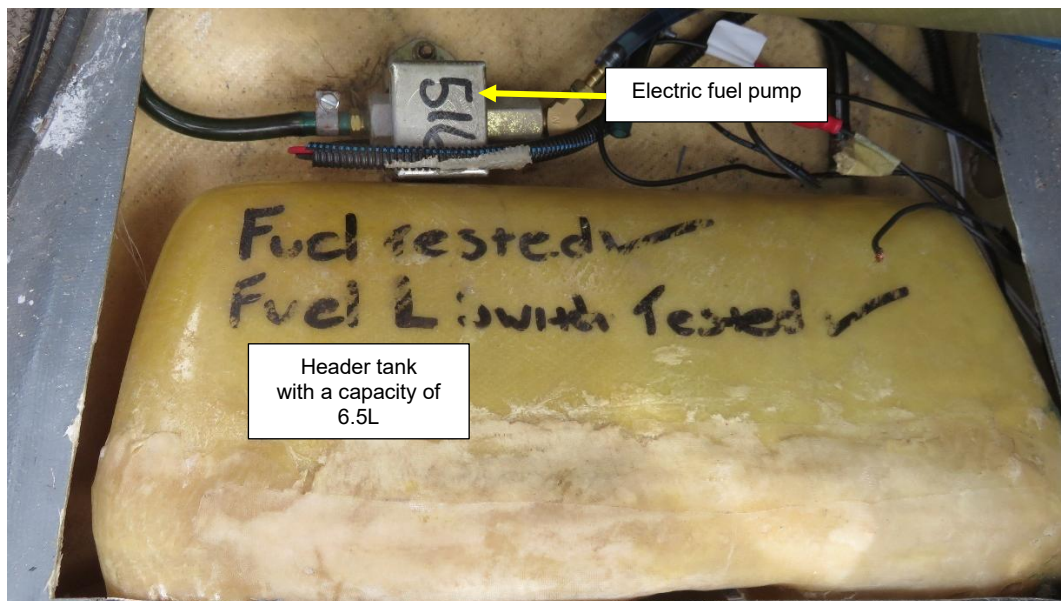
**Figure 8:** The header tank and the electric fuel pump are installed underneath the right front seat.

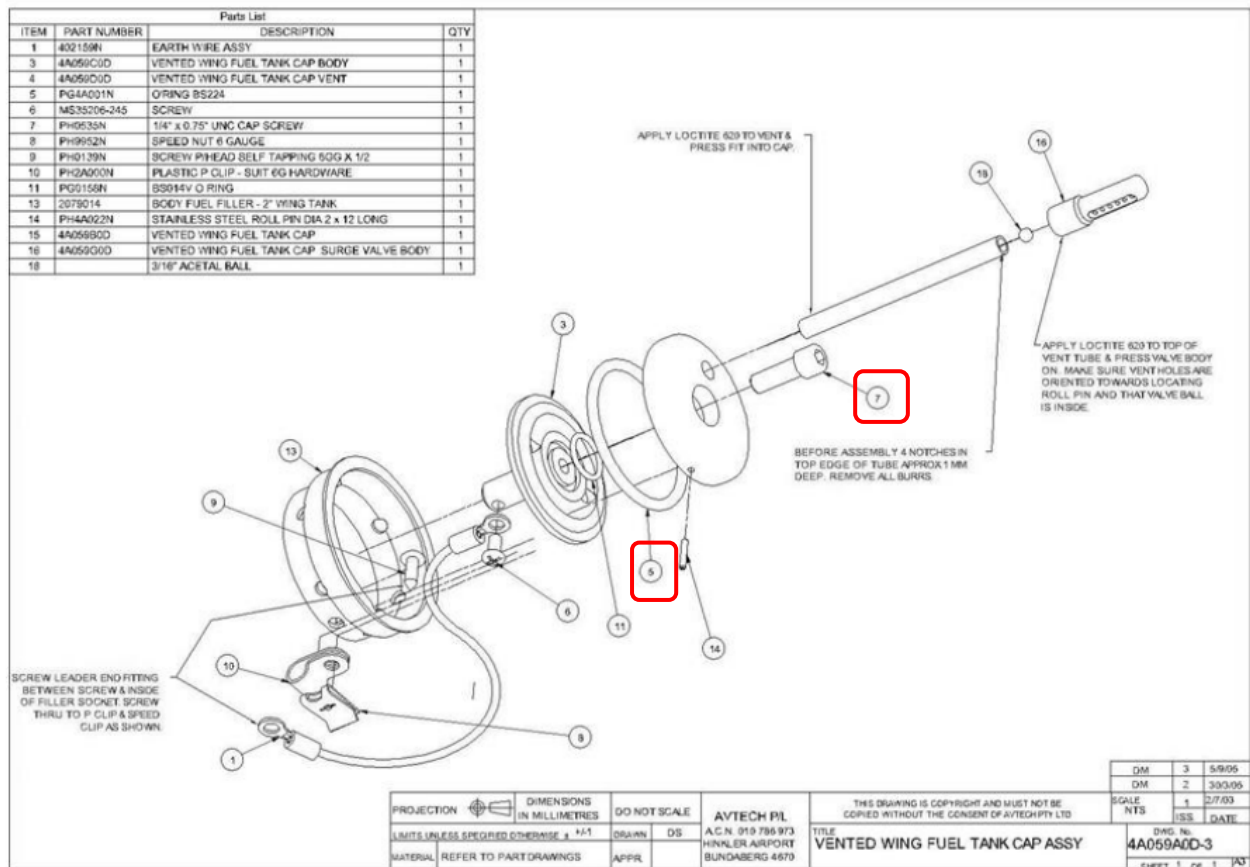
**Diagram 2:** Vented fuel tank cap assembly. (Source: Technical Manual for Jabiru Aircraft)

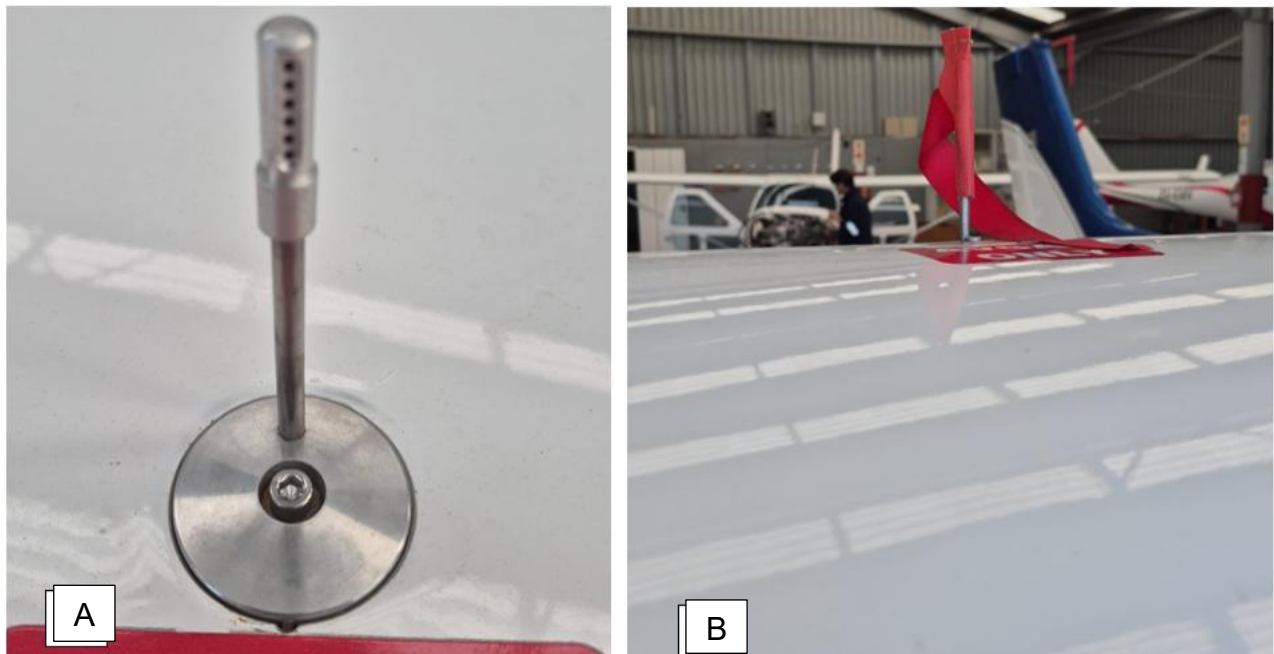
**Figure 11:** (a) Displays a new fuel cap.

(b) Indicates the fuel cap with the cover used to prevent insects and dirt from entering the vent holes.

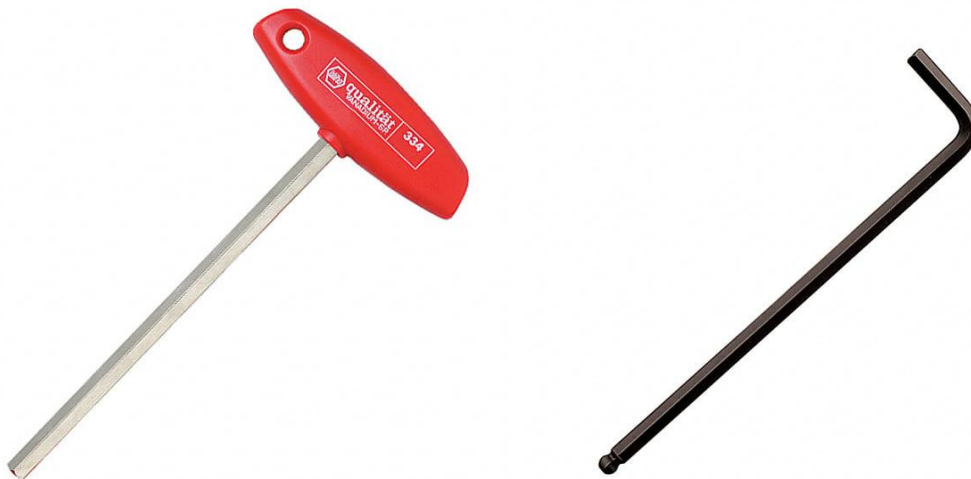
The cap screw is tightened using either a Hex T bar or an Allen key, which is an L-shaped tool designed to turn bolts and screws with a hexagonal (six-sided) socket.

**Figure 12:** A Hex T bar (left) and an Allen key (right).

- 2.9 Neither of the fuel tank cap screws could be loosened or tightened with a Hex T bar or an Allen key as required before and after refuelling because the cap screw sockets were widened. The fuel caps were, therefore, pressed into position but were not secured as required.
