LIMITED OCCURRENCE INVESTIGATION REPORT – FINAL

Reference Number	CA18/3/2/1503						
Classification	Serious Incident	Date	15 September 2025		Time	0620Z	
Type of Operation	Training (Part 141)						
Location							
Place of Departure	Herminie Farm, near Hartswater, Northern Cape Province		Place of Intended Landing	Herminie Farm, near Hartswater, Northern Cape Province			
Place of Occurrence	On a field in Hermine Farm near Hartswater, Northern Cape Province						
GPS Co-ordinates	Latitude	27°47'48.58" S	Longitude	024°56'49.40" E	Elevation	4 228 feet	
Aircraft Information							
Registration	ZU-FSF						
Make; Model; S/N	Shadow Lite, Jabiru J430 (Serial Number: 825)						
Damage to Aircraft	Minor			Total Aircraft Hours	644.4		
Pilot-in-command							
Licence Type	Student Pilot Licence (SPL)		Gender	Female		Age	42
Licence Valid	Yes	Total Hours	24.5		Total Hours on Type	24.5	
Total Hours 30 Days	14.1		Total Flying on Type Past 90 Days	24.5			
People On-board	1 + 0	Injuries	0	Fatalities	0	Other (on ground)	0

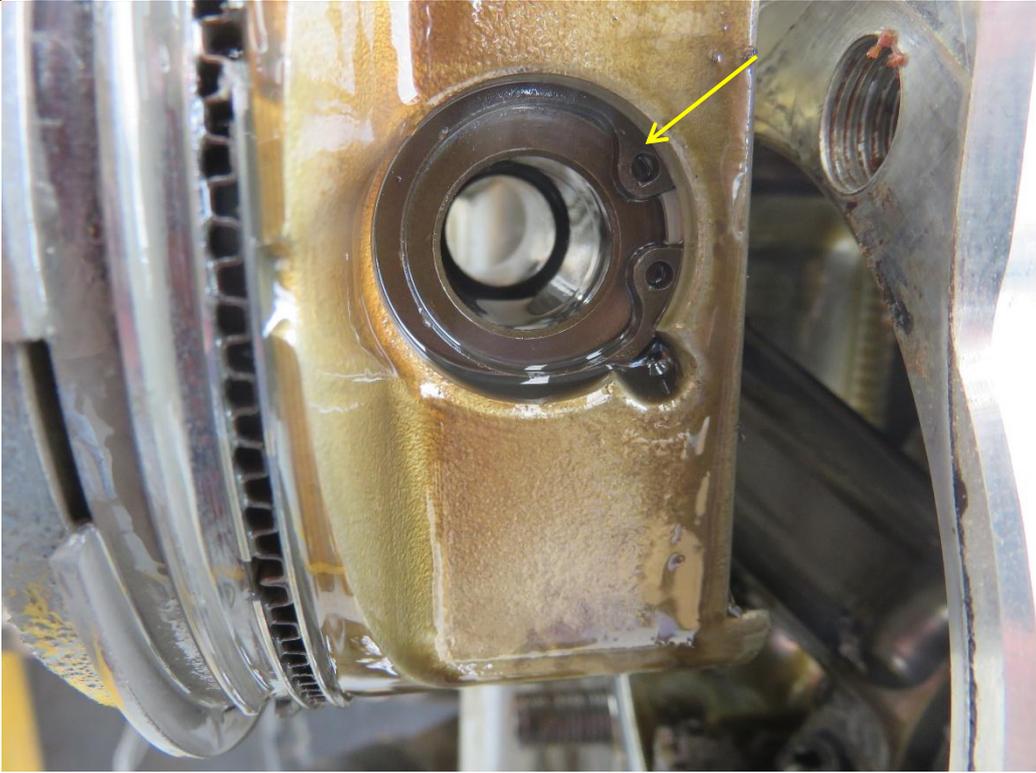
A circlip can dislodge due to improper installation. This could cause the gudgeon (wrist) pin to move axially which would lead to catastrophic engine failure. Contributing factors include incorrect orientation, insufficient compression during installation, worn piston grooves or a bent connecting rod which could hammer the circlip out of its groove.

Figure 10: An example of an installed circlip from another piston on the same engine.
