LIMITED OCCURRENCE INVESTIGATION REPORT – FINAL

Reference Number	CA18/3/2/1506						
Classification	Serious Incident		Date	25 September 2025		Time	1123Z
Type of Operation	Commercial (Part 121)						
Location							
Place of Departure	Hoedspruit Eastgate Airport (FAHS), Limpopo Province		Place of Intended Landing	O.R. Tambo International Airport, Gauteng Province			
Place of Occurrence	Taxiway Alpha at Hoedspruit Eastgate Airport, Limpopo Province						
GPS Co-ordinates	Latitude	24°20'25.27"S	Longitude	31°2'37.23" E	Elevation	1 740ft	
Aircraft Information							
Registration	ZS-CMX						
Make; Model; S/N	Bombardier Aerospace; CRJ-700 (Serial Number: 10246)						
Damage to Aircraft	Minor		Total Aircraft Hours	34 951.56			
Pilot-in-command							
Licence Type	Airline Transport Pilot Licence (ATPL)		Gender	Male		Age	41
Licence Valid	Yes	Total Hours	6 747.4		Total Hours on Type	108.8	
Total Hours 30 Days	35		Total Flying on Type Past 90 Days	90.6			
People On-board	2 + 2 + 45	Injuries	0	Fatalities	0	Other (on ground)	0

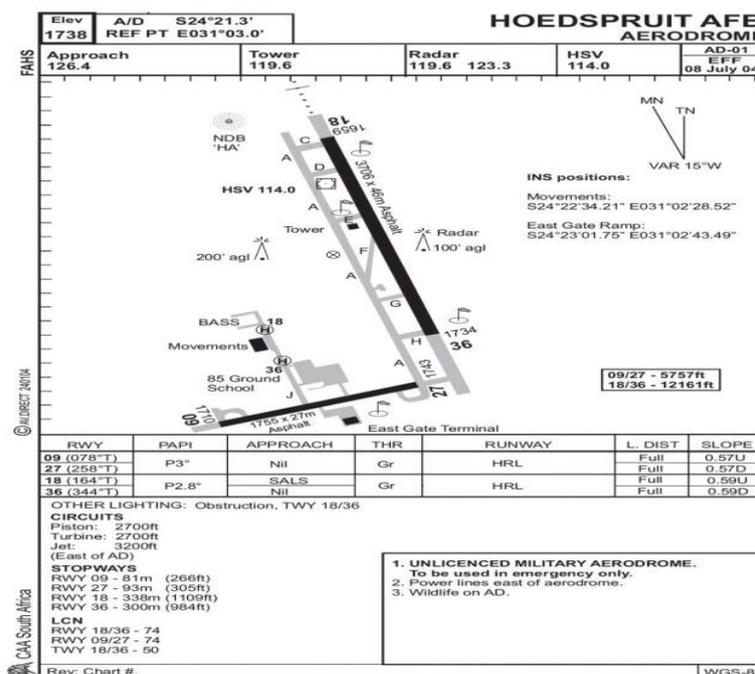
Figure 6: Hoedspruit East Gate Airport layout. (Source: Aeronautical Information Publication [AIP])

The investigating team noted that the flight crew had the airport layout on their iPads, they taxied the aircraft past D intersection, likely due to distraction in the cockpit which resulted in them omitting to count the unmarked intersections during taxi on taxiway A. The aircraft continued to taxi past C intersection and crossed the five yellow lines leading to the non-movement area. *From intersection C and after passing the five yellow lines, the taxiway becomes narrow.* The flight crew should have stopped the aircraft on the five yellow lines and requested assistance from the tower/ATCO. The investigation concluded that the serious incident was likely caused by the flight crew's distraction in the cockpit which resulted in them (flight crew) losing situational awareness whilst taxiing the aircraft on taxiway A.

The safety officer at FAHS was briefed about the findings of the on-site investigation and he committed to erecting signs/guide boards that will show all intersections, as well as a no entry board after the C intersection in addition to the five yellow lines painted across the taxiway (see Figure 4).
