**LIMITED OCCURRENCE INVESTIGATION REPORT – FINAL**

<b>Reference Number</b>	CA18/3/2/1507						
<b>Classification</b>	Serious Incident		<b>Date</b>	26 September 2025		<b>Time</b>	1005Z
<b>Type of Operation</b>	Private (Part 94)						
<b>Location</b>							
Place of Departure	Robertsvale Airfield in Gonubie Broads, East London, Eastern Cape Province		Place of Intended Landing		Robertsvale Airfield in Gonubie Broads, East London, Eastern Cape Province		
Place of Occurrence	Open area to the right of Runway 12, approximately 7.2 nautical miles (nm) north-east of Robertsvale Airfield in Gonubie Broads, East London, Eastern Cape Province						
GPS Co-ordinates	Latitude	32°55'34.79" S	Longitude	27°59'39.53" E	Elevation	656.17 ft	
<b>Aircraft Information</b>							
Registration	ZU-TEL						
Make; Model; S/N	I.C.P. Aviazione; Ventura 4 (Serial Number: 21-01-64-0018K)						
Damage to Aircraft	Minor			Total Aircraft Hours	18.1		
<b>Pilot-in-command</b>							
Licence Type	Private Pilot Licence (PPL)		Gender	Male		Age	60

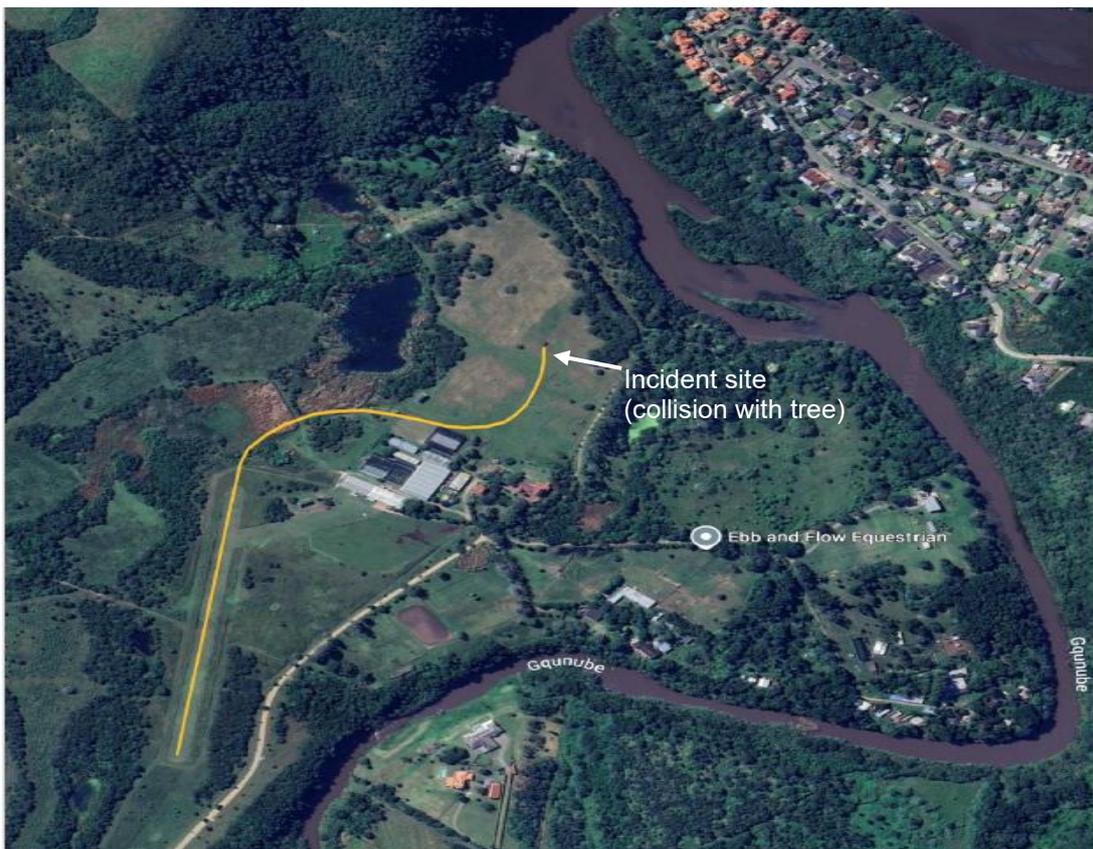
The serious incident occurred during daylight outside Robertsville Airfield at Global Positioning System (GPS) co-ordinates determined to be 32°55'34.79" South 27°59'39.53" East, at an elevation of 656.17 feet (ft).

**Figure 1:** An aerial view of the approximate serious incident site. (Source: Google Earth)
