LIMITED OCCURRENCE INVESTIGATION REPORT – FINAL

Reference Number		CA18/3/2/1508					
Classification	Serious Incident	Date	26 September 2025		Time	1105Z	
Type of Operation	Private (Part 91)						
Location							
Place of Departure	Calvinia Airfield (FACV), Northern Cape Province		Place of Intended Landing	Rosebank Private Airstrip, Northern Cape Province			
Place of Occurrence	Roseback Private Airstrip, Northern Cape.						
GPS Co-ordinates	Latitude	30° 49' 21.34" S	Longitude	022° 02' 38.82" E	Elevation	3190 ft	
Aircraft Information							
Registration	ZS-LBS						
Make; Model; S/N	Mooney; M20J (Serial Number: 24-0205)						
Damage to Aircraft	Minor			Total Aircraft Hours	1818.5		
Pilot-in-command							
Licence Type	Private Pilot Licence (PPL)		Gender	Male		Age	66
Licence Valid	Yes	Total Hours	288.4	Total Hours on Type	96.8		
Total Hours 30 Days	4		Total Flying on Type Past 90 Days			4	
People On-board	1+1	Injuries	0	Fatalities	0	Other (on ground)	0
What Happened

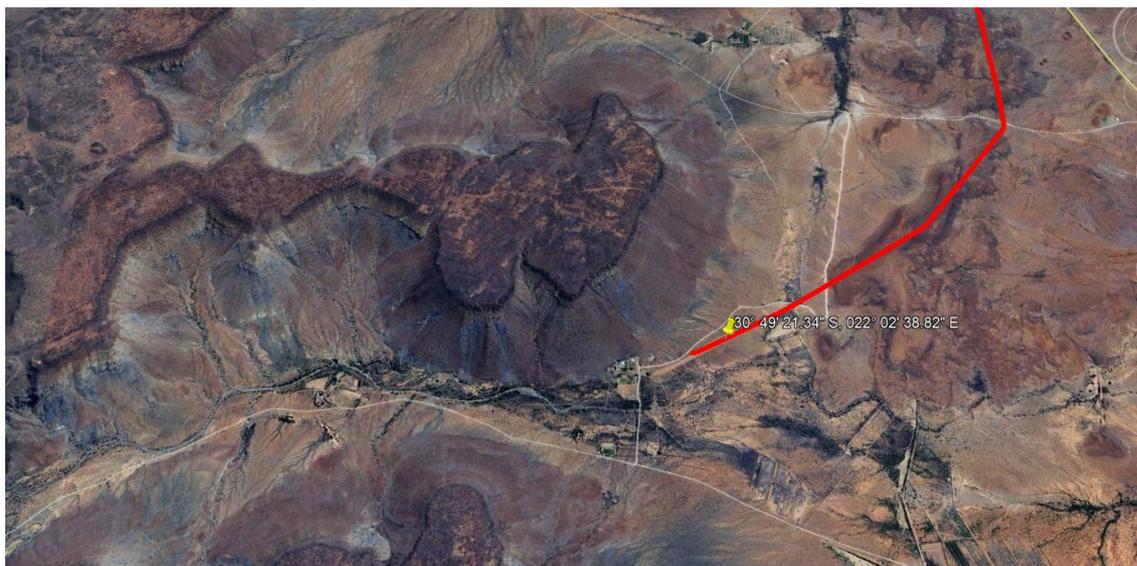
<p>On Friday, 26 September 2025, a pilot and a passenger on-board a Mooney M20J aircraft with registration ZS-LBS took off from Calvinia Airfield (FACV) to Rosebank private airstrip, both situated in Northern Cape province. The flight was conducted under visual meteorological conditions (VMC) by day and under the provisions of Part 91 of the Civil Aviation Regulations (CAR) 2011, as amended.</p> <p>The pilot reported that upon arrival at Rosebank private airstrip located on his farm, the windsock was fully horizontal which indicated a strong north-westerly crosswind. Based on this observation, the pilot decided that he will use Runway 24 to land, which is approximately 850 metres (m) long. He completed the pre-landing checks and configured the aircraft for approach and landing. The aircraft touched down smoothly at approximately 80 miles per hour (mph) (69.5 knots); however, the touchdown point was deeper into the runway than usual. Shortly after touchdown, the aircraft experienced a sudden lateral movement to the right. The pilot applied the left rudder input to counteract the drift, but the aircraft skidded and veered off to the right side of the runway.</p> <p>After departing the prepared surface, the aircraft's left main landing gear collapsed as it rolled on an uneven terrain. It came to rest a few metres on the right-side of the runway facing it, and with its left wing touching the ground.</p>

Figure 1: An aerial view of the accident site. (Source: Google Earth Map)
