## LIMITED OCCURRENCE INVESTIGATION REPORT – FINAL

<b>Reference Number</b>	CA18/3/2/1509						
<b>Classification</b>	Serious Incident		<b>Date</b>	3 October 2025		<b>Time</b>	0630Z
<b>Type of Operation</b>	Training (Part 141)						
<b>Location</b>							
Place of Departure	Morningstar Airfield, Western Cape Province		Place of Intended Landing	Morningstar Airfield, Western Cape Province			
Place of Occurrence	Runway 20 at Morningstar Airfield, Western Cape Province						
GPS Co-ordinates	Latitude	34° 45' 34.49" S	Longitude	018° 32' 57.79" E	Elevation	221 ft	
<b>Aircraft Information</b>							
Registration	ZU-IAZ						
Make; Model; S/N	Airplane Factory; Sling 2 (Serial Number: 069)						
Damage to Aircraft	Minor			Total Aircraft Hours	1 095.8		
<b>Pilot-in-command</b>							
Licence Type	Student Pilot Licence (SPL)		Gender	Male		Age	64
Licence Valid	Yes	Total Hours	33.6		Total Hours on Type	33.6	
Total Hours 30 Days	3.6		Total Flying on Type Past 90 Days	11.1

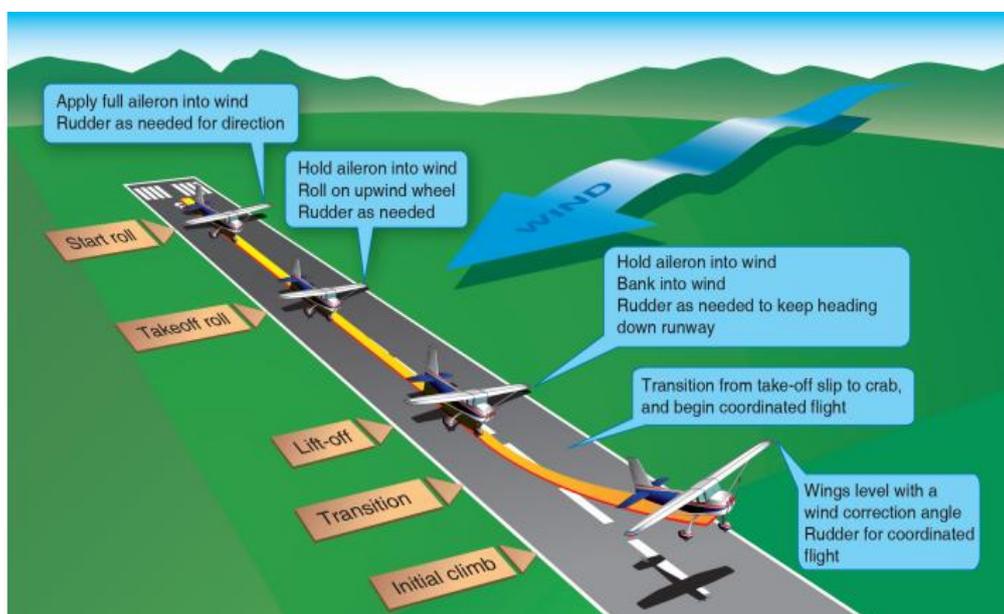
Illustration 1: Crosswind at the time of roll and take-off climb. (Source: FAA-8083-3C)

During a crosswind take-off roll, it is important that the pilot hold sufficient aileron pressure into the wind not only to keep the upwind wing from rising but to hold that wing down so that the airplane sideslips into the wind enough to counteract drift immediately after lift-off.
