LIMITED OCCURRENCE INVESTIGATION REPORT – FINAL

Reference Number		CA18/3/2/1518								
Classification		Serious Incident		Date	27 December 2025		Time	0425Z		
Type of Operation			Private (Part 91)							
Location										
Place of Departure		Bram Fischer International Airport (FABL), Free State Province			Place of Intended Landing		Wonderboom Airport (FAWB), Gauteng Province			
Place of Occurrence		Runway 11 Wonderboom Airport (FAWB)								
GPS Co-ordinates		Latitude	25° 39' 19.00" S		Longitude	028° 13' 25.00" E		Elevation	4 095ft	
Aircraft Information										
Registration		ZS-NTT								
Make; Model; S/N		Beechcraft; King Air B200 (Serial Number: BB-350)								
Damage to Aircraft		Substantial			Total Aircraft Hours		9 056.9			
Pilot-in-command										
Licence Type		Airline Transport Pilot Licence (ATPL)			Gender	Male		Age	31	
Licence Valid		Yes		Total Hours	5 314		Total Hours on Type		14	
Total Hours 30 Days		27			Total Flying on Type Past 90 Days		66

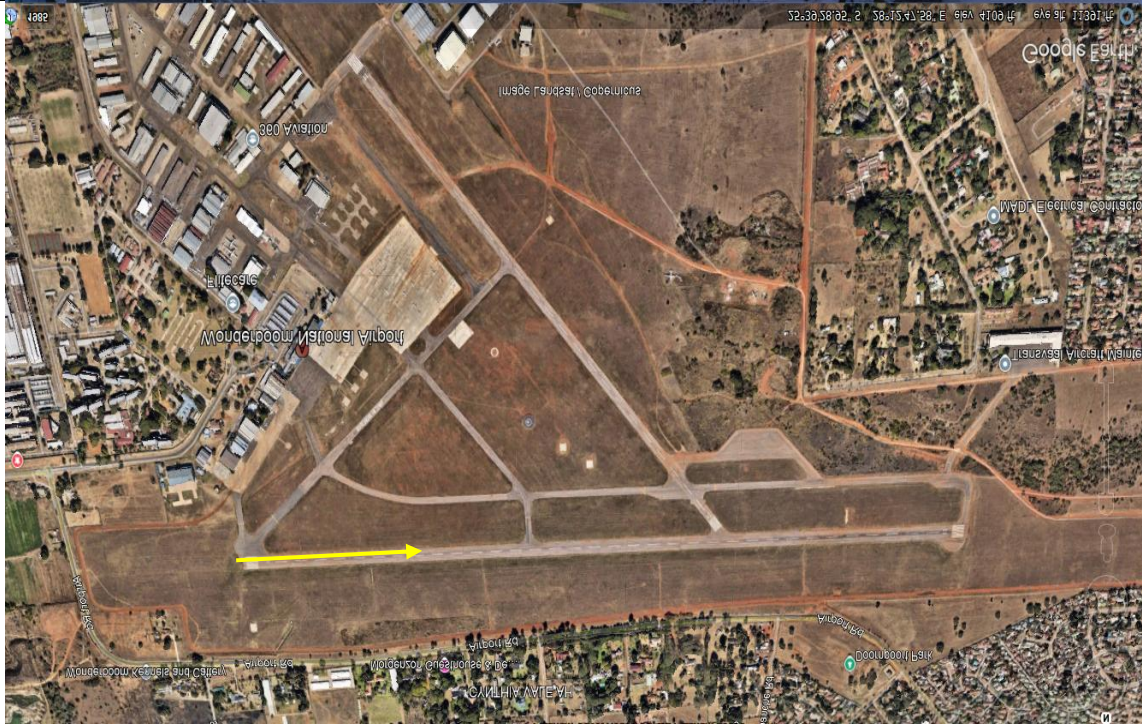
Figure 1: An aerial view of FAWB Runway 11 and the direction of landing (yellow arrow).
(Source: Google Earth)

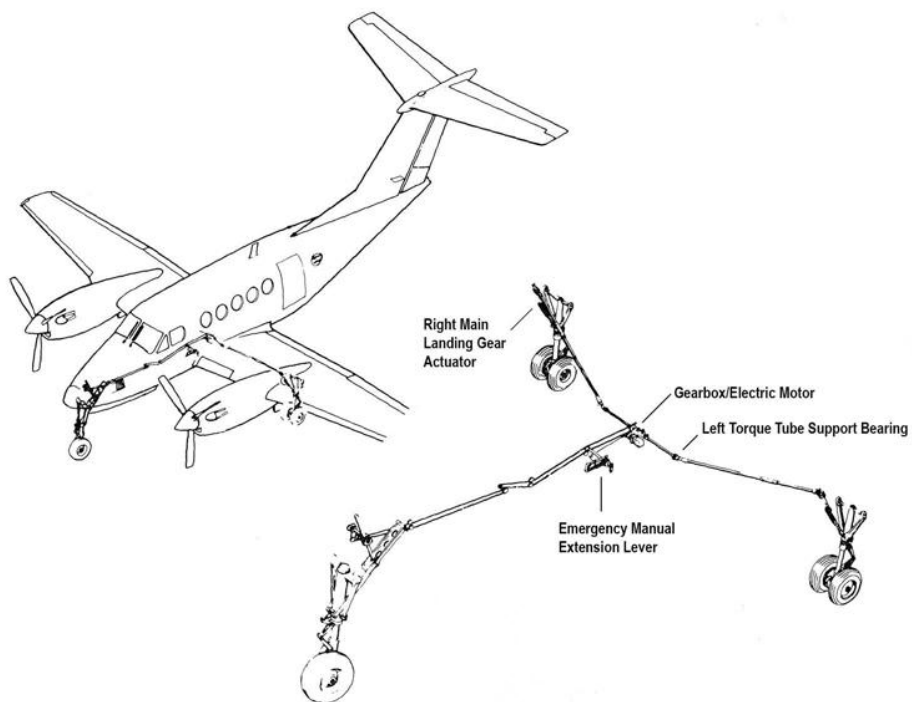
The main landing gear actuators drive torque tubes from the gearbox. A duplex chain from a sprocket on the gearbox torque shaft drives the nose gear. Four support bearings retain the left and right main landing gear torque tubes. Each outboard torque tube is coupled to a pinion gear within the main landing gear actuator housing. A spring-loaded clutch between the gearbox and the torque shaft protects the system in the event of a mechanical malfunction. A 60-Ampere circuit breaker protects the system from an electrical overload.

Illustration 1: The mechanical landing gear system of the Super King Air 200 B200.
 (Source: Pilot's Operating Handbook)
