LIMITED OCCURRENCE INVESTIGATION REPORT – FINAL

Reference Number	CA18/3/2/1525						
Classification	Serious Incident	Date	01 February 2026		Time	0735Z	
Type of Operation	Training (Part 141)						
Location							
Place of Departure	Lanseria International Airport (FALA), Gauteng Province		Place of Intended Landing		Lanseria International Airport (FALA), Gauteng Province		
Place of Occurrence	On a field approximately 3.4 nautical miles (nm) south-west of Runway 07 at Lanseria International Airport (FALA)						
GPS Co-ordinates	Latitude	25° 59' 17" S	Longitude	27° 59' 12" E	Elevation	4 517 ft	
Aircraft Information							
Registration	ZS-SDR						
Make; Model; S/N	Piper, PA-28-181 Acher II (Serial Number: 28-7890063)						
Damage to Aircraft	None			Total Aircraft Hours	1 521.9		
Pilot-in-command							
Licence Type	Commercial Pilot Licence (CPL)		Gender	Male		Age	24
Licence Valid	Yes	Total Hours	2 148.5		Total Hours on Type	1 530.3	
Total Hours 30 Days	95.2		Total Flying on Type Past 90 Days	209.3

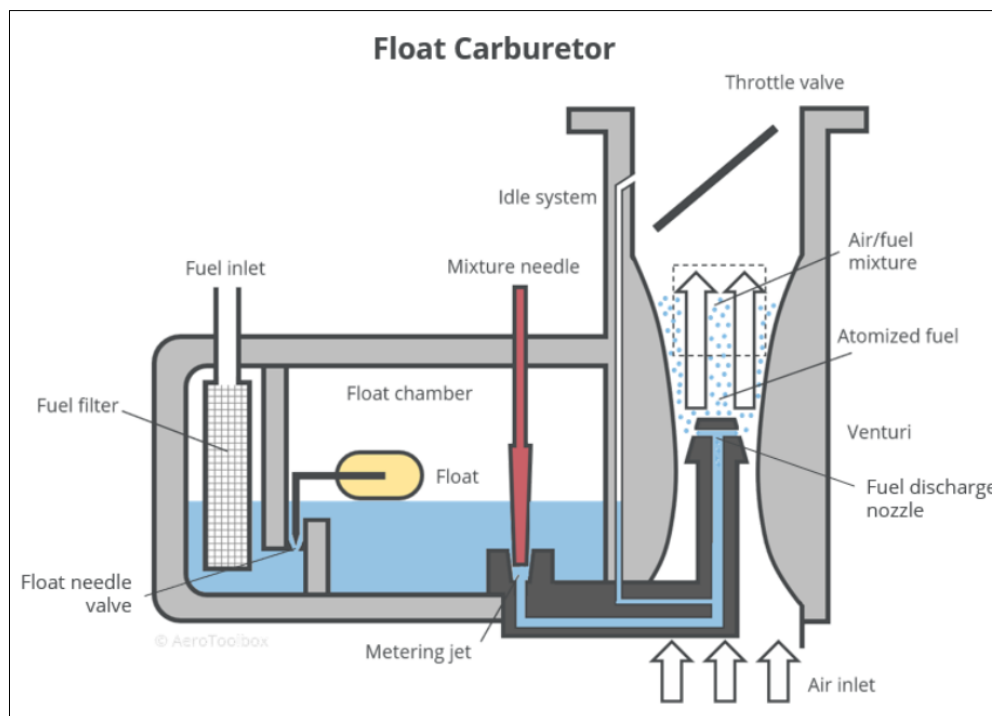
Diagram 1: A typical float type carburettor component.

The combination of the temperature drop as a result of the geometry of the venturi and the drop due to the latent heat required to vaporise the fuel can quite easily result in a situation where the temperature in the throat drops below freezing. If this happens, then any moisture in the air entering the venturi may freeze and stick to the side of the venturi.

This type of icing is termed fuel evaporation icing and can take place in ambient temperatures as high as 100°F (38°C) under the correct conditions of humidity. Icing is most likely to occur when temperatures are at or below 70°F (21°C) and relative humidity is above 80%.
