**AIRCRAFT SERIOUS INCIDENT REPORT AND EXECUTIVE SUMMARY**

| | | | | <b>Reference:</b> | | CA18/3/2/1539 | |
| <b>Aircraft Registration</b> | ZU-IXR | <b>Date of Incident</b> | 28 February 2026 | | <b>Time of Incident</b> | 1130Z | |
| <b>Type of Aircraft</b> | Jabiru J430 | | <b>Type of Operation</b> | | Private (Part 94) | | |

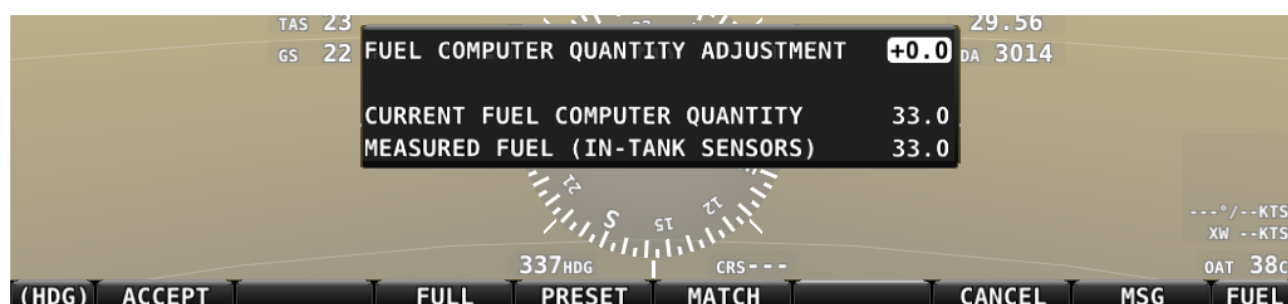
**Figure 9:** Fuel computer and menu.

Fuel computer adjustments are made by selecting the FUEL icon(s) on the Engine Tools Page. When Fuel is selected, a pop-up window will appear near the bottom of the screen, and the bottom bar menu will change to present options for changing the current fuel state in the fuel computer

- 2.2.9. The AMO engineer stated that when they arrived at the scene to assist in co-ordinating the recovery of the aircraft, the EFIS indicated that it had 52 litres of fuel remaining. The pilot indicated to the engineer that the low fuel light was on (once the light illuminates, the pilot has 10 minutes to land before the fuel runs out). During disassembly of the aircraft for transportation to the AMO's facility, the wings were removed and it was noted that there was no fuel in the fuel tanks (apart from the less than a litre of unusable fuel).

- 3.2.4. The pilot demonstrated an insufficient understanding of the EFIS, resulting in failure to correctly know the fuel state prior to take-off.

**NB:** To obtain accurate data, one must reset the fuel computer every time one adds fuel to the aircraft. SkyView HDX can assist with this through the Fuel Auto Detect setting described in this section.

- 2.2.10. At the AMO facility, the aircraft engine and fuel system were inspected, and no faults were found. The EFIS system was also inspected, and no anomalies were identified. The EFIS system was reset to show the correct fuel reading and it worked normally.
