Section/division **Accident and Incident Investigations Division**

## LIMITED OCCURRENCE INVESTIGATION REPORT – FINAL

| <b>Reference Number</b> | CA18/3/2/1551 | | | | | | |
| <b>Make; Model; S/N</b> | Ayres S2R-T34 (Serial Number: 6013) | | | | | | |

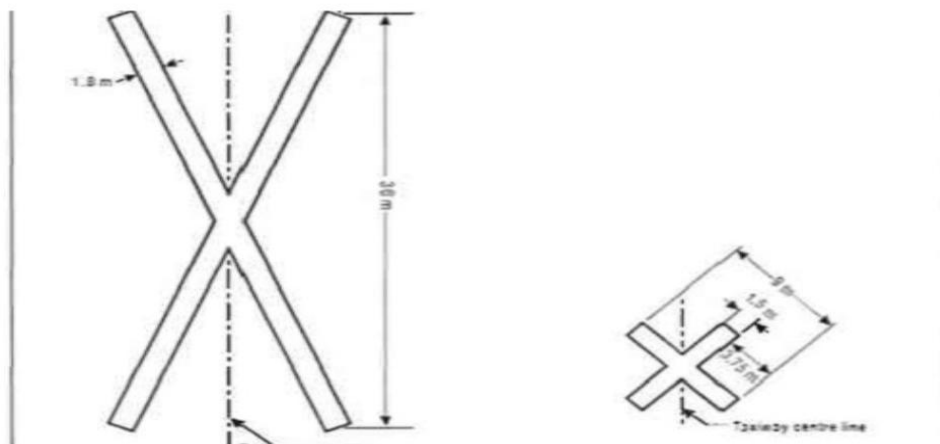
**Diagram 1:** An illustration of a closed runway or taxiway. (Source: SA-CATS 139.02.23 Subpart 12)

The airfield (FABM) was not compliant with the requirements of the SA-CATS 139.02.23, Subpart 12. Although the NOTAM was issued which advised of the temporary closure of RWY 13/31, no physical runway closure marking or signage was displayed on the runway at the time of the serious incident. The required marking or signage was only installed (displayed) after the serious incident.
