LIMITED ACCIDENT INVESTIGATION REPORT

Reference Number	CA18/2/3/9940						
Classification	Accident	Date	10 January 2021	Time	0810Z		
Type of Operation	Private (Part 91)						
Location							
Place of Departure	Brits Aerodrome (FABS)		Place of Intended Landing	Brits Aerodrome (FABS)			
Place of Accident	In the Crocodile River 3.5nm Southwest of FABS, Northwest Province						
GPS Co-ordinates	Latitude	25°35'37.5" S	Longitude	027°45'28.5"E	Elevation	3555 ft	
Aircraft Information							
Registration	ZU-RAJ						
Make/Model	Aerospatiale SE 3130-Alouette II (Serial Number. 1414)						
Damage to Aircraft	Destroyed		Total Aircraft Hours	8517			
Pilot-in-command							
Licence Valid	Yes	Gender	Male	Age	58		
Licence Type	Private Pilot Licence (PPL)						
Total Hours on Type	429.9		Total Flying Hours	936.4			
People On-board	1+2	Injuries	2	Fatalities	1	Other (On ground)	0
What Happened							
<p>On Sunday morning 10 January 2021, the pilot accompanied by two passengers on-board an Alouette II helicopter with registration ZU-RAJ, took off from Brits Aerodrome (FABS), in the Northwest province on a private (scenic) flight to Roodekoppies Dam, which was approximately 12.5 nautical miles (nm) fr

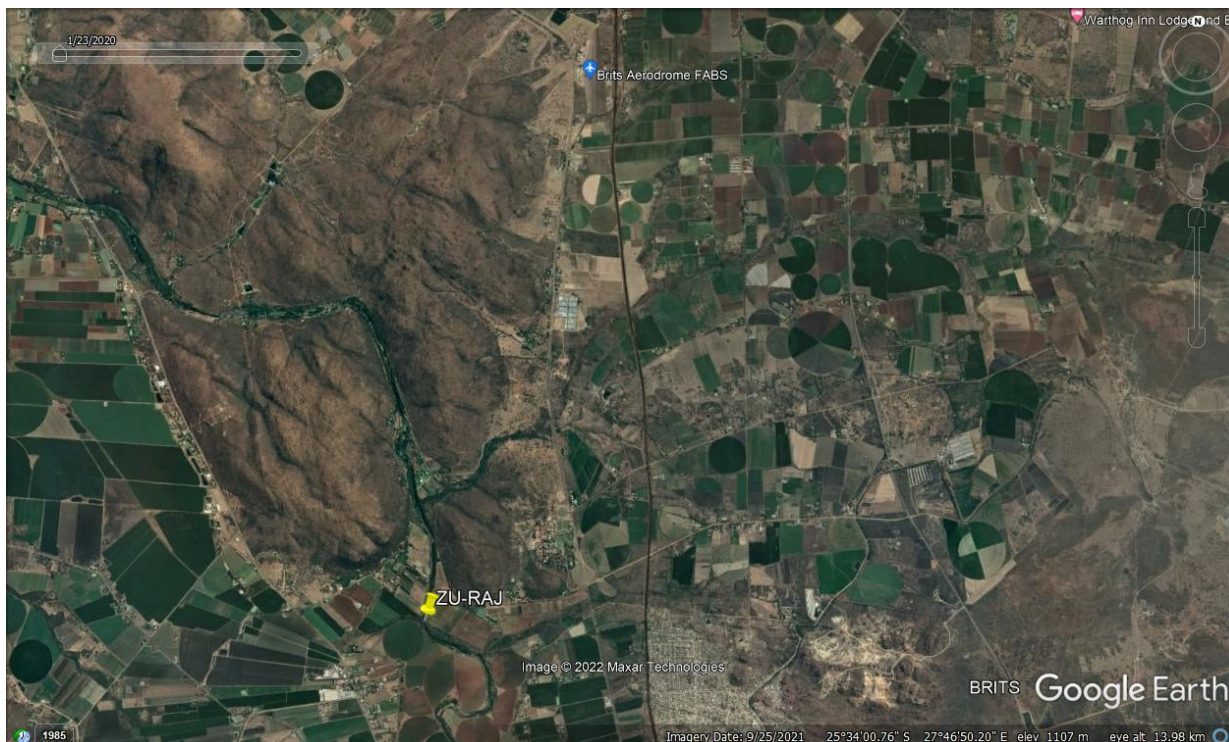
Figure 1: Google Earth overlay of the accident site (yellow pin) in relation to FABS

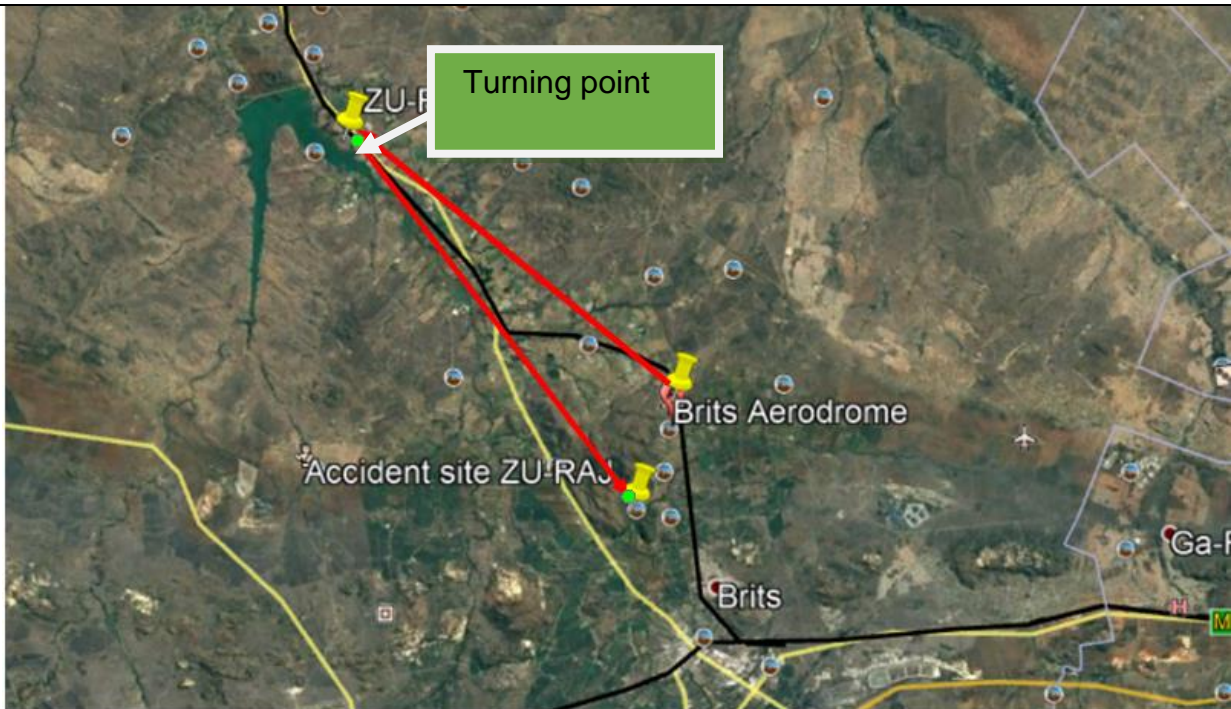
The pilot and one of the passengers were seriously injured in the accident while the second passenger was fatally injured, and the helicopter was destroyed. The accident took place 3.5nm Southwest of FABS at Global Positioning System determined to be 25°35'37.5" South 027°45'28.5" East at an elevation of 3 555ft.

Figure 2: Google Earth Image showing approximate flight path and accident location.
