AIRCRAFT ACCIDENT REPORT AND EXECUTIVE SUMMARY

Reference:		CA18/2/3/9970	
Aircraft Registration	ZU-CPJ	Date of Accident	17 March 2021		Time of Accident	0650Z	
Type of Aircraft	Windlass Aquilla Trike			Type of Operation	Training (Part 141)		
Pilot-in-command Licence Type	National Pilot Licence (NPL)		Age	58	Licence Valid	Yes	
Pilot-in-command Flying Experience	Total Flying Hours			21 826	Hours on Type	105.8	
Last Point of Departure	Ballito Airfield, KwaZulu-Natal Province						
Next Point of Intended Landing	Ballito Airfield, KwaZulu-Natal Province						
Damage to Aircraft	Destroyed						
Location of the accident site with reference to easily defined geographical points (GPS readings if possible)							
Skyland sugarcane farm, north-east of Ballito Airfield at Global Positioning System (GPS) co-ordinates determined to be 29°29'11.14" South 31°10'53.93" East at an elevation of 230 feet (ft)							
Meteorological Information	Wind direction: 100°; Wind speed: 4kts; Temperature: 22°C; Cloud Cover: Few; Cloud Base: 3 800ft; Visibility: 9 999m; QNH: 1013hPa

Reference Number : CA18/2/3/9970
Occurrence Category : Category 1
Type of Operation : Training (Part 141)
Name of Operator : Ballit

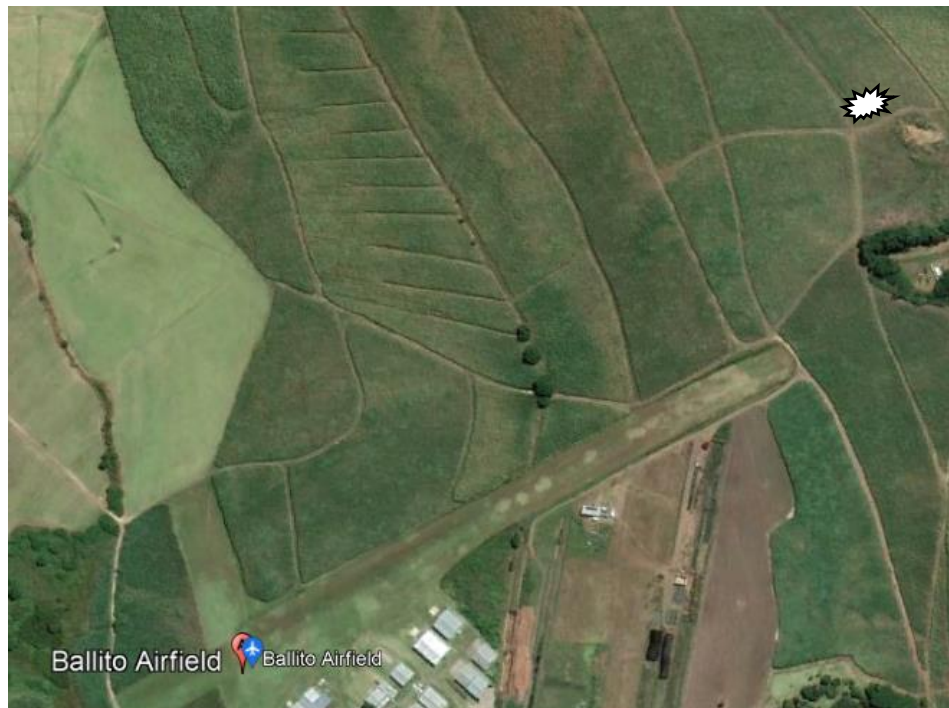
- 1.1.8 The accident occurred during daylight at Skyland sugarcane farm, north-east of Ballito Microlight School at Global Positioning System (GPS) co-ordinates determined to be 29°29'10.14" South 31°10'53.93" East, at an elevation of 230 feet (ft).

Figure 1: The accident location. (Source: Google Earth)
