PRELIMINARY ACCIDENT REPORT

Accident
- Preliminary Report -
AIID Ref No: CA18/2/3/10501

Reference Number	: CA18/2/3/10501
Occurrence Category	: Accident Category 1
Type of Operation	: Private (Part 94)
Name of Operator	: JA Earle
Aircraft Registration	: ZS-BGN
Aircraft Make and Model	: De Havilland Aircraft Company, DH-82A
Nationality	: South Africa
Registration Marks	: ZS-BGN
Place	: Dirt road near R42 and R551
Date and Time	: 28 September 2024 at 0815Z
Injuries	: None
Damage	: Substantial

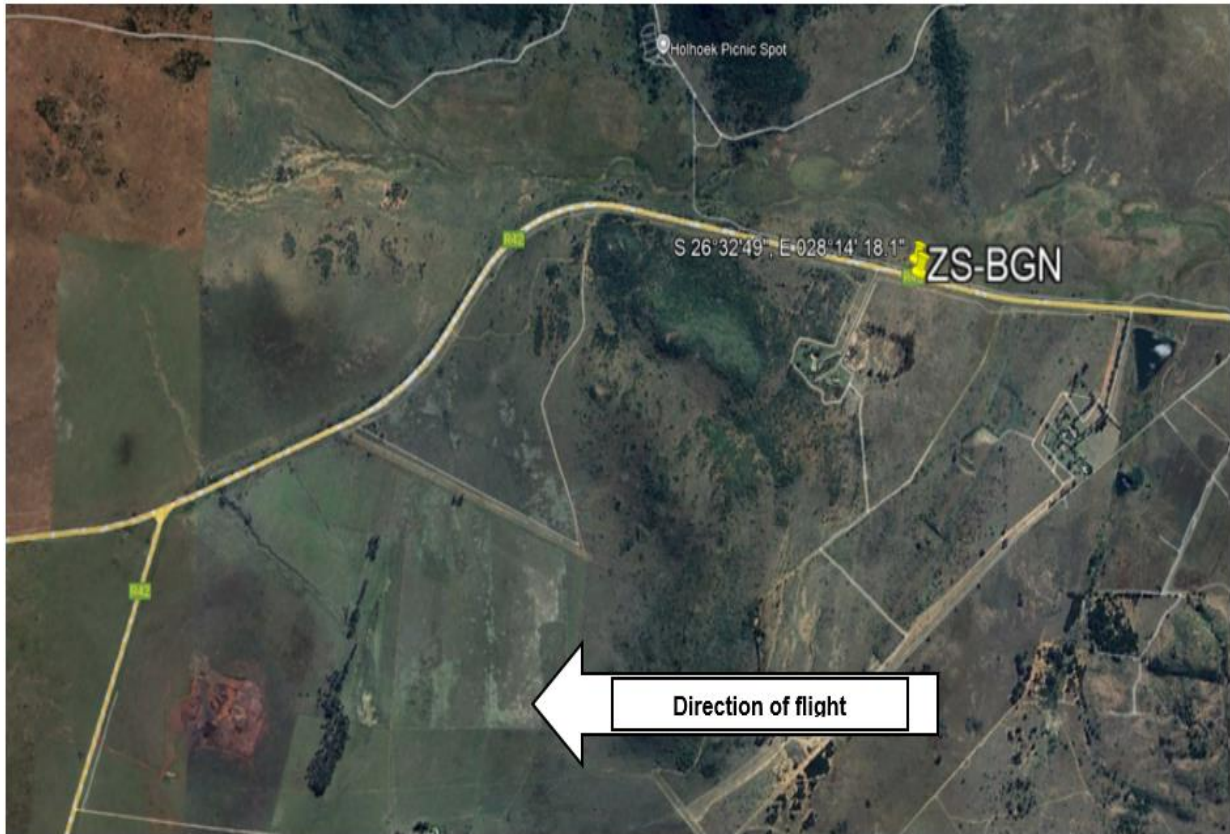
1.1.3. The accident occurred on the dirt road near the intersection of R42 and R551 at Global Positioning System (GPS) co-ordinates determined to be 26°32'49" South 28°14' 18.1" East, at an elevation of 4 846 ft.

Figure 2: The accident site. (Source: Google Maps)

1.12.2 The aircraft was found in an inverted attitude; it faced the direction from which it had approached. The dirt road surface was uneven and unfavourable to perform a safe landing.

1.12.3 The bottom side of the nose section was damaged, consistent with impact with the ground (see Figure 2). The propeller was severed, and the engine mountings were bent. The right upper wing was also damaged during the accident sequence, indicative of impact with a solid surface. The tail fin and rudder were substantially damaged due to the hard impact with the ground as the aircraft had flipped over.
