PRELIMINARY ACCIDENT REPORT

Accident
- Preliminary Report -
AIID Ref No: CA18/2/3/10392

Reference Number : CA18/2/3/10392
Occurrence Category : Category 1
Type of Operation : Training (Part 141)
Name of Operator : Unitas Flying School
Aircraft Registration : ZS-CZR
Aircraft Make and Model : Piper, PA-28-180 Cherokee
Nationality : South African
Place : Approximately 1.38nm from Vereeniging Airfield Runway 03
Date and Time : 23 November 2023 at 1430Z
Injuries : None
Damage : Substantial

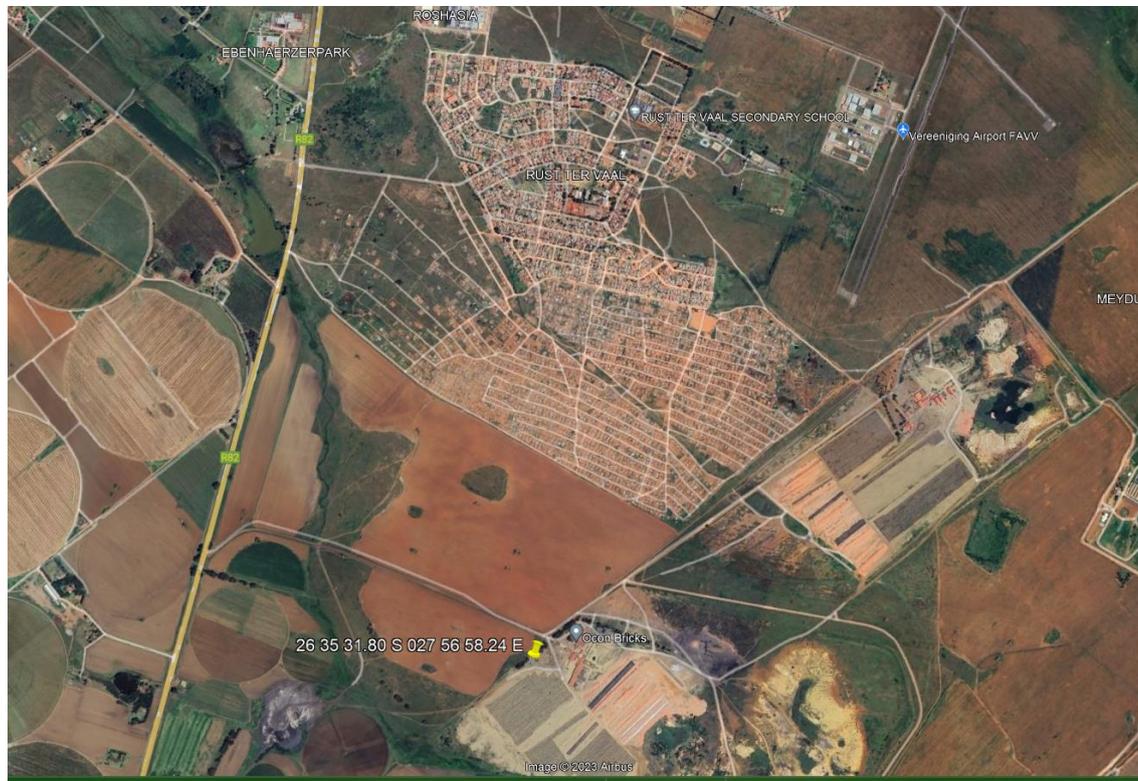
- 1.1.3 The accident occurred during daytime at approximately 1.38nm from FAVV Runway 03 threshold at Global Positioning System (GPS) co-ordinates determined to be 26°35'31.80 South 027°56'58.24" East, at a field elevation of 4 855 ft.

Figure 2: The view of the accident site (yellow pin). (Source: Google Earth)
