PRELIMINARY ACCIDENT REPORT

Accident  
- Preliminary Report -  
AIID Ref No: CA18/2/3/10588

<b>Reference Number</b>	: CA18/2/3/10588
<b>Occurrence Category</b>	: Accident (Category 2)
<b>Type of Operation</b>	: Private (Part 91)
<b>Aircraft Registration</b>	: ZS-CZU
<b>Aircraft Make and Model</b>	: Piper Aircraft Corporation, PA-28-180
<b>Nationality</b>	: South African
<b>Place</b>	: Bloemhof Farm near Greytown, KwaZulu-Natal Province
<b>Date and Time</b>	: 8 June 2025 at 1630Z
<b>Injuries</b>	: One of the crew members sustained minor injuries
<b>Damage</b>	: Substantial

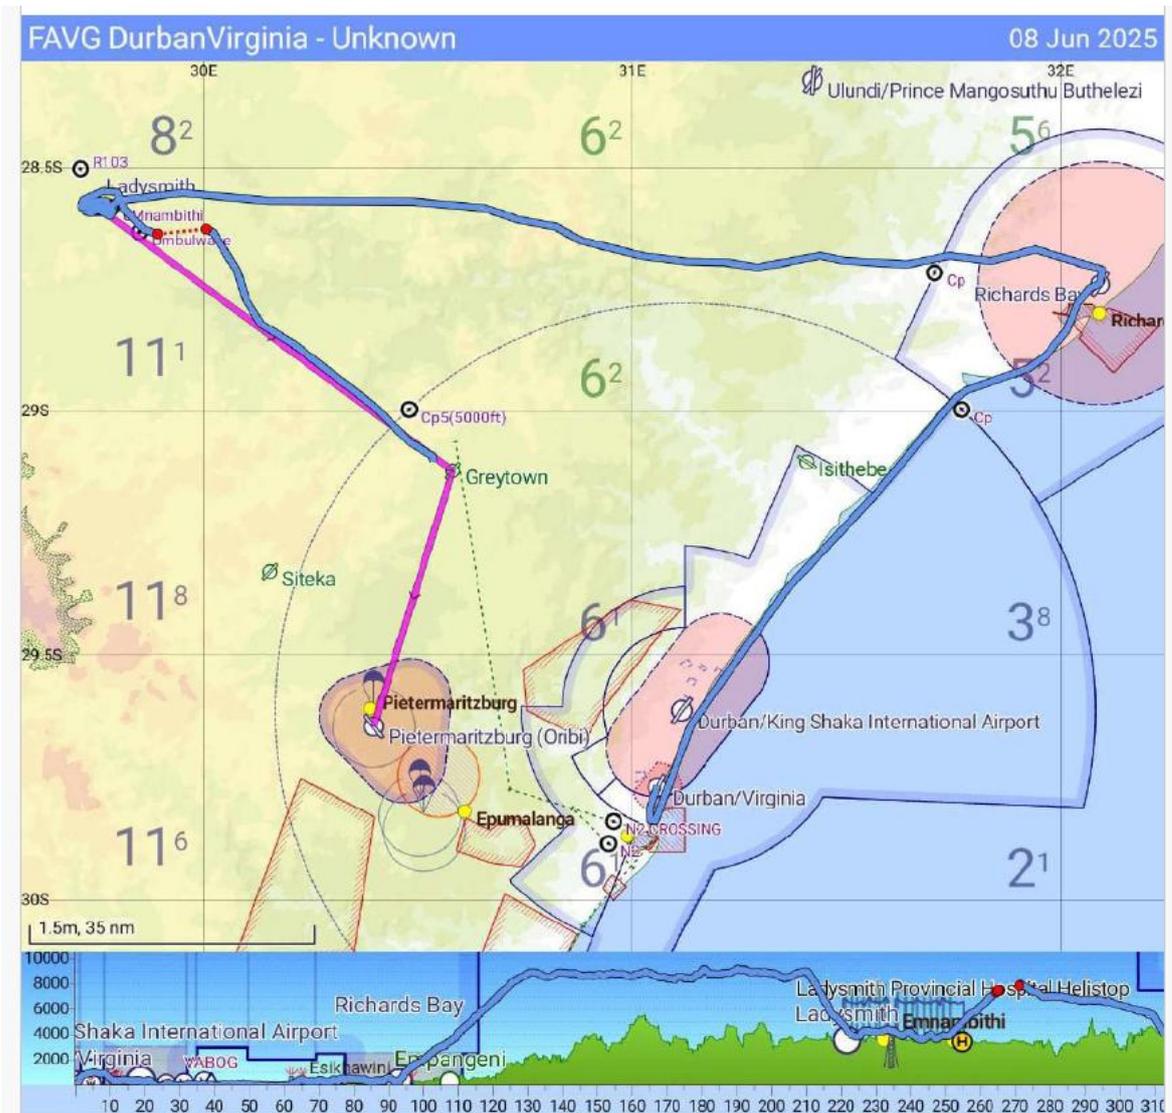
**Figure 2:** The flight track that was downloaded from the iPad.

- 1.1.5 Figure 2 shows the iPad software application flight track (blue line). The software application, however, stopped recording when the aircraft was north-west of Greytown. The accident site was approximately 3 nautical miles (nm) south-west of Greytown.

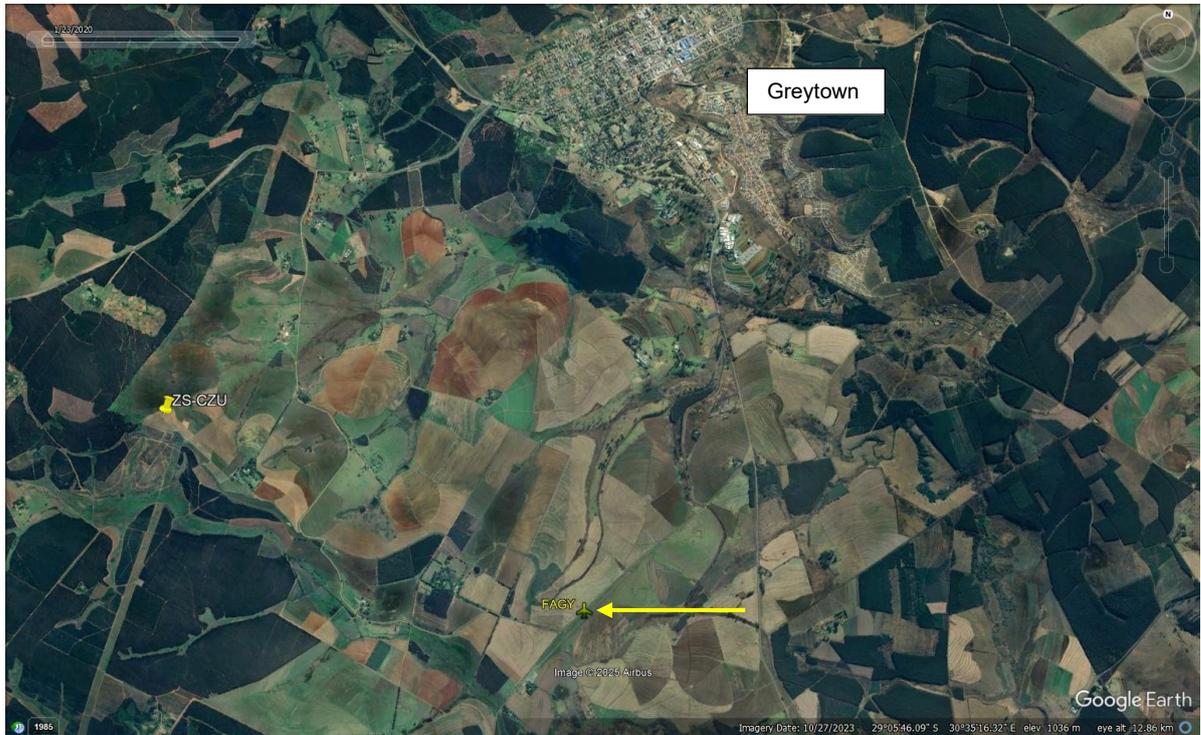
**Figure 3:** The position of ZS-CZU with reference to FAGY and Greytown. (Source: Google Earth)

- 1.1.6 After the accident, the PF called one of the pilots on the ZS-EIL aircraft to inform him that they had crashed on a sugarcane field, south-west of Greytown. Thereafter, at 1631Z, he informed the Aeronautical Rescue Co-ordination Centre (ARCC) about the accident. An official search for the aircraft commenced, and the PF was contacted to send a pin location to the ARCC. The local police and emergency services personnel were also notified about the accident. The emergency services were the first to arrive at the scene at 1810Z, 2.8 nautical miles (nm) west of FAGY and 33nm north of FAPM.
- 1.1.7 The accident occurred during nighttime at Bloemhof Farm, approximately 3nm south-west of Greytown at Global Positioning System (GPS) co-ordinates determined to be 29°06'13.60" South 030°32'13.22" East, at an elevation of 3 821 feet (ft).

2.2.17 Greytown Aerodrome (FAGY) was the crew's selected second alternate aerodrome on the filed flight plan. FAGY is licensed with runway lights and approach lights for Runway 24; however, the runway lights needed to be activated from the aircraft. The crew was not familiar with the procedure to switch on the lights. There was also a DVOR navigational beacon at the aerodrome. Furthermore, the aerodrome chart stated that *to land at this facility at night, pilot(s) need to be IF-rated*; neither of the crew members complied with this requirement. The accident site was 2.8nm east of FAGY (see Figure 3).

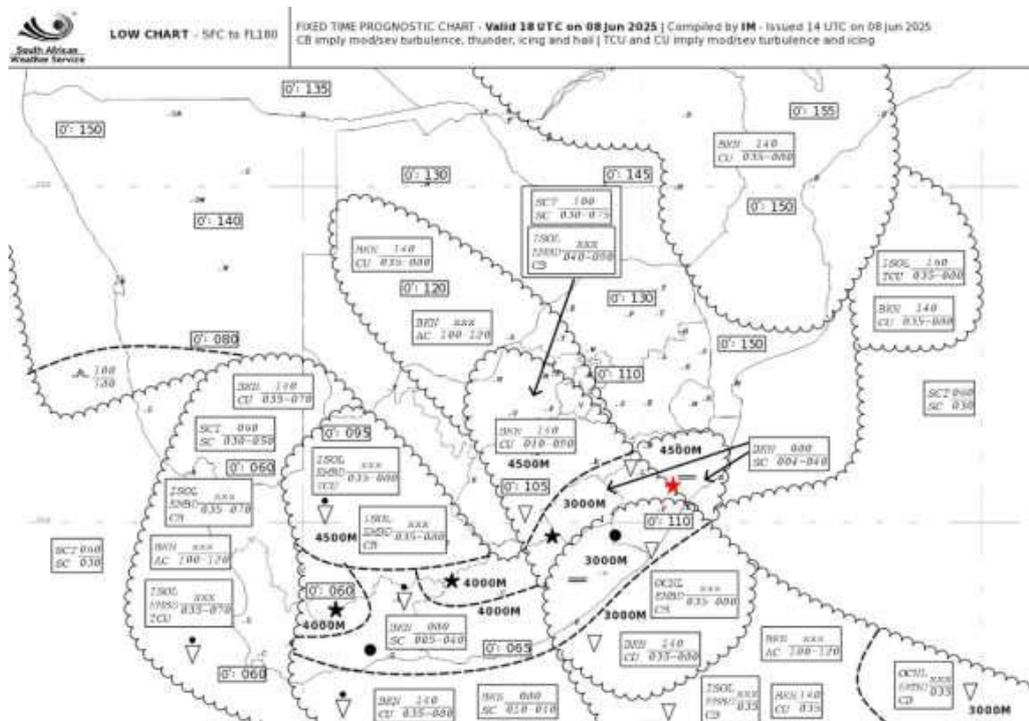
**Figure 5:** The 1800Z low-level SigWx chart for 8 June 2025. (Source: SAWS)

The low-level Significant Weather (SigWx) chart that was issued at 1400Z and valid for 1800Z on 8 June 2025 forecasted low-level clouds with reduced visibility (mist) (see Figure 5 low-level chart). The forecast also showed that there were embedded cumulonimbus clouds in the vicinity where visibility was expected to reduce to 3000m in thundershowers. The red star indicates the approximate estimated area of the accident.

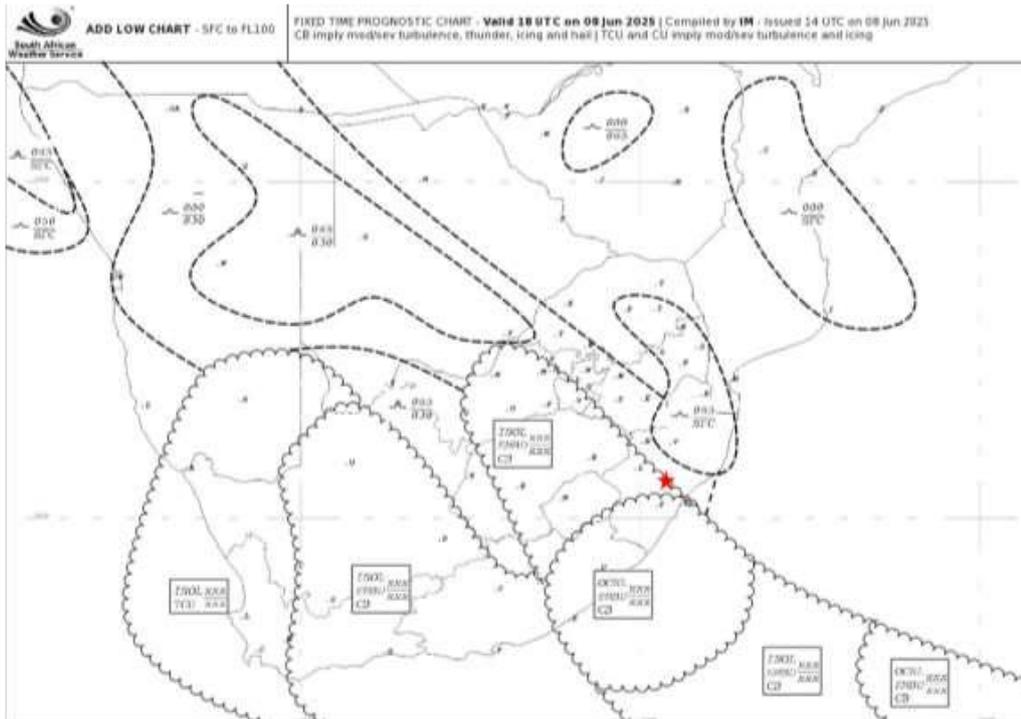
**Figure 6:** The 1800Z additional low-level SigWx chart for 8 June 2025. (Source: SAWS)

The additional low-level Significant Weather (SigWx) chart forecast that was issued at 1400Z and valid for 1800Z on 8 June 2025 also indicated embedded cumulonimbus clouds with moderate low-level turbulence from surface to 8000ft east/north-east of the accident site (see Figure 11). The red star indicates the accident area.

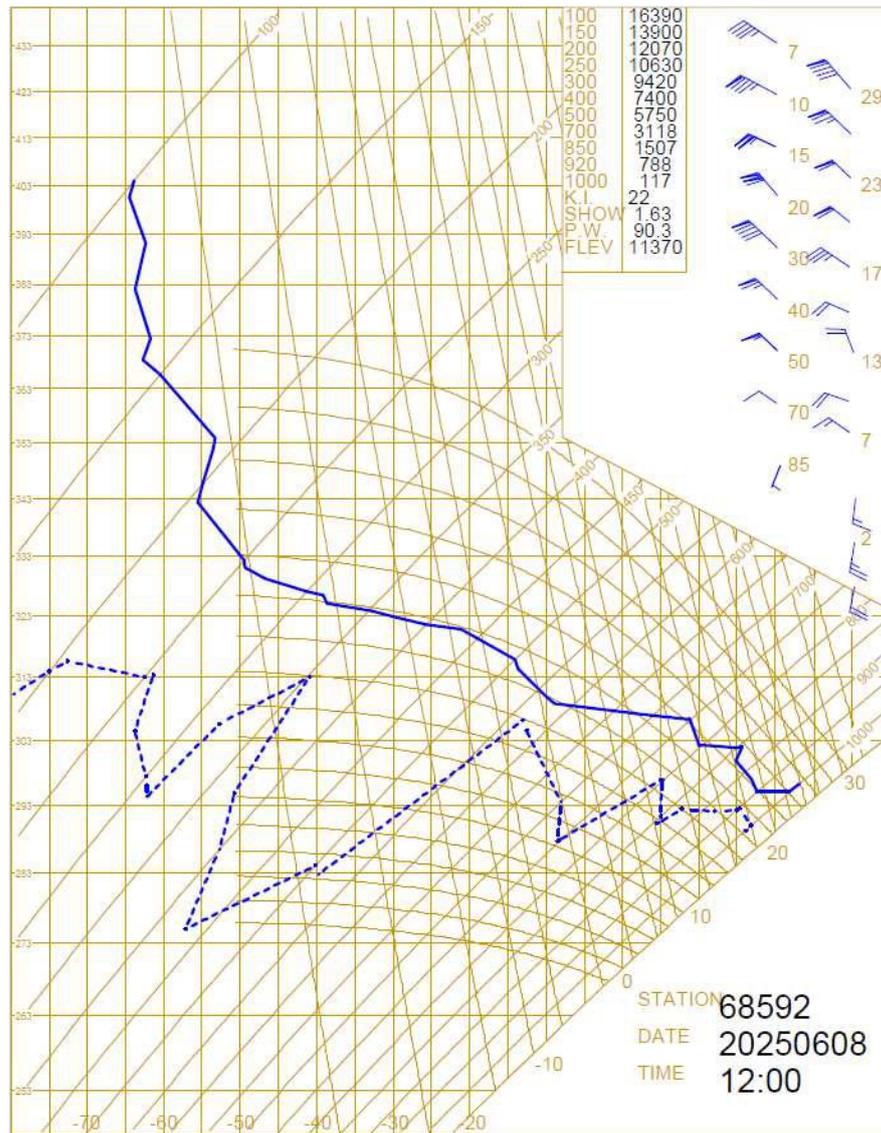
Figure 7: The 1200Z midday upper air ascent from FALE on 8 June 2025. (Source: SAWS)

The 1200Z midday upper air ascent from King Shaka International Aerodrome (FALE) (68592) showed moist and unstable (K-index was 22) conditions. There was an inversion at the surface, and wind at the surface was moderate-to-strong southerly to south-westerly at 20 to 25 knots (kts) above 850 hectopascal (hPa) in the lower level of the atmosphere.
