**PRELIMINARY ACCIDENT REPORT**

**Accident and Incident Investigations Division**

Accident  
- Preliminary Report -  
AIID Ref No: CA18/2/3/10664

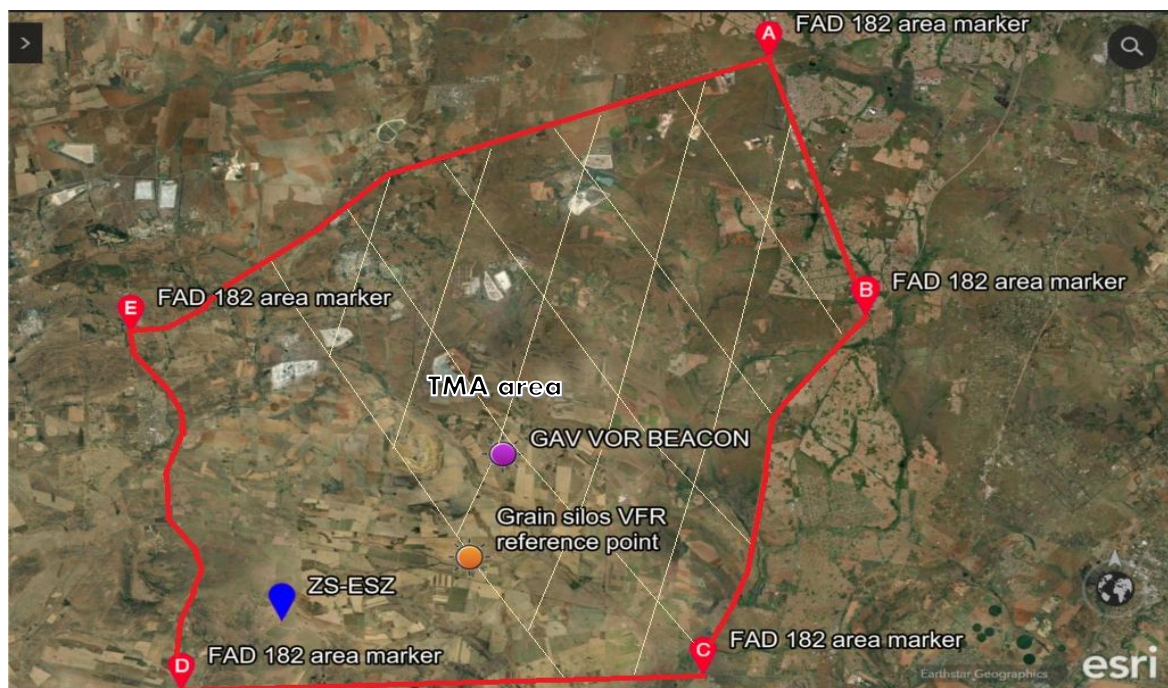
**Figure 7:** The accident site (blue mark) in the FAD 182 airspace with the TMA space denoted by the hatched area. (Source: ArcGIS Earth Esri Map)

1.18.1. The accident occurred in the Johannesburg GFA at FAD 182, outside of the terminal control area (TMA). The vertical limits of FAD 182 start from the ground to flight level 100 (10 000ft), except where it intersects the TMA (see Figure 7).
