**PRELIMINARY SERIOUS INCIDENT REPORT**

**Accident and Incident Investigations Division**

Serious Incident  
- Preliminary Report -  
AIID Ref No: CA18/3/2/1447

On Sunday morning, 21 April 2024 at approximately 0948Z, a Boeing 737-800 aircraft with registration ZS-FGE was on a scheduled commercial flight from O.R. Tambo International Aerodrome (FAOR) in Gauteng province to Cape Town International Aerodrome (FACT) in the Western Cape province when the left outer (No.1) mainwheel separated from its axle during rotation. The crew opted to fly to the holding pattern to burn fuel. After being airborne for 2 hours and 17 minutes, the crew was cleared to land on Runway 21R at FAOR. The landing was uneventful; however, approximately 30 metres (m) before the aircraft was brought to a stop on the runway, the left inner (No. 2) mainwheel tyre burst. No person was injured during the serious incident.

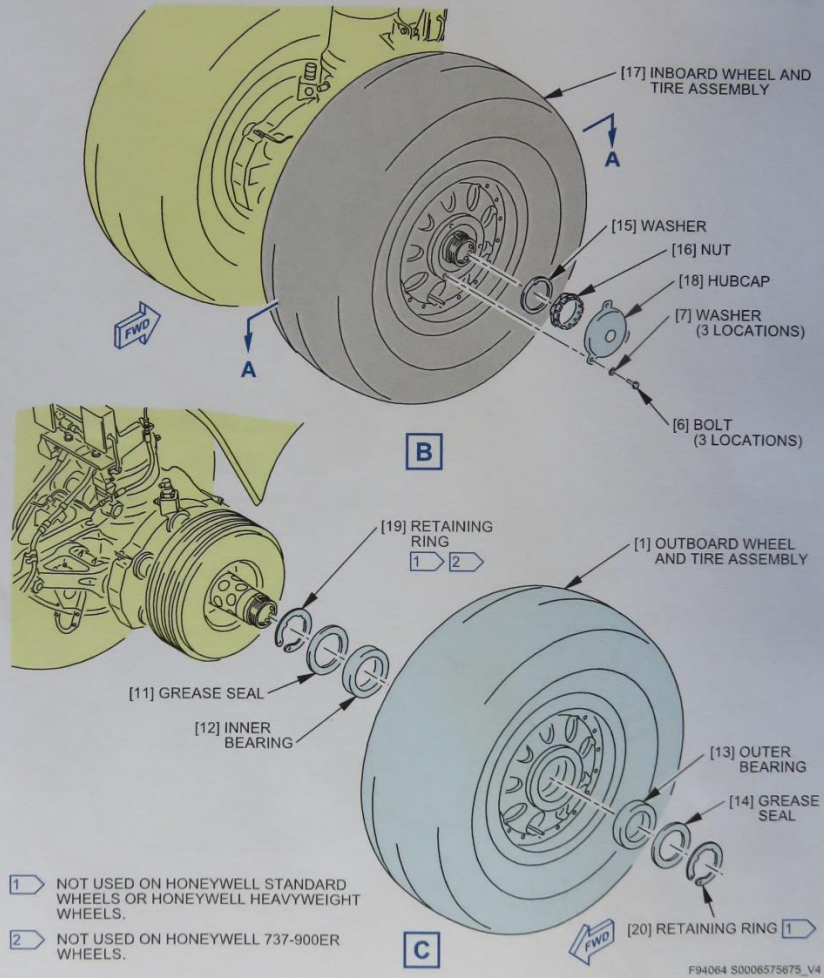
*The wheels are of a split hub design with the hubs containing the inboard and outboard tapered roller bearings (see Figure 12). The outer bearing component is known as the cup and the inner bearing component as the cone. The cup-bearing raceway is an interference fit within the hub, and the cone is a sliding fit on the stub axle. The rollers run on tracks in the cone and cup. The track on the cone is defined by a rib around its edges; there are no ribs on the cup. The inboard and outboard bearing assemblies are fitted with external grease seals which are held in place by spring steel retaining rings located in grooves in the wheel hub.*

*The bearings are provided as part of the wheel assembly. When fitted to the axle, a nut and washer are used to apply pressure to the bearings, which is known as the preload. The preload ensures the bearing cups and cones are correctly seated, and the rollers correctly aligned. This is achieved by applying a torque to the nut using a suitable torque wrench. Once the bearing assembly has been preloaded, the nut is loosened slightly, whilst maintaining a tight contact between the cup, cone and rollers, then retightened to this service torque, which is usually about 20-25% of the preload torque. Both these procedures are done whilst slowly rotating the wheel clockwise to ensure that the large roller ends are seated against the cone rib.*

**Figure 11:** Landing gear mainwheel general arrangement. (Source: Boeing)

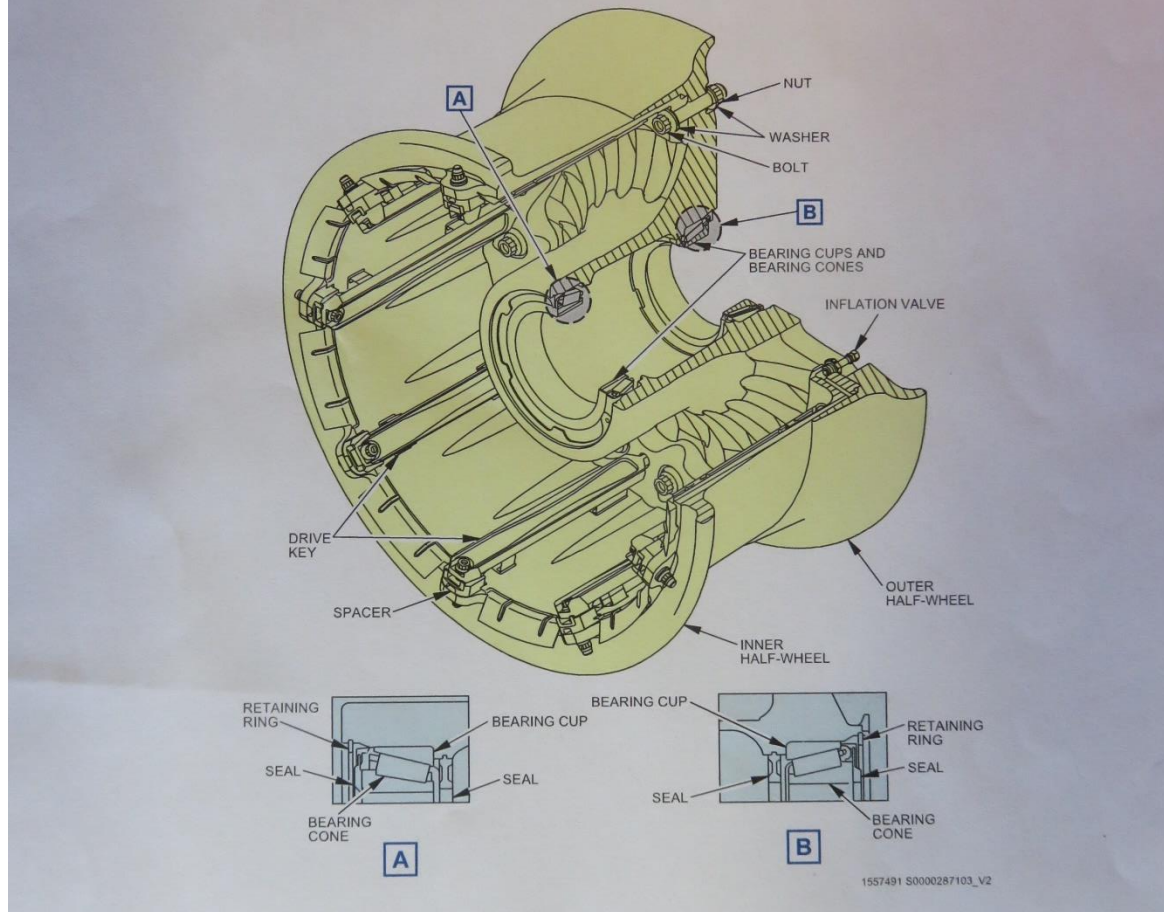
**Figure 12:** The inner [A] and outer [B] bearing arrangement. (Source: Boeing)
