PRELIMINARY ACCIDENT REPORT

Accident and Incident Investigations Division

Accident
- Preliminary Report -
AIID Ref No: CA18/2/3/10606

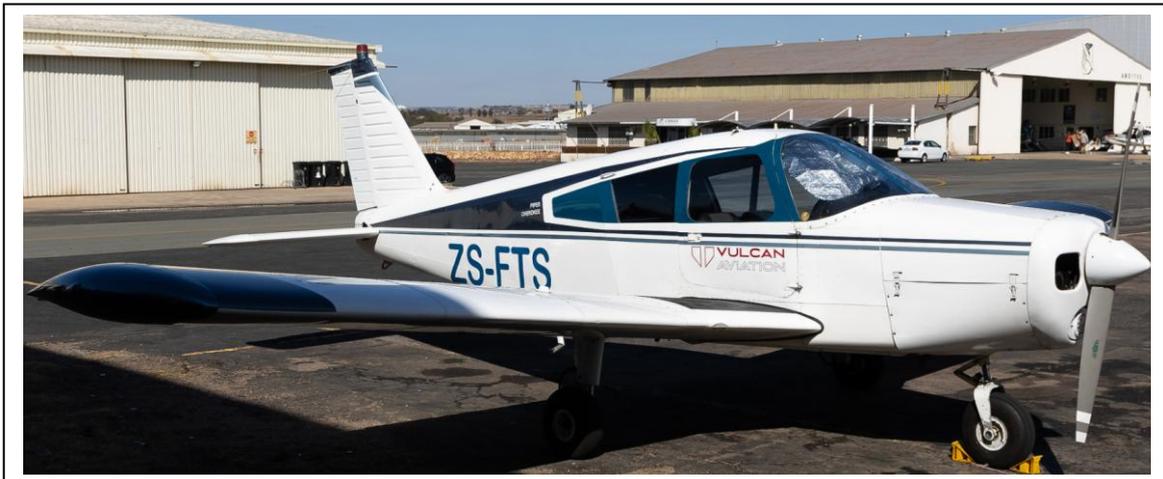
Figure 1: The file picture of ZS-FTS aircraft. (Source: <https://www.jetphotos.com/photo/11035588>)

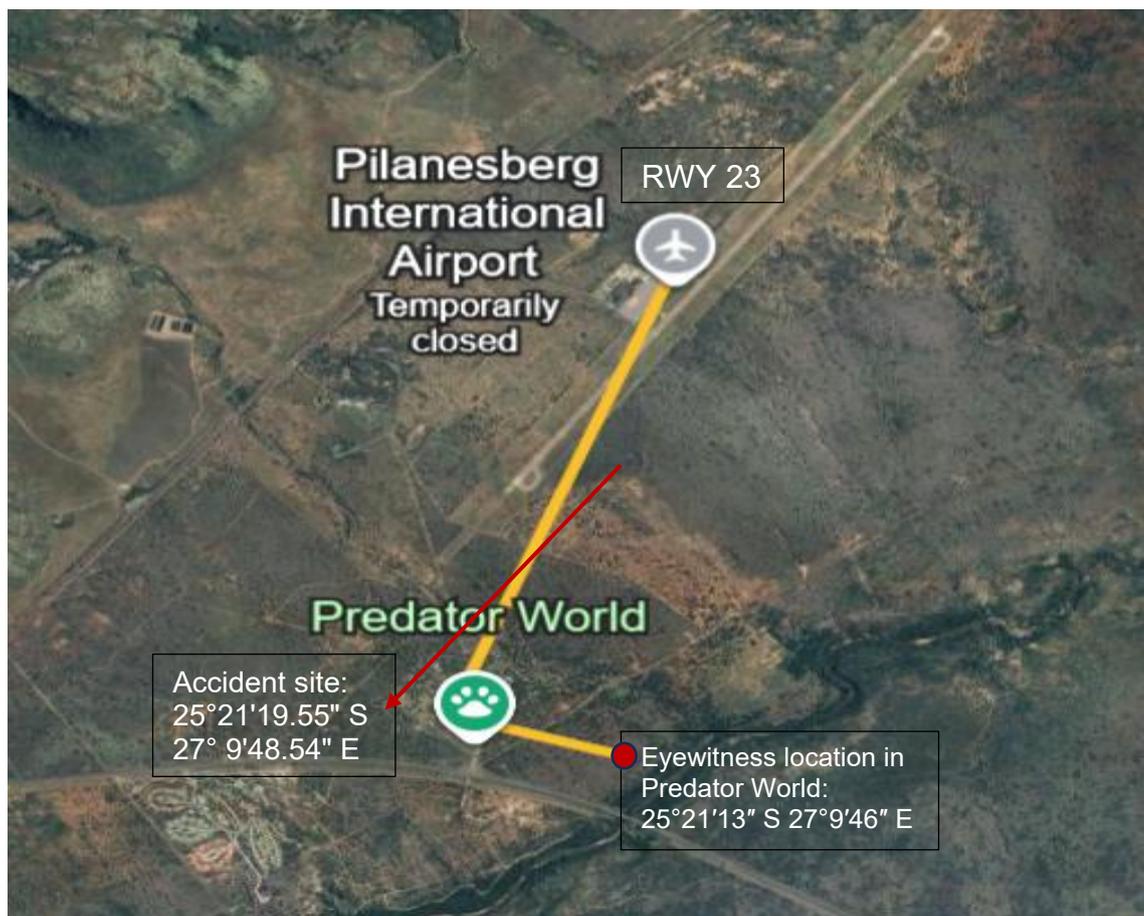
- 1.1.7. The accident occurred on the border of the Predator World wildlife sanctuary approximately 1.6km south of FAPN at Global Positioning System (GPS) co-ordinates: 25°21'19.55" S 27° 9'48.54" E, at an elevation of 3 412ft.

Figure 2: An aerial view of FAPN, the eyewitness location at Predator World wildlife sanctuary, and the accident site. (Source: Google Earth)

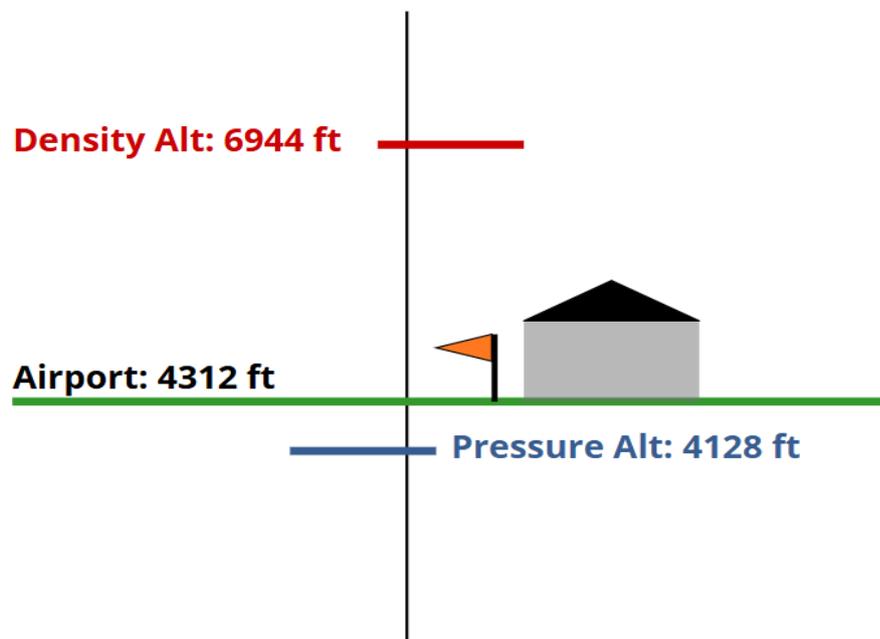
Figure 7: A diagrammatic representation of the density altitude results.

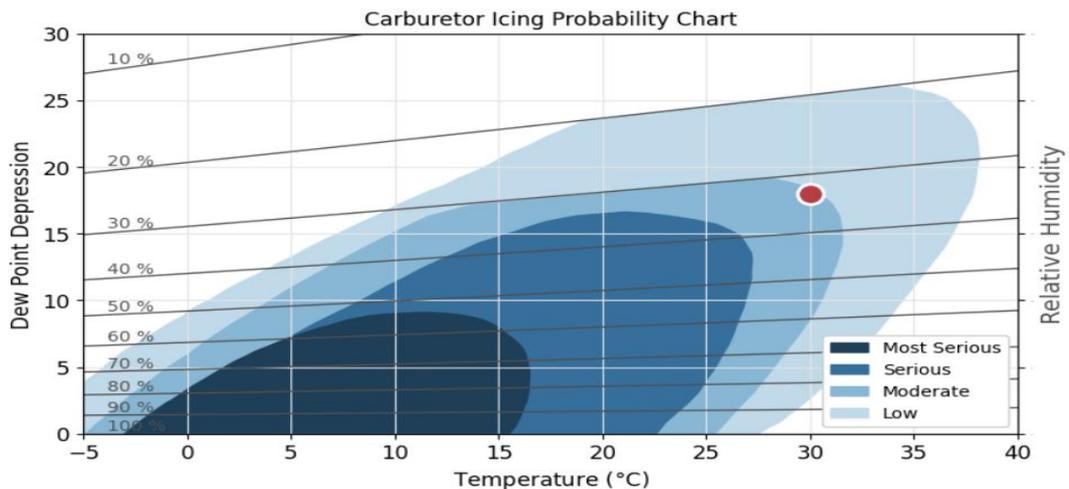
- 1.7.3. The calculated dew point depression suggested that the weather conditions at the time of the flight were favourable for the formation of moderate icing.

Moderate Risk
 Temperature: 30.0 °C | Dew point: 12.0 °C | RH: 33.05 % | Dew Point Depression: 18.0 °C

Serious icing at descent power settings.

Figure 9: The Carburettor icing-probability chart.

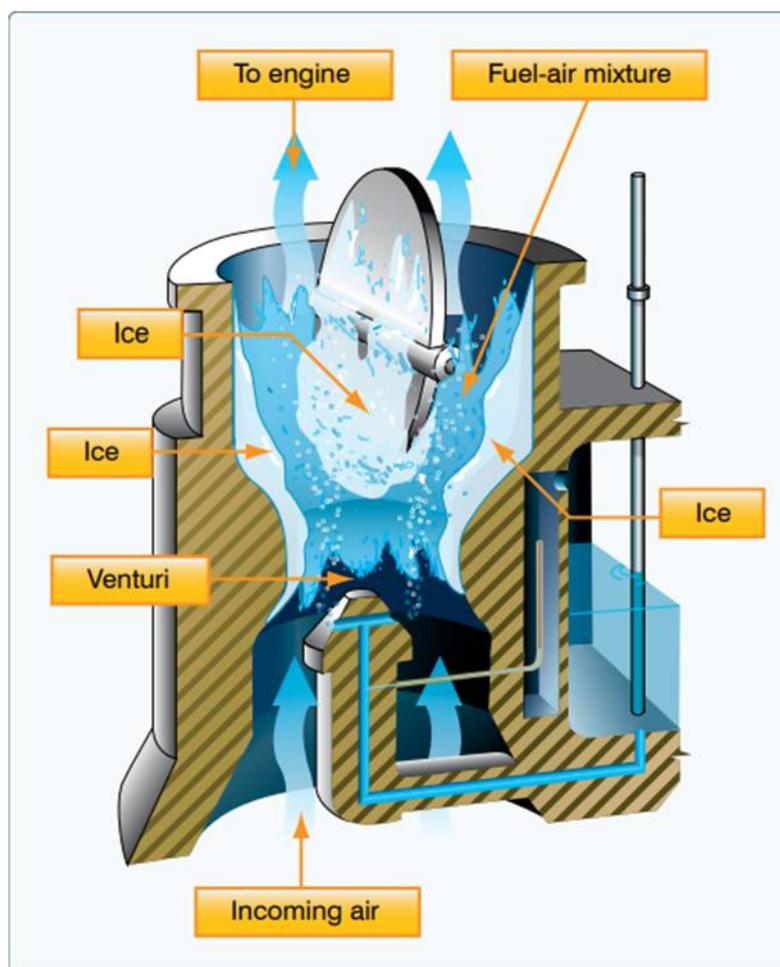
According to the ICAO (Annex 3 and Document 9760), carburettor icing during descent can significantly affect an aircraft's performance by restricting or blocking airflow to the engine due to ice forming inside the carburettor. This occurs because of the cooling effect caused by fuel vaporisation and pressure drop within the carburettor, especially when engine power is reduced during descent. The result can be a gradual or sudden loss of engine power, rough running or even engine failure if not promptly addressed. This poses a serious risk during the approach and landing phases where altitude and

time to recover are limited. During severe cases of carburettor icing, the throttle valve can become stuck due to ice build-up.

Figure 13: Typical carburettor ice build-up.
