PRELIMINARY ACCIDENT REPORT

Accident and Incident Investigations Division

Accident  
- Preliminary Report -  
AIID Ref No: CA18/2/3/10590

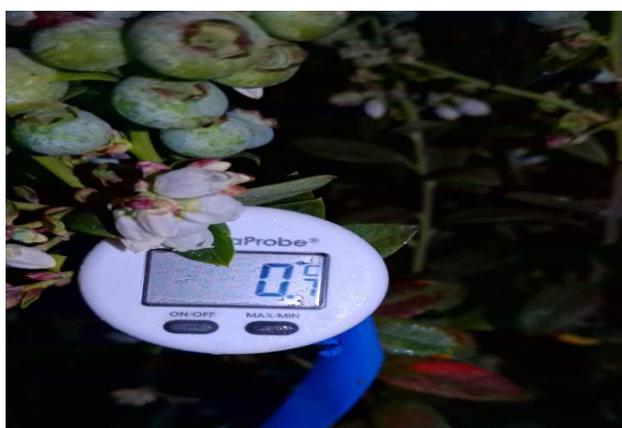
**Figure 2:** One of the temperature probes fitted to the berry crops (berries not ripe yet).  
(Source: Farm production manager)

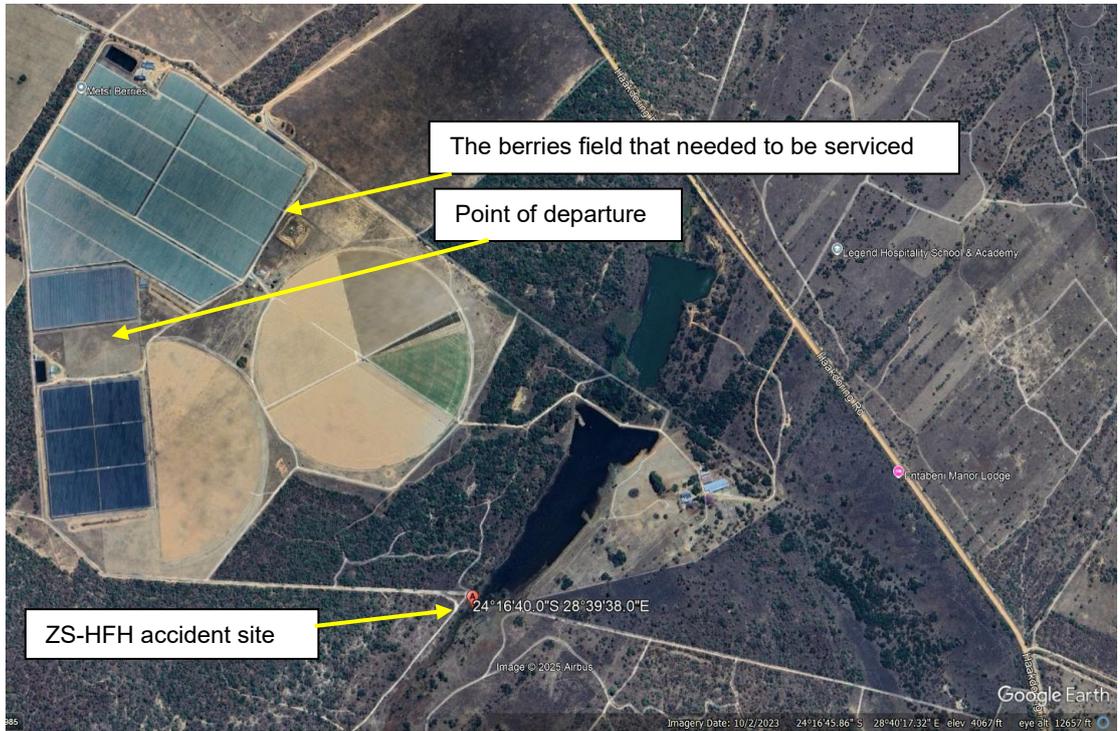
- 1.1.5 The accident occurred in a flooded ditch which stretched through the borders of Metsi Berries Farm in Modimolle-Mookgopong at Global Positioning System (GPS) co-ordinates determined to be S24°16'.40'' E28°39'.38'', at an elevation of 4 067 feet (ft).

**Figure 3:** Aerial view of the approximate accident site and the point of departure.  
 (Source: Google Earth)
