**PRELIMINARY ACCIDENT REPORT**

**Accident and Incident Investigations Division**

Accident  
- Preliminary Report -  
AIID Ref No: CA18/2/3/10657

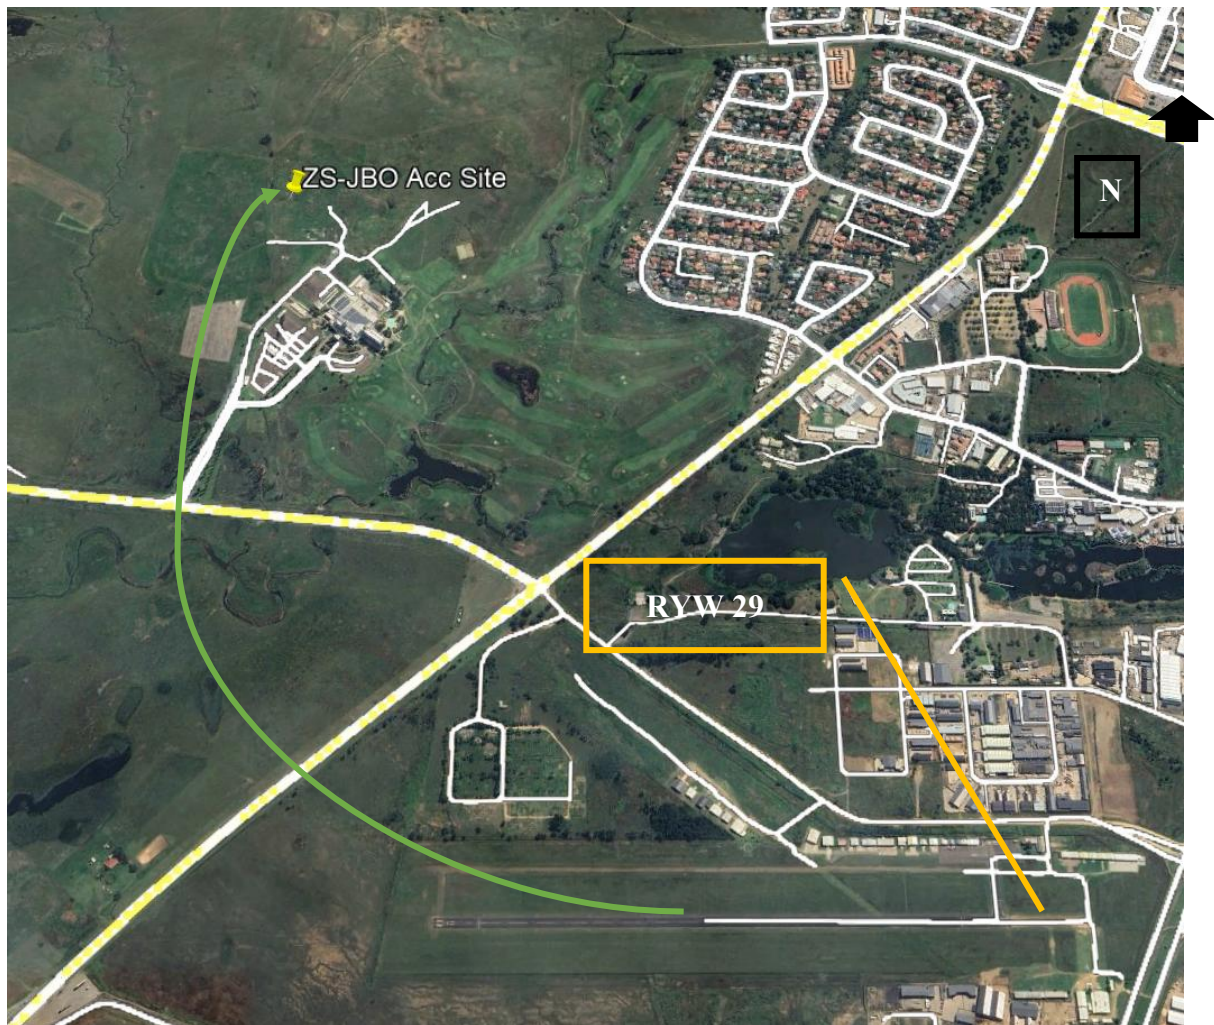
1.1.5. The accident occurred during the day, approximately 2 330m from FASC in Mpumalanga province, at Global Positioning System (GPS) co-ordinates determined to be 26°30'54" South 29°09'40" East, at a field elevation of 5 195ft.

**Figure 2:** An aerial view of the accident site which is approximately 2 330m from FASC RWY 29.  
(Source: Google Earth)
