PRELIMINARY ACCIDENT REPORT

Accident and Incident Investigations Division

Accident
- Preliminary Report -
AIID Ref No: CA18/2/3/10378

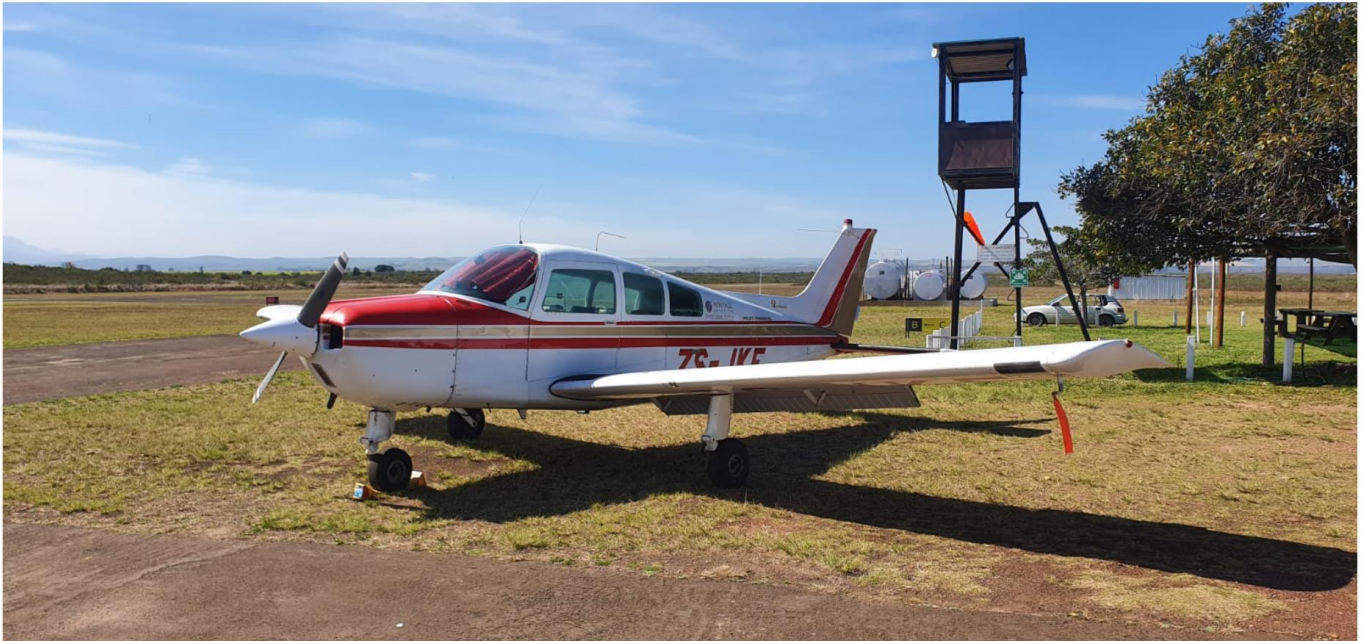
Figure 1: File picture of ZS-JKE aircraft before it was re-painted in blue stripes. (Source: Safety Pilot)

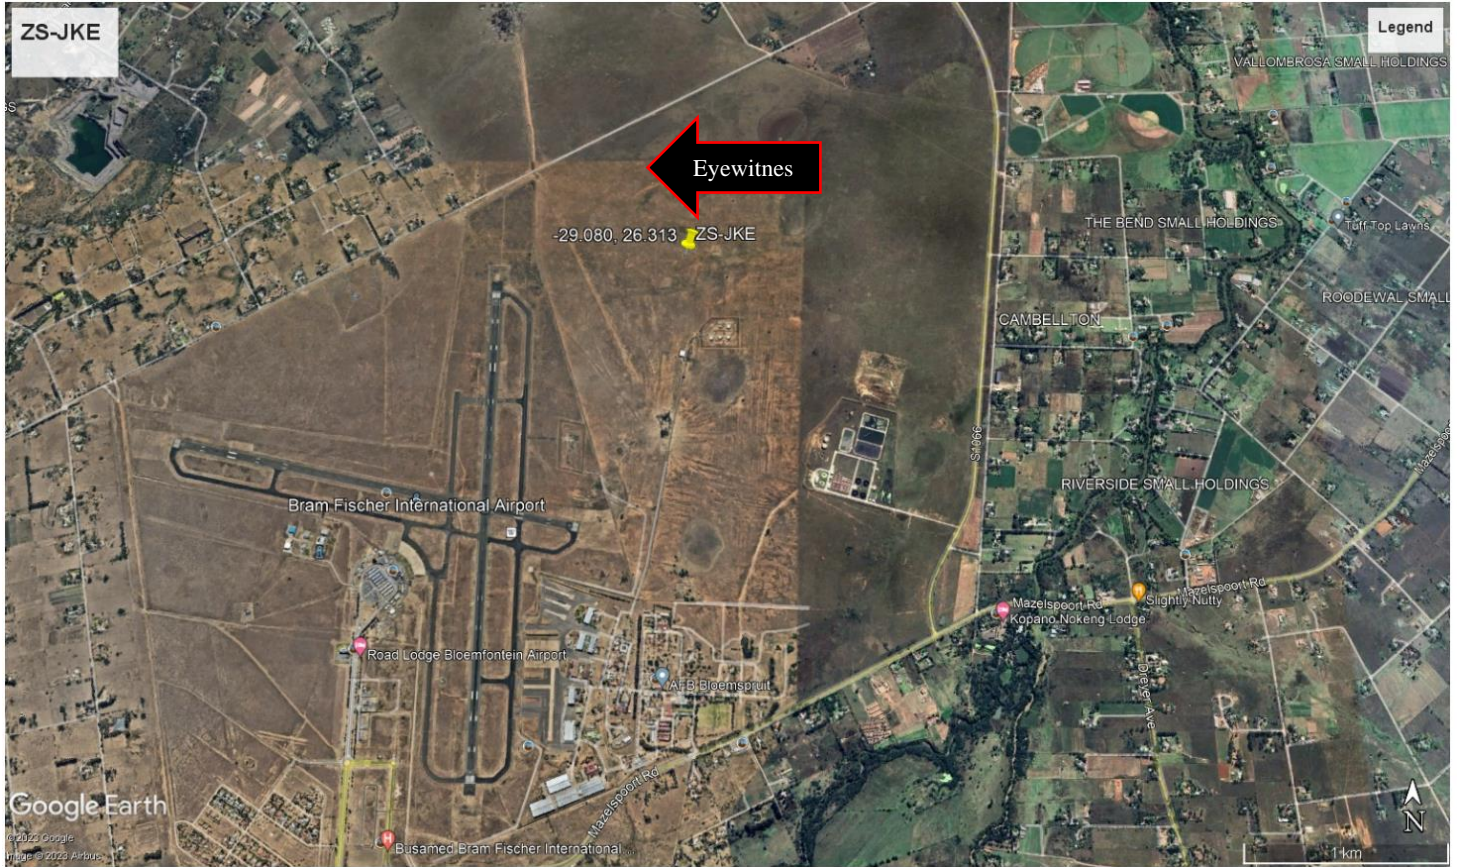
- 1.1.5 The aircraft was destroyed by post-impact fire.
- 1.1.6 The accident occurred during daylight on an open field at Bram Fischer International Airport (FABL) at Global Positioning System (GPS) co-ordinates determined to be 29°04'47.98" South 026°18'46.83" East, at an elevation of 4 409 feet (ft).

Figure 2: Aerial view and elevation profile of the crash site. (Source: Google Earth)
