PRELIMINARY ACCIDENT REPORT

Accident and Incident Investigations Division

Accident
- Preliminary Report -
AIID Ref No: CA18/2/3/10572

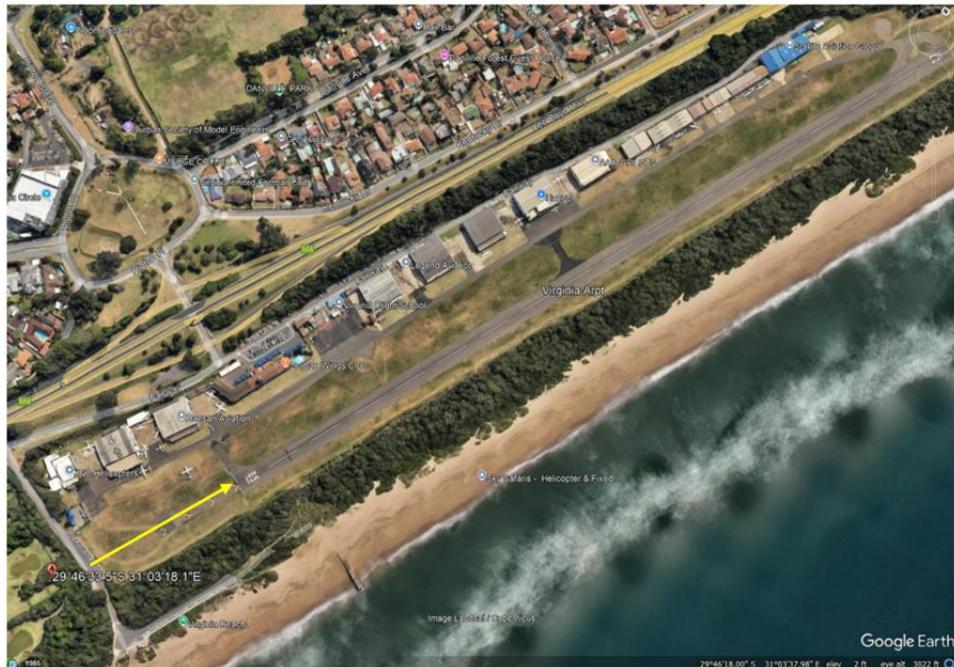
1.1.5. The accident occurred during the day, approximately 300m from the threshold of FAVG Runway 05 at Global Positioning System (GPS) co-ordinates determined to be S29°46′33.5″ E31°03′18.1″.

Figure 2: Aerial view of the accident site. The yellow arrow indicates the distance between the crash site and FAVG Runway 05 threshold. (Source: Google Earth)
