PRELIMINARY ACCIDENT REPORT

Accident and Incident Investigations Division

Accident
- Preliminary Report -
AIID Ref No: CA18/2/3/10541

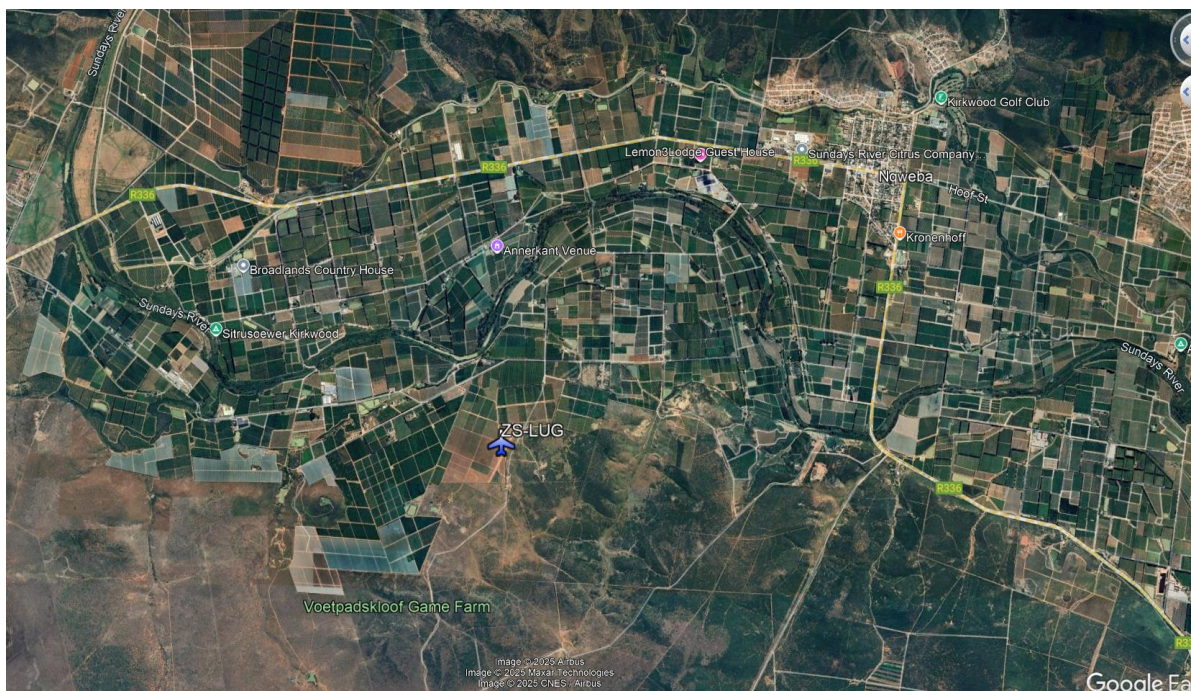
Figure 2: Aerial view of the accident site. (Source: Google Earth)

- 1.1.5. The accident occurred on Runway 22 at Kirkwood Airstrip, Sundays River Valley, 30 nautical miles (nm) north-west of Port Elizabeth Airport (FAPE) and at Global Positioning System (GPS) co-ordinates determined to be 33°25'49" South 025°23'48" East, at an elevation of 450 feet (ft).
