PRELIMINARY ACCIDENT REPORT

Accident and Incident Investigations Division

Accident
- Preliminary Report -
AIID Ref No: CA18/2/3/10564

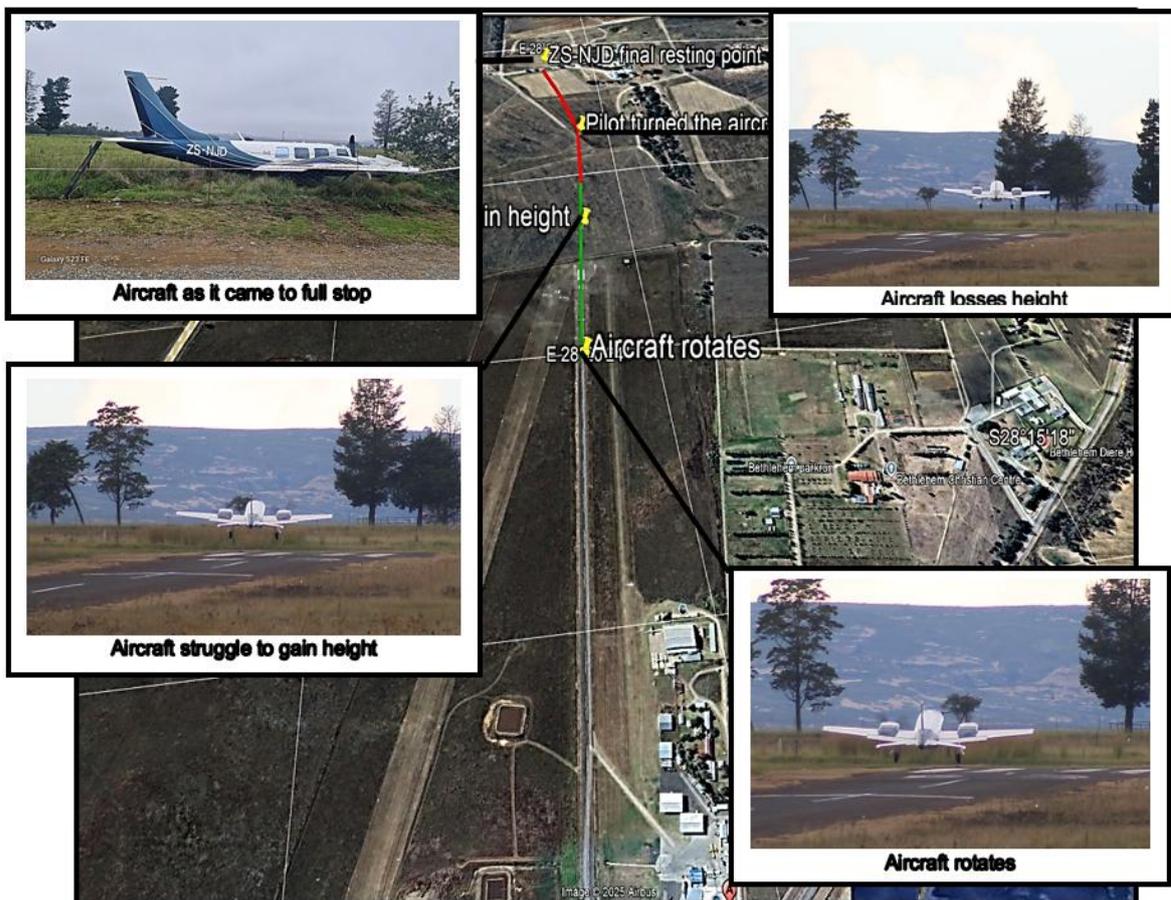
1.1.8. The accident occurred during daylight on a private farm about 750m from RWY 11 at Global Positioning System (GPS) co-ordinate determined to be S 28° 14' 53.69", E 028° 20' 42.75".

Figure 2: A view of the accident site with inset pictures showing the aircraft after take-off. (Source: Google Map)

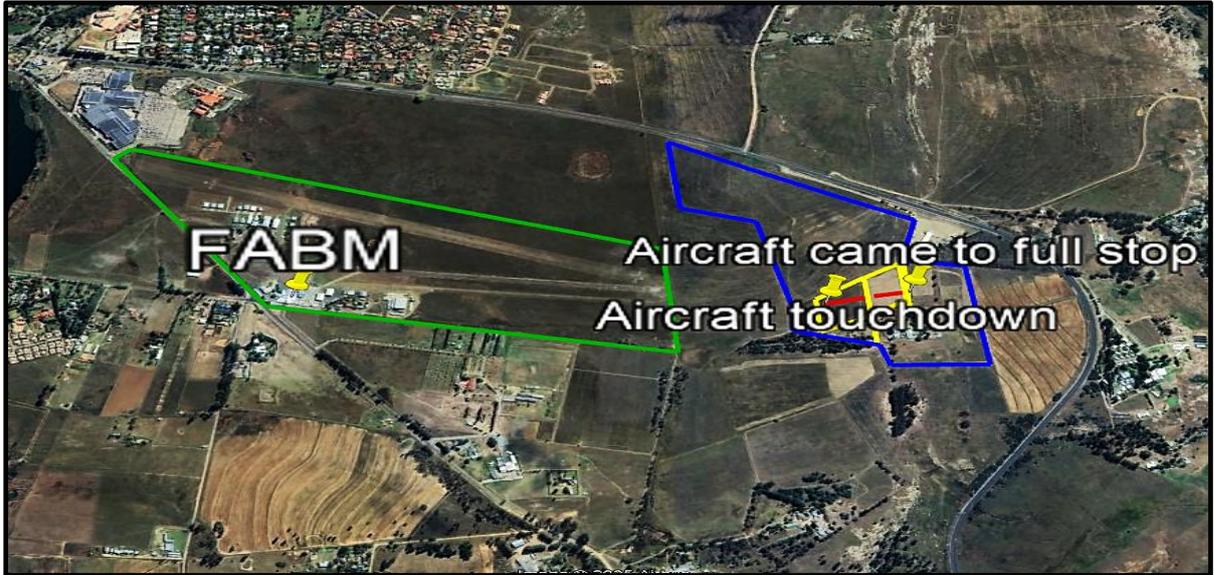
Figure 4: An overview of the accident site. (Source: Google Earth map)

1.12.1. The accident occurred during the take-off phase from FABM (indicated by the green demarcated area). The final accident site was on a field at a private farm (blue demarcated area), approximately 750m east of Runway 11. The aircraft remained largely intact with most structural components still attached to the fuselage. The terrain at the accident site comprised several obstacles including a barrier fence and tall trees (see Figure 5).

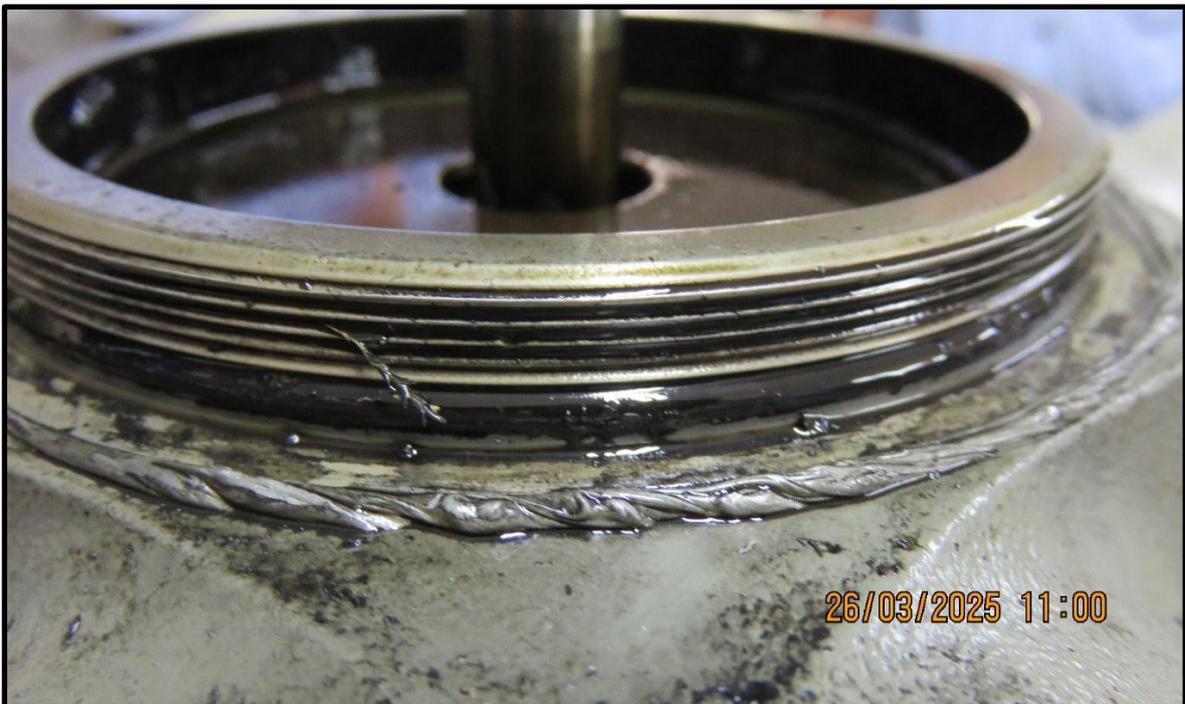
Figure 14: The threads of the intact propeller assembly with the rubber seal in place.

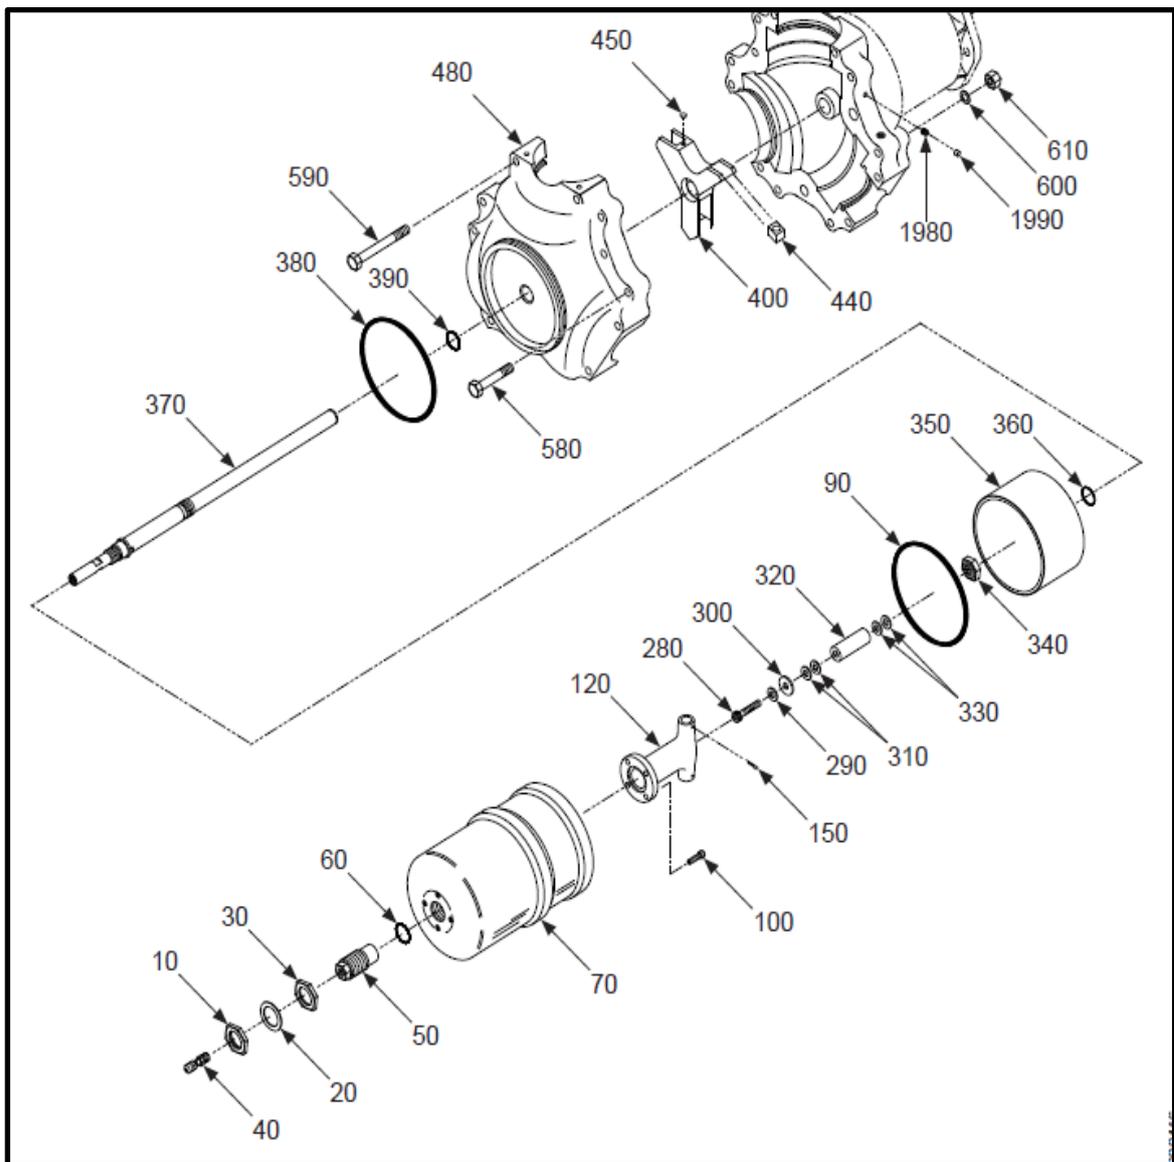
Diagram 1: The schematic diagram of the propeller hub assembly.

1.18.1. The schematic diagram (below) of the propeller hub assembly identifies item number 70 as the propeller cylinder. Item number 380 refers to the O-ring used to seal the dome-cylinder. The dome-cylinder houses the propeller pitch-changing mechanism which includes a spring-loaded piston actuated by engine oil pressure during operation.

1.18.2. The installation of the dome-cylinder does not require torque application.
