PRELIMINARY SERIOUS INCIDENT REPORT

Serious Incident  
- Preliminary Report -  
AIID Ref No: CA18/3/2/1460

On Sunday, 27 October 2024, a Boeing 737-800 aircraft with registration ZS-ZWY was on a scheduled commercial flight SFR313 from Cape Town International Airport (FACT) in the Western Cape province to Lanseria International Airport (FALA) in Gauteng province. After landing at FALA during taxi, the right-side bearing stopped operating and the crew increased thrust to maintain taxi speed. The aircraft was brought to a stop in the parking bay. After a walk-around inspection at the parking bay, the aircraft maintenance engineer (AME) found that there was smoke which originated in the right main wheel assembly. Moreover, the right main wheel assembly showed signs of metal deposit. No person was injured during this serious incident.

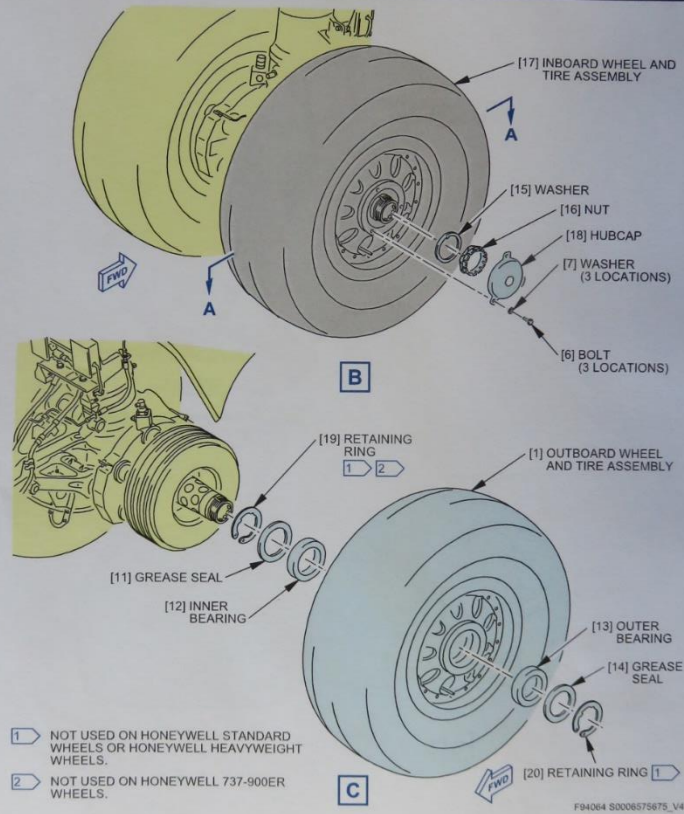
**Figure 9:** Landing gear mainwheel general arrangement. (Source: Boeing 737 Manual)

*The main wheels, designed to allow easy replacement, are fitted to fixed stub axles and held in place by a single wheel nut and washer. The wheel nut is secured by locking bolts.*

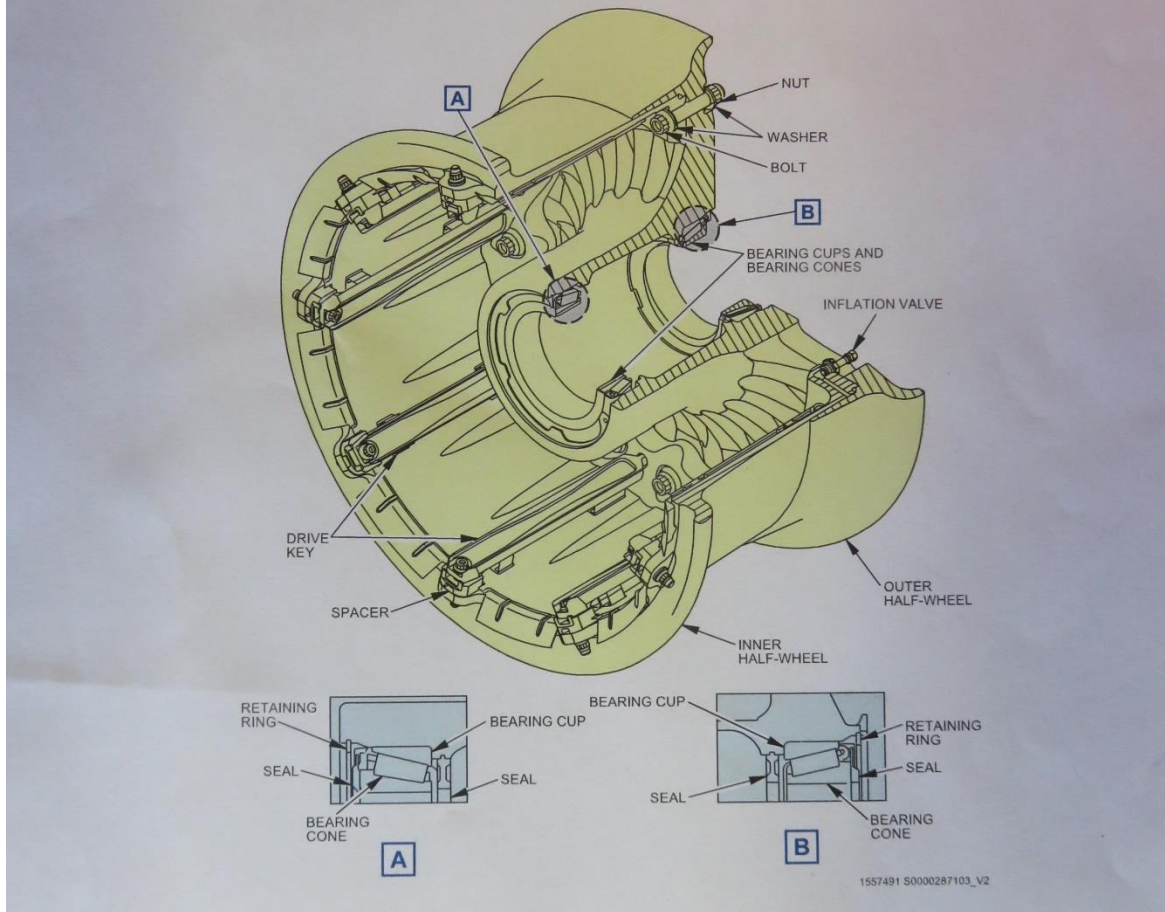
**Figure 10:** The inner [A] and outer [B] bearing arrangement. (Source: Boeing 737 Manual)

1.12.5 The Number 4 inner bearing exhibited signs of overheating which included discoloration and surface damage.

*The bearings are provided as part of the wheel assembly. When fitted to the axle, a nut and washer are used to apply pressure to the bearings, which is known as the preload. The preload ensures the bearing cups and cones are correctly seated, and the rollers correctly aligned. This is achieved by applying a torque to the nut using a suitable torque wrench. Once the bearing assembly has been preloaded, the nut is loosened slightly, whilst maintaining a tight contact between the cup, cone and rollers, then retightened to this service torque, which is usually about 20-25% of the preload torque. Both these procedures are done whilst slowly rotating the wheel clockwise to ensure that the large roller ends are seated against the cone rib.*
