FACTUAL ACCIDENT REPORT

Accident
- Factual Report -
AIID Ref No: CA18/2/3/10380

Reference Number : CA18/2/3/10380
Occurrence Category : Category 1
Type of Operation : Private (Part 91)
Name of Operator : West Dunes Aviation (PTY) LTD
Helicopter Registration : ZT-RBU
Helicopter Make and Model : Robinson 44 Raven II
Nationality : South African
Place : Marataba Mountain Lodge, Limpopo Province
Date and Time : 26 October 2023 at 0356Z
Injuries : None
Damage : Substantial

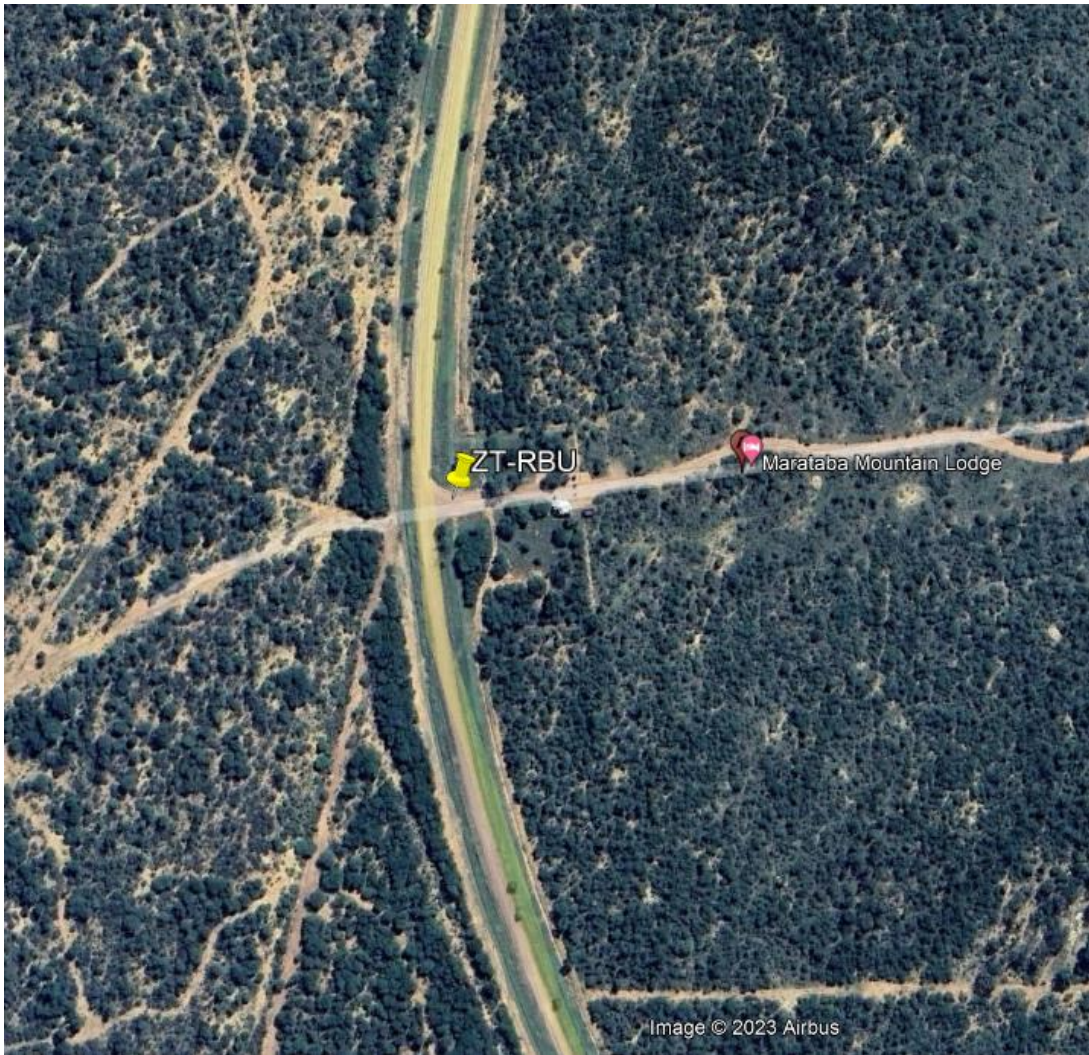
- 1.1.4 The accident occurred during daylight at Global Positioning System (GPS) co-ordinates determined to be 24°20'44.51" South 027°29'41.89" East, at an elevation of 3 349 feet (ft).

Figure 2: Overview of the accident site. (Source: Google Earth)
