PRELIMINARY ACCIDENT REPORT

Accident and Incident Investigations Division

Accident
- Preliminary Report -
AIID Ref No: CA18/2/3/10362

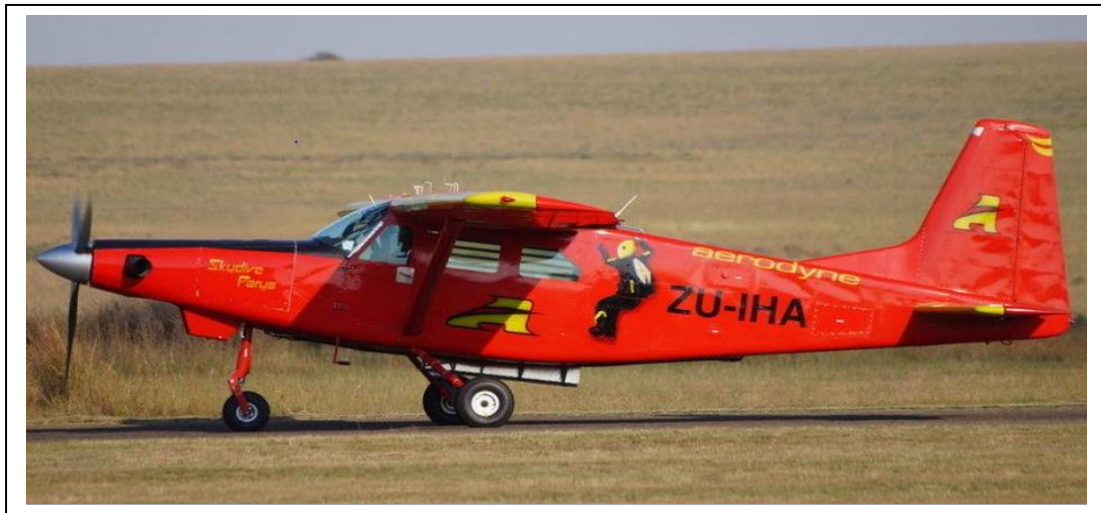
Figure 1: The file picture of the accident aircraft. (Source: www.flightzone.co.za)

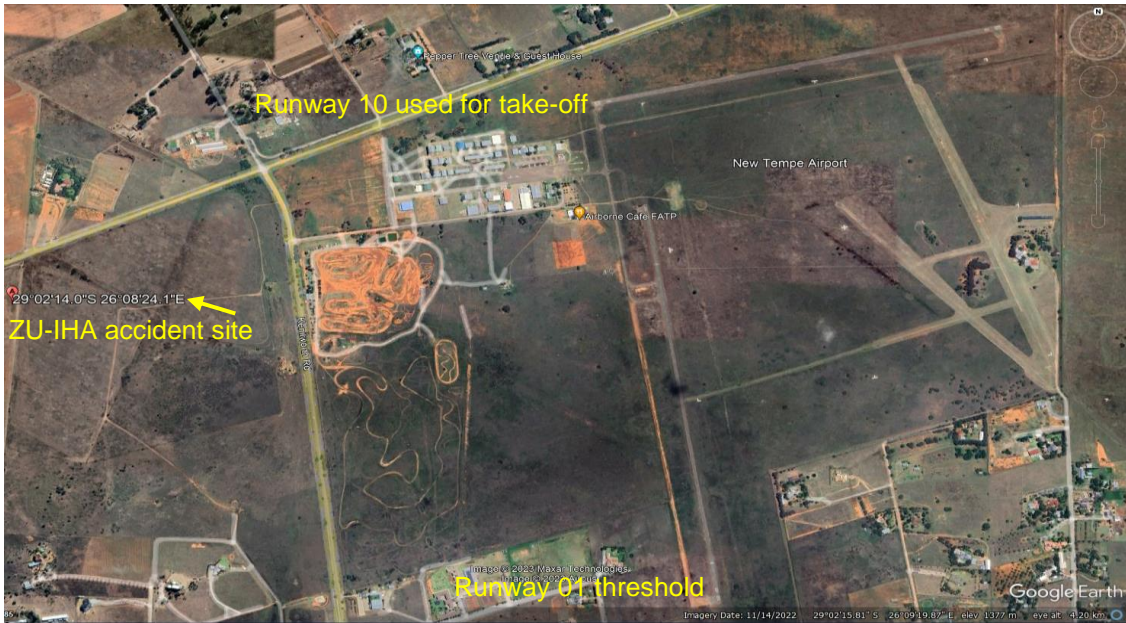
Figure 2: The view of the accident site and the runway used for take-off. (Source: Google Earth Map)

1.12.1 The pilot performed a forced landing on an open field approximately 0.83 nautical miles (nm) west of FATP. The nose gear collapsed during the landing roll which resulted in the aircraft propeller blades striking the ground. The aircraft came to rest in an upright position. The airframe and the cockpit cabin area remained intact. The aircraft sustained damage to the nose gear strut, the engine intake, the lower engine cowling and the propeller blades.
