PRELIMINARY ACCIDENT REPORT

Accident
- Preliminary Report -
AIID Ref No: CA18/2/3/10312

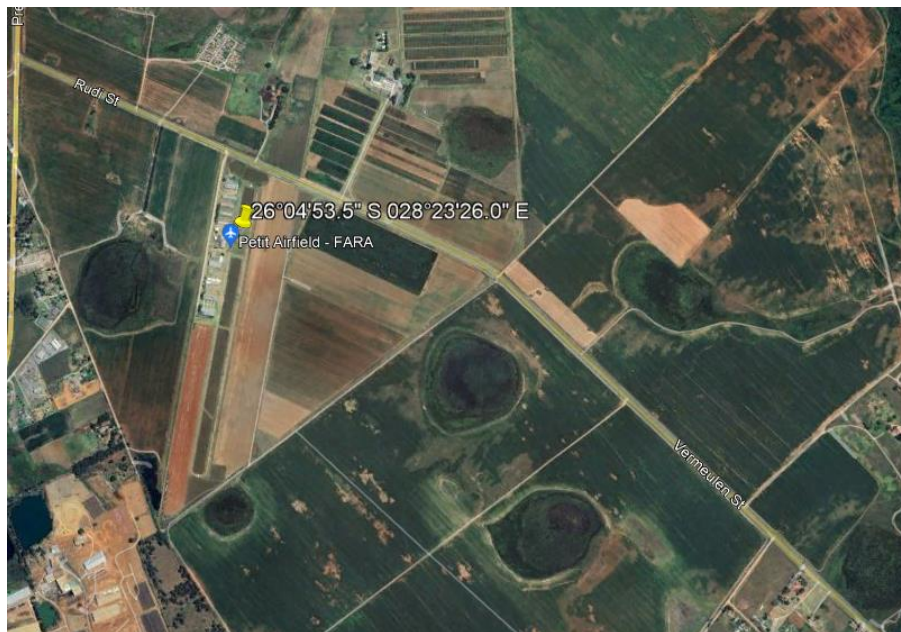
1.1.3 The accident occurred during taxi at FARA at Global Positioning System (GPS) coordinates determined to be 26°04'53.5" South 028°23'26.0" East at a field elevation of 5450 feet (ft).

Figure 2: View of the accident site. (Source: Google Earth)
