**PRELIMINARY ACCIDENT REPORT**

**Accident and Incident Investigations Division**

Accident  
- Preliminary Report -  
AIID Ref No: CA18/2/3/10381

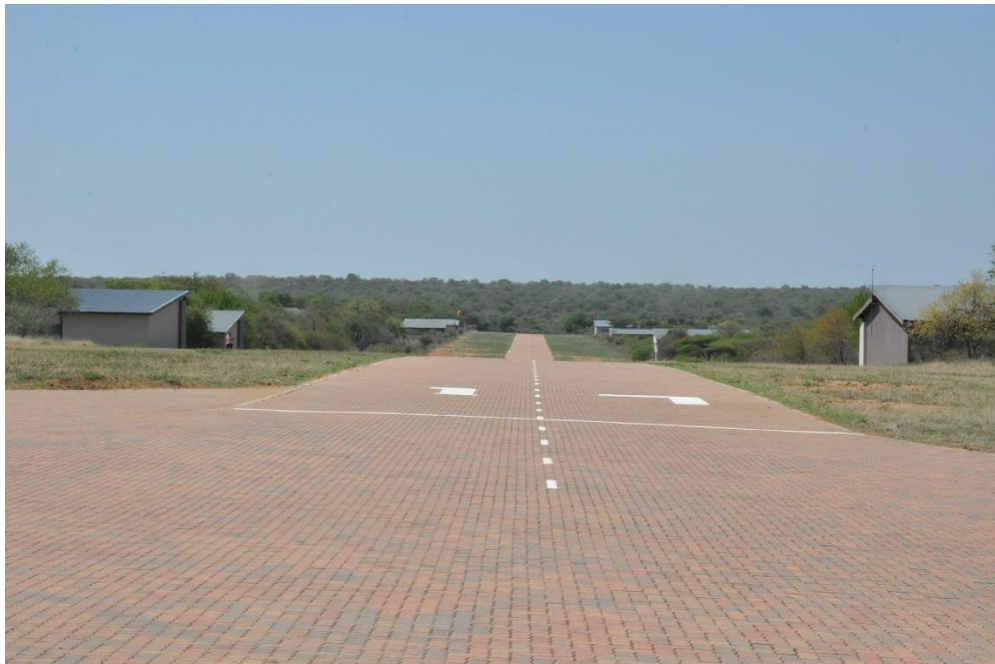
1.10.1 Zandspruit Aero Estate private airstrip is an unmanned, unlicensed airstrip with a single runway oriented 17/35.

**Figure 4:** Zandspruit Aero Estate private airstrip.

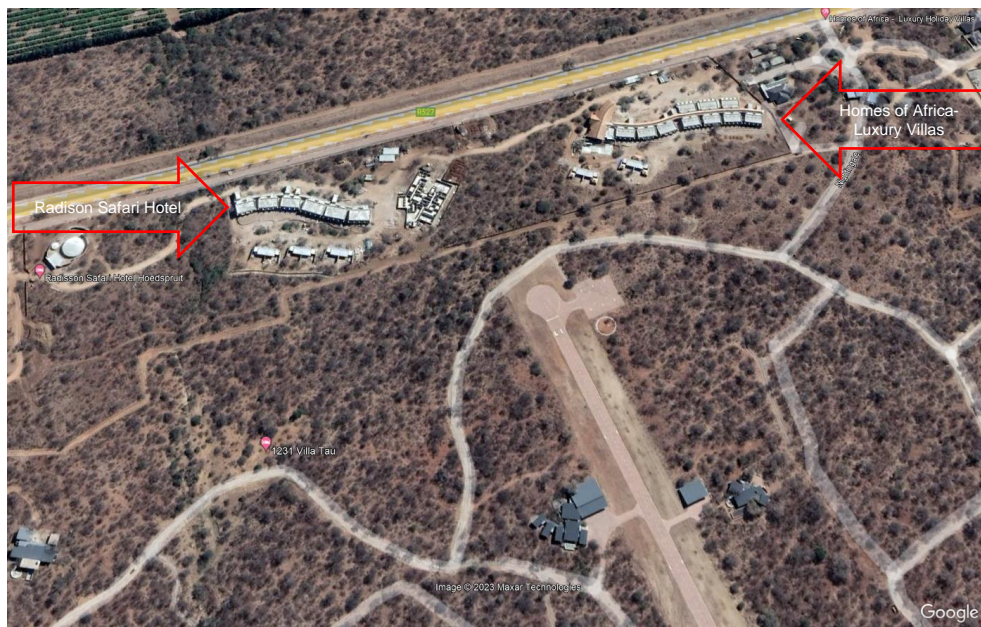
**Figure 5:** Threshold of Runway 17 and the nearby hotel and luxury villas.
