**PRELIMINARY ACCIDENT REPORT**

**Accident and Incident Investigations Division**

Accident  
- Preliminary Report -  
AIID Ref No: CA18/2/3/10607

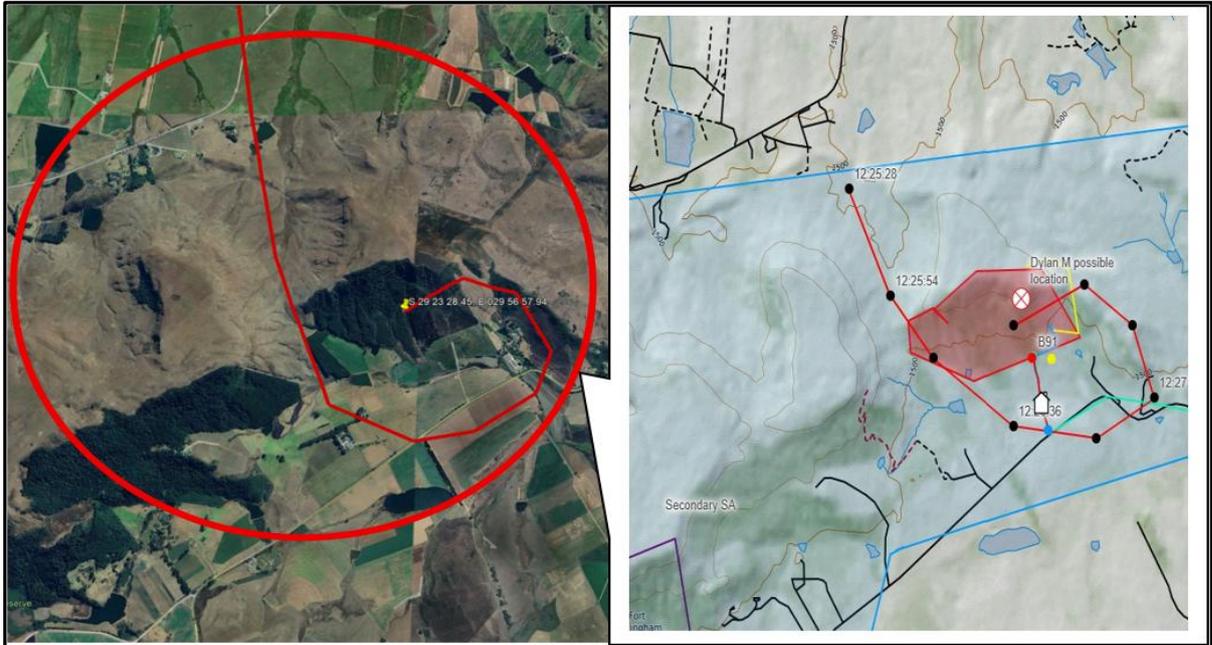
- 1.1.4. The accident occurred on a mountainous bushy terrain at Global Positioning System (GPS) co-ordinates determined to be South 29° 23' 28.45" East 029° 56' 57.94", at a field elevation of 4970 feet (ft).

**Figure 2:** An aerial view of the accident site. (Source: Google Earth)
