PRELIMINARY ACCIDENT REPORT

Accident
- Preliminary Report -
AIID Ref No: CA18/2/3/10246

Figure 1: The Sling 4 TSi aircraft, ZU-PPA.
(Source: <https://www.avcom.co.za/phpBB3/viewtopic.php?t=225496>)

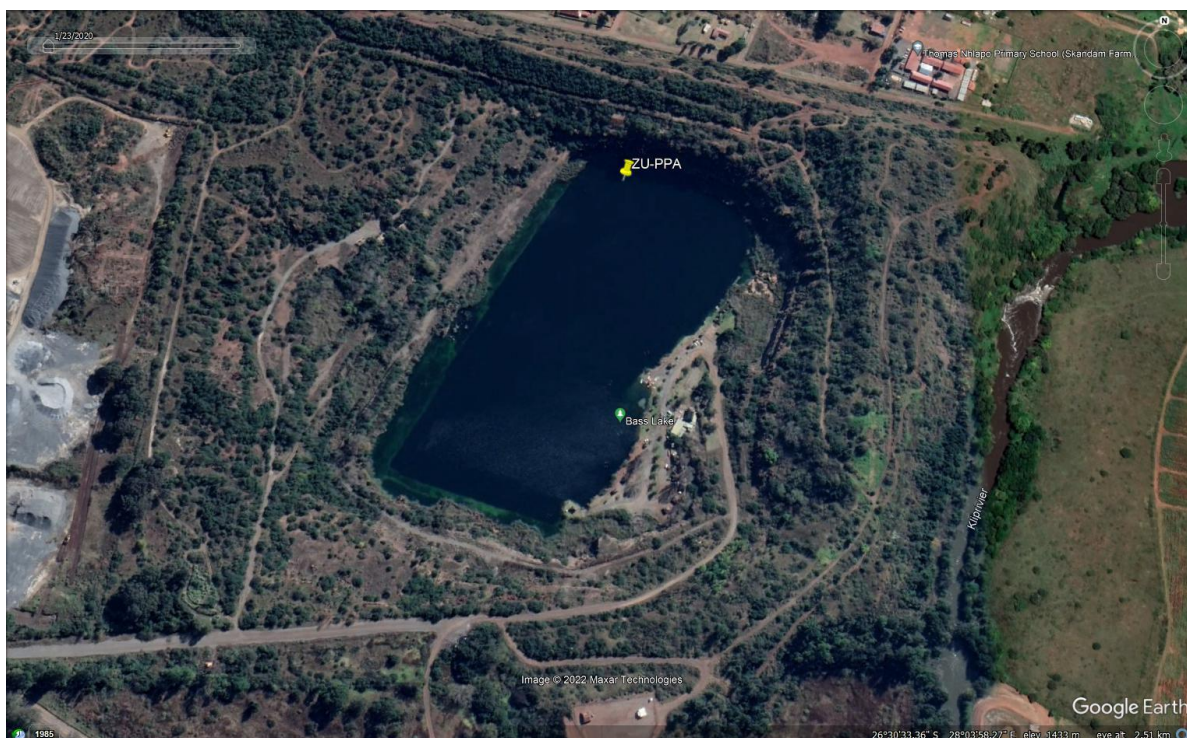
1.1.6 The accident occurred during daylight at Bass Lake at a Global Positioning System (GPS) co-ordinate determined to be: 026°30'33.66" South 028°03'58.27" East, at an elevation of 4 850 feet (ft).

Figure 2: The accident site is indicated by the yellow pin ZU-PPA. (Source: Google Earth)
