PRELIMINARY ACCIDENT REPORT

Accident and Incident Investigations Division

Accident
- Preliminary Report -
AIID Ref No: CA18/2/3/10518

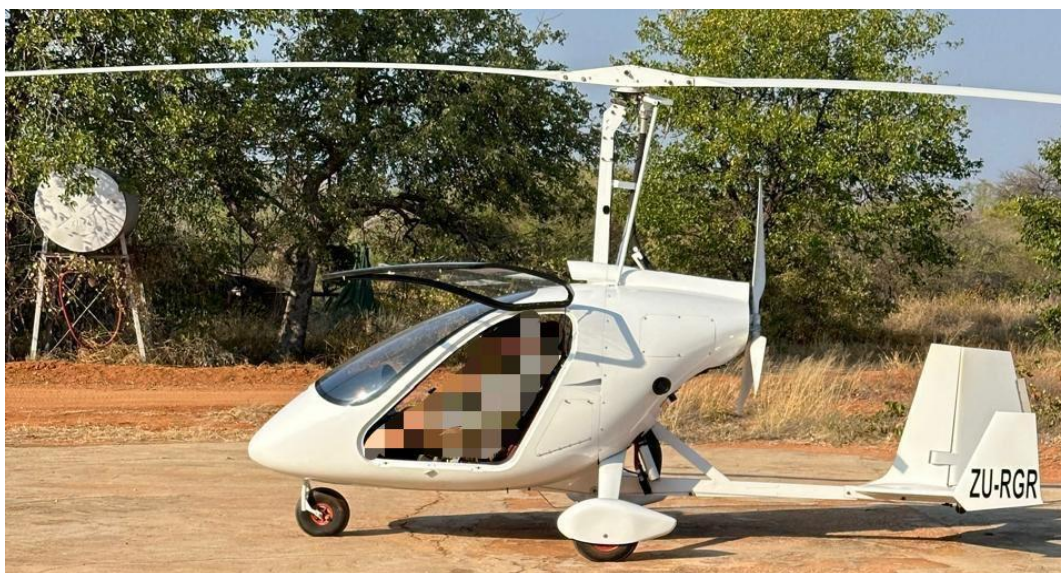
Figure 1: The file picture of the ZU-RGR aircraft. (Source: The rescue team)

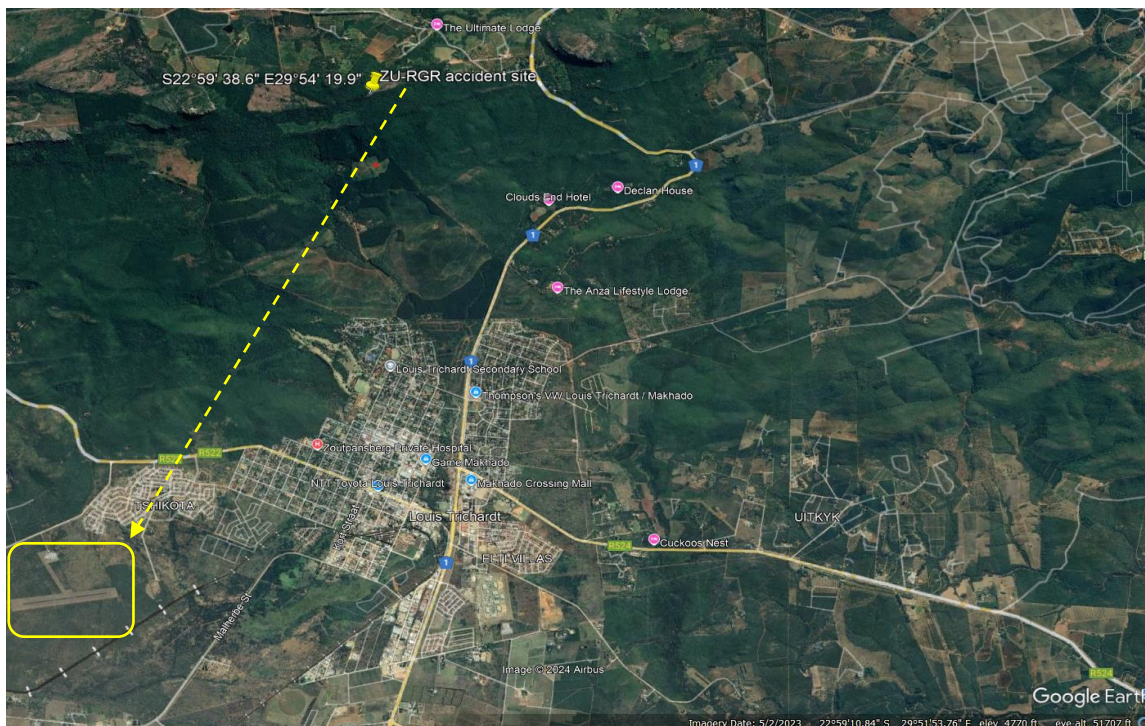
1.1.5. The accident occurred during daytime at Global Positioning System (GPS) co-ordinates determined to be 22°59' 38.6" South 29°54' 19.9" East, at an elevation of 4 770 feet (ft).

Figure 2: The accident site and Louis Trichardt Civil Airfield (FALO). (Source: Google Earth)

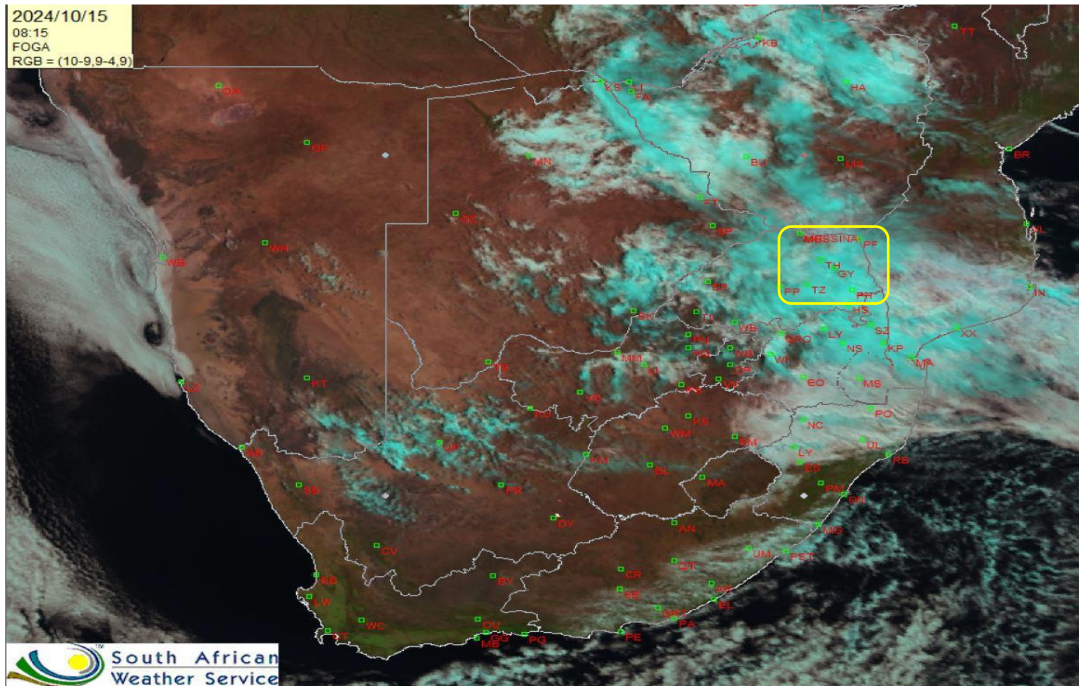
1.7.2 The satellite indicated low clouds with possible clouds below 10 000 feet (ft); however, the METAR recorded at FAPP indicated that the lowest clouds were 2 000ft above ground level (AGL) and scattered. This aligns with the METAR and Terminal Area Forecast (TAFs) on the day in terms of wind and temperatures, but the clouds observed were higher than what was forecasted.

Figure 4: The satellite image at 08:15 (local time) on 15 October 2024.
