PRELIMINARY ACCIDENT REPORT

Accident  
- Preliminary Report -  
AIID Ref No: CA18/2/3/10265

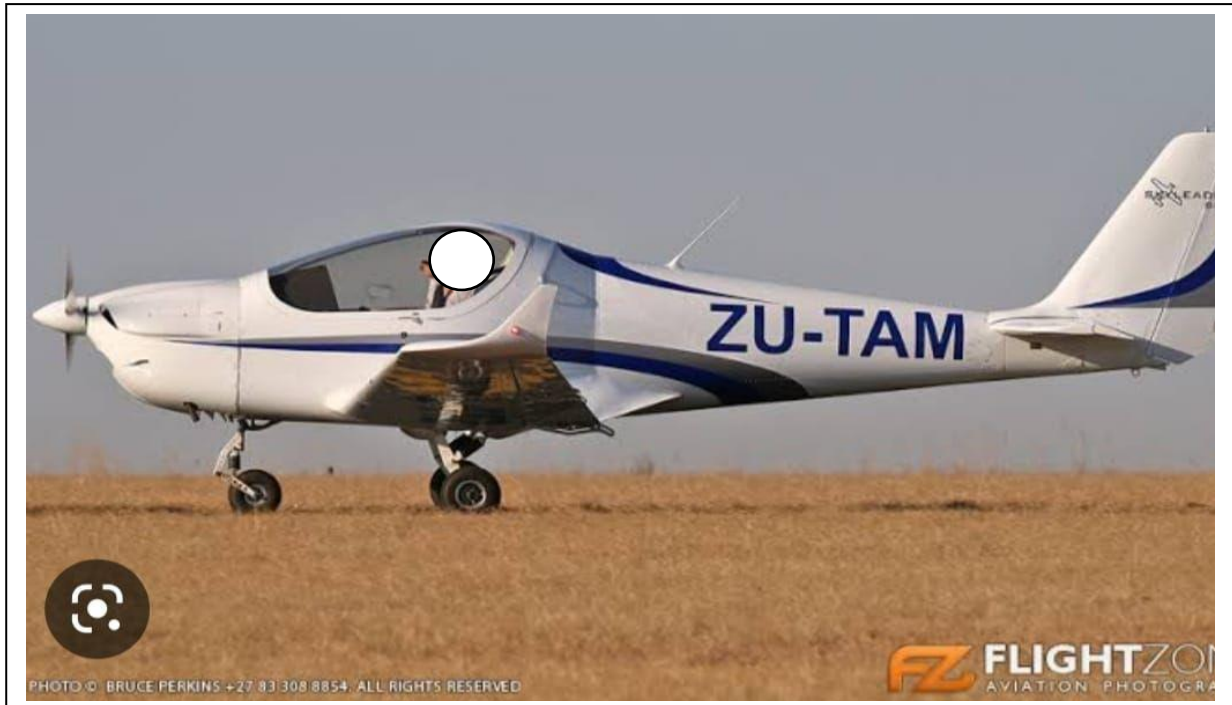
**Figure 1:** The Skyleader 600 aircraft, registered ZU-TAM. (Source: Flightzone.co.za)

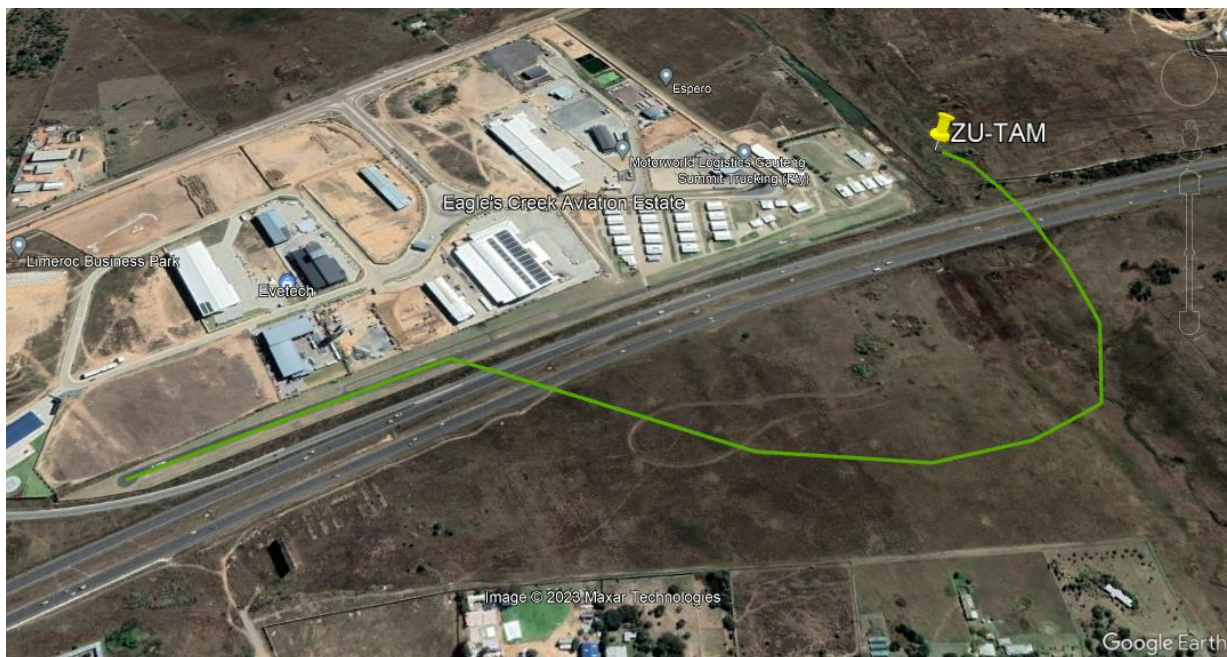
1.1.6 The accident occurred during daylight under visual meteorological conditions at Global Positioning System (GPS) co-ordinates determined to be 25°54'14.67"S 28° 2'30.59"E and at an elevation of 4620.8 feet (ft).

Figure 2: The path followed by the ZU-TAM. (Source Google Earth)
