PRELIMINARY ACCIDENT REPORT

Accident
- Preliminary Report -
AIID Ref No: CA18/2/3/10393

Reference Number : CA18/2/3/10393
Occurrence Category : Category 1
Type of Operation : Private 94 (NTCA)
Name of Operator : Plane ADS (PTY) LTD
Aircraft Make and Model : Micro Aviation SA; Bat Hawk R
Nationality : South African
Registration Marks : ZU-XCO
Place : Grassland Airfield, Centurion, Gauteng Province
Date and Time : 26 November 2023 at 0545Z
Injuries : Fatal
Damage : Substantial

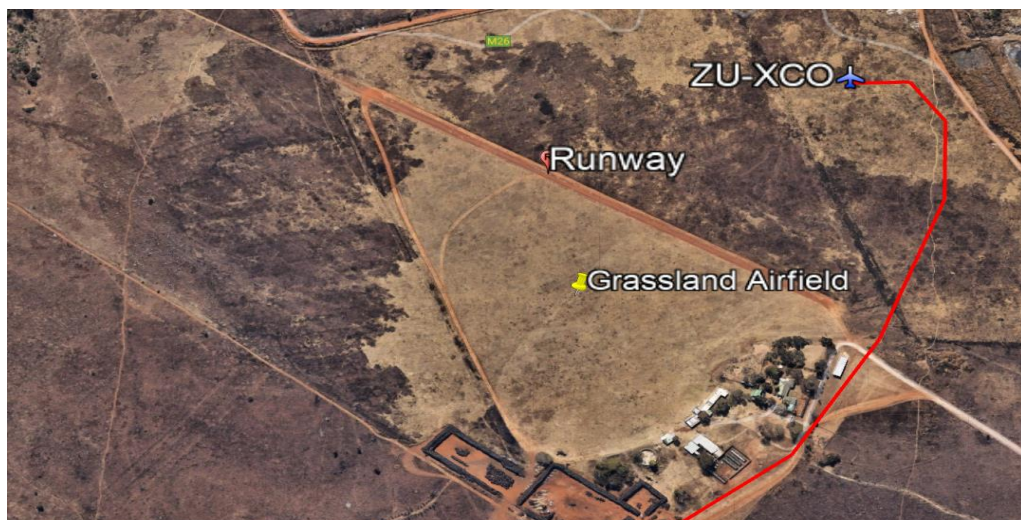
- 1.1.5. The accident occurred during daylight at Grassland Airfield at Global Positioning System (GPS) co-ordinates determined to be 25°49'38.0" South 028°05'43" East, at an elevation of about 4 530 feet (ft) above mean sea level (AMSL).

Figure 2: The view of the accident site. (Source: Google Maps)
