AIRCRAFT ACCIDENT REPORT AND EXECUTIVE SUMMARY

Reference:		CA18/2/3/10003	
Aircraft Registration	ZS-CKM	Date of Accident	13 May 2021		Time of Accident	1420Z	
Type of Aircraft	PA-32RT-300T		Type of Operation		Private (Part 91)		
Pilot-in-command Licence Type	Airline Transport Pilot Licence (ATPL)		Age	32	Licence Valid	Yes	
Pilot-in-command Flying Experience	Total Flying Hours		2 327.4		Hours on Type	87.3	
Last Point of Departure	Port Elizabeth Aerodrome (FAPE), Eastern Cape Province						
Next Point of Intended Landing	Pietermaritzburg Aerodrome (FAPM), KwaZulu-Natal Province						
Damage to Aircraft	Substantial						
Location of the accident site with reference to easily defined geographical points (GPS readings if possible)							
Umtentweni, about 50nm south-west of FAPM at GPS S 30°33'11.1" E030°17'20.2", and at an elevation of 1 411 feet							
Meteorological Information	Wind direction: 90°; Wind speed: 10kts; Visibility: 10km; Temperature: 22°C; Cloud cover: CAVOK; Dew point: 7°C

COMPILED BY:	UNIVERSITY OF PRETORIA LABORATORY FOR MICROSCOPY & MICROANALYSIS	PAGE 1 OF 12	
	FAILURE ANALYSIS REPORT: Crankshaft Assembly, Lycoming TIO-540-S1AD, Piper Turbo Lance II, ZS-CKM	DOCUMEN

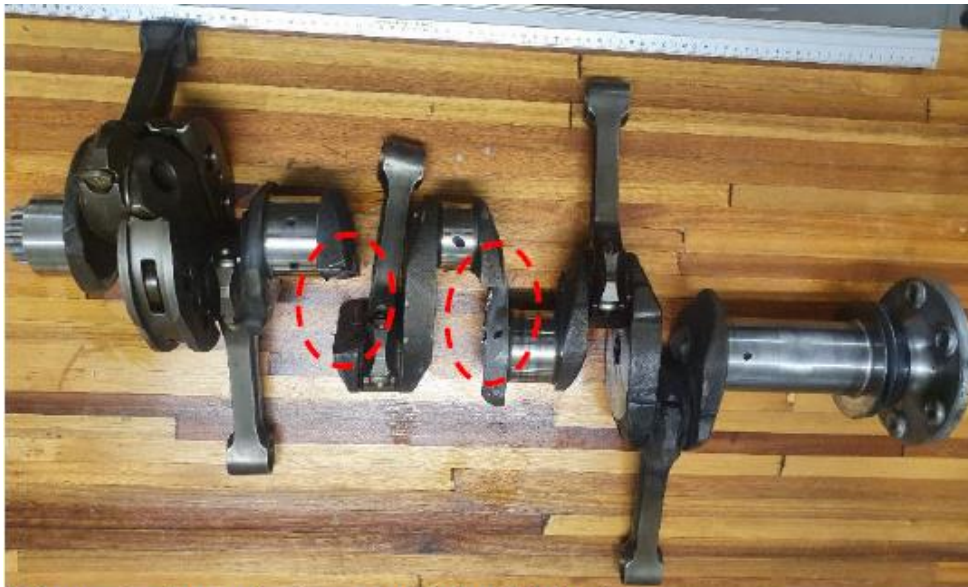
Photo 3: Supplied assembly (Digital)

After the accident, the engine was removed from the aircraft and was sent to an approved engine workshop for inspection where an engine strip was carried out on 26 May 2021. During this inspection, it was found that the engine crankshaft, with Serial Number LW15302, had broken and was sent for metallurgical testing (see Photo 3). The detailed report of the metallurgical testing is attached as Annexure B.

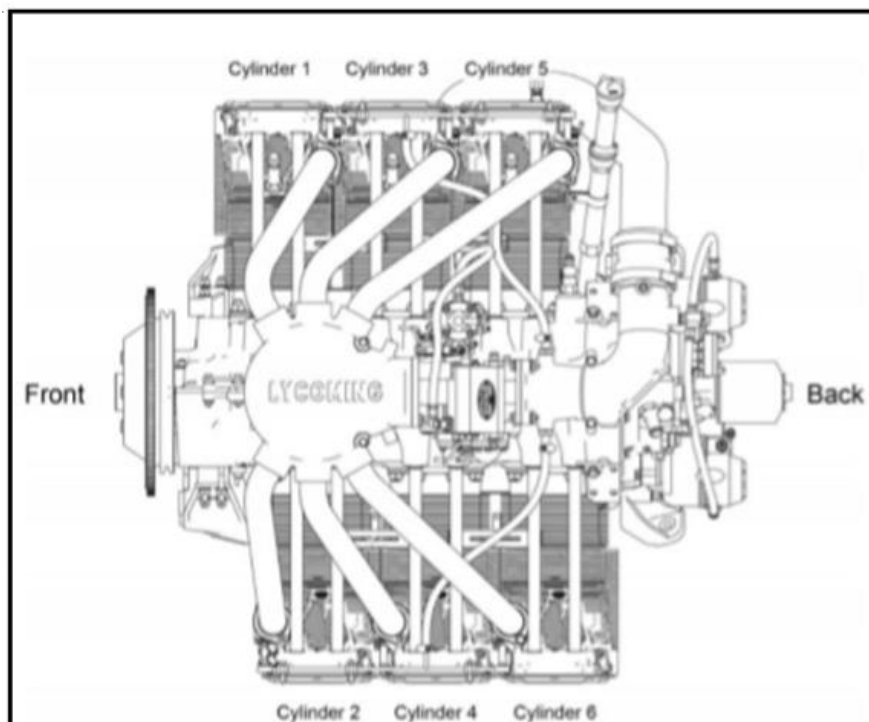
Diagram 1: Engine layout

Visual inspection of the supplied crankshaft revealed two fractures marked A and B (Photos 7 and 8) within the web sections between the adjacent main bearings M2 and M3 and piston conrod positions 3 and 4 (Photo 6; Diagrams 1 and 3). Both fractured surfaces revealed signs corresponding with a fatigue mode of failure and initiated within the radius sections of the main bearings M2 and M3, respectively (Photos 7 and 8, red circles). The fractures progressed through the web sections in the directions as indicated (yellow arrows) until final fast fracture.

The big-end connecting rods C1 and C2 (Diagram 1; Photo 6) and bearings revealed signs of high temperature exposures, excessive wear and imminent seizure (Photo 9). This could be considered as collateral damages induced during the failure sequence of the crankshaft due to the blockage of the oil feed lines.

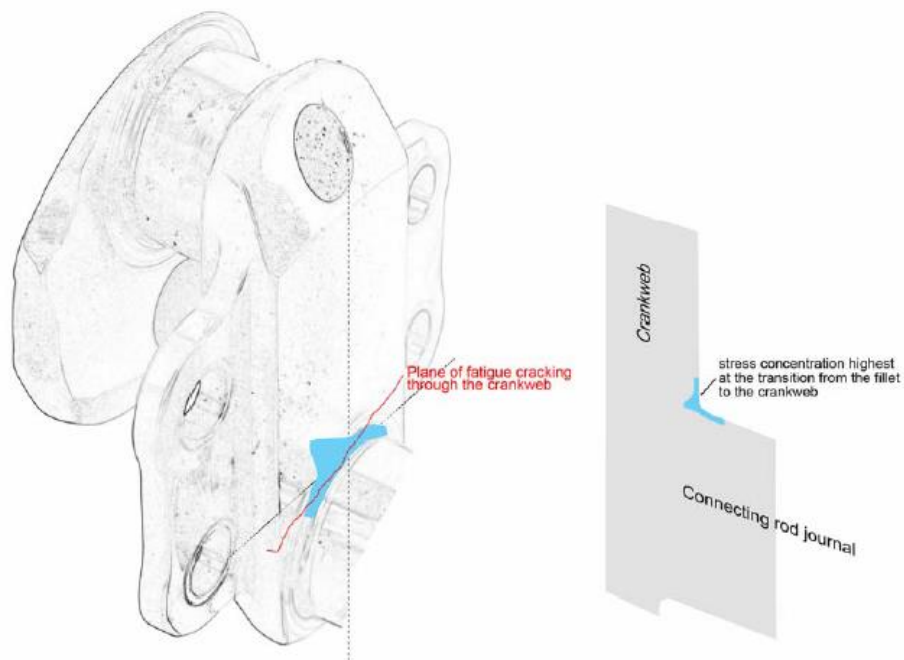
The distribution of stress developed within a crankshaft, through crankshaft bending and torsional, is not uniform (Taylor, 1999, vol.2, pp.496-498). Stress gradients are formed under bending and torsion loading. The stress decreases in magnitude from the surface to the centre of the component. The form of a crankshaft results in non-uniform distributions of stress. Torsional stresses are concentrated in the journals and bending stresses are concentrated in the transitions between the journals and crankwebs. For the case of crankshaft bending, the distribution of bending stress in the journal fillet region is not uniform around the circumference of the fillet or around the fillet radius, figures 8.74 and 8.80. The distribution of bending stress is influenced by detailed geometry and the timing of the maximum load with respect to the angular position of the crankshaft.

Figure 8.74: Schematic showing the distribution of crankweb bending stress at the forward fillet of a No.6 connecting rod journal

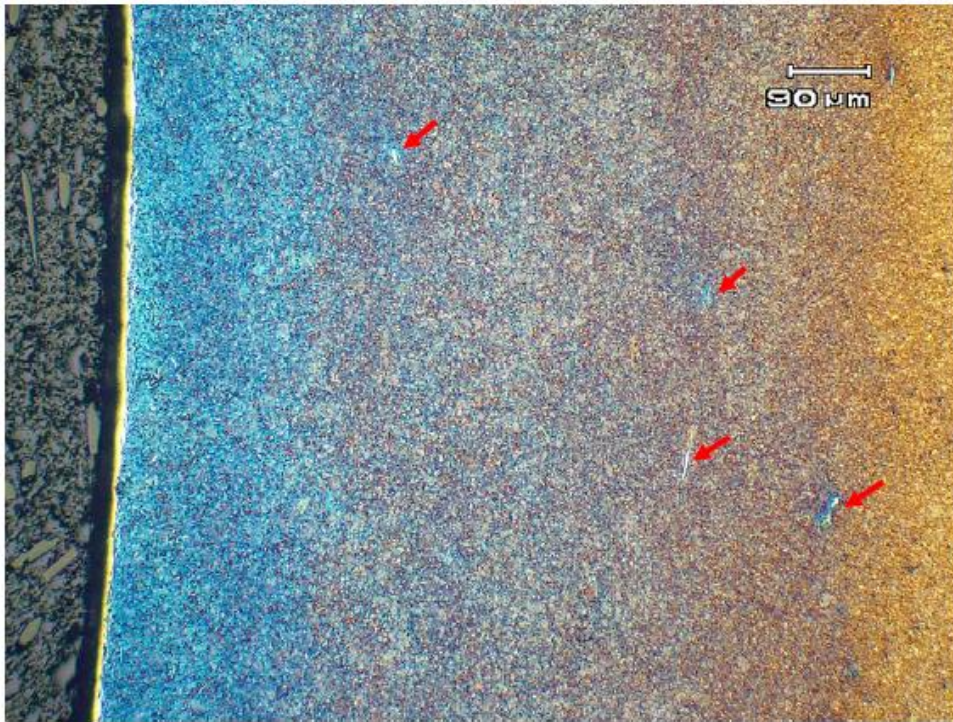
Figure 8.80: Metallographic section through the No.1 connecting-rod journal fillet

The fillet surface is at the left of the micrograph. The depth of nitriding can be distinguished by the colourisation; the core material is at the right (straw/gold). Several non-metallic inclusions are evident (arrowed).

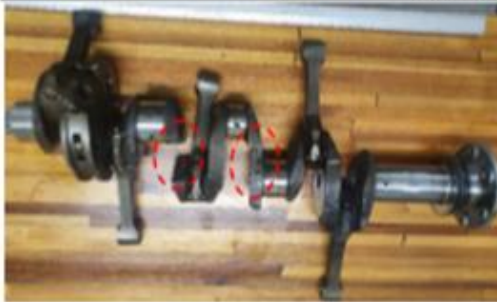
Photo 3: Supplied assembly (Digital)

ITEM: Crankshaft assembly, Lycoming TIO-540-S1AD engine, Piper Turbo Lance II PA-32-RT-300T, ZS-CKM			
1. BACKGROUND INFORMATION			
1.1. The fractured Crankshaft Assembly (Photo 3), serial number LW15302, from a Lycoming TIO-540-S1AD reciprocal engine, serial no L-5536-61A, originating from a Piper PA-32-RT-300T Turbo Lance II, aircraft no ZS-CKM (Photo 1), was submitted to determine the most probable modes of failure and possible contributing factor/s.

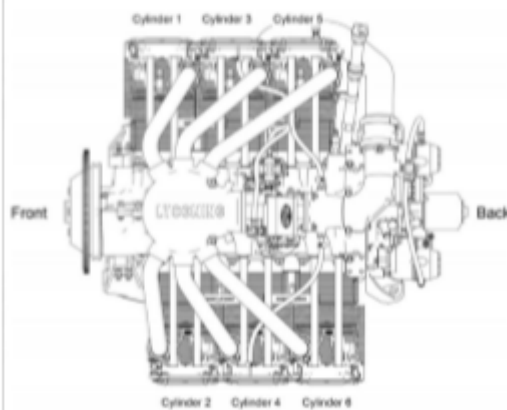
Diagram 1: Engine layout

Visual inspection of the supplied crankshaft revealed two fractures marked A and B (Photo's 7 and 8) within the web sections between the adjacent main bearings M2 and M3 and piston conrod positions 3 and 4 (Photo 6; Diagrams 1 and 3). Both fracture surfaces revealed signs corresponding with a fatigue mode of failure and initiated within the radius sections of the main bearings M2 and M3 respectively (Photo's 7 and 8, red circles). The fractures progressed through the web sections in the directions as indicated (yellow arrows) until final fast fracture.

The big-end connecting rods C1 and C2 (Diagram 1; Photo 6) and bearings revealed signs of high temperature exposures, excessive wear and imminent seizure (Photo 9). This could be considered as collateral damages induced during the failure sequence of the crankshaft due to the blockage of the oil feed lines.

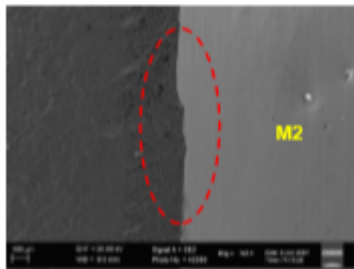
Fracture initiations (Fractograph 1, red dashed circle) at both fractures A and B proved to be preferential to the original machining marks. In the absence of evidence towards prior overhaul procedure/s involving machining at these positions, this supports the notion towards an applied radial stress during operation resulting in surface fracture initiation (Photo 10). When one, or more, of these surface fractures reach a critical flaw size (a function of material condition and

Fractograph 1: Fracture A, surface morphology (145X, SE, 20kV, FEGSEM)

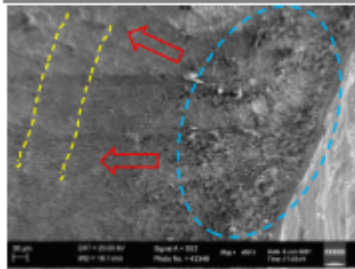
Fractograph 2: Fracture A, surface morphology (400X, SE, 20kV, FEGSEM)

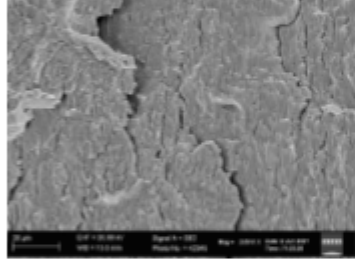
Fractograph 3: Fracture A, surface morphology (3000X, SE, 20kV, FEGSEM)

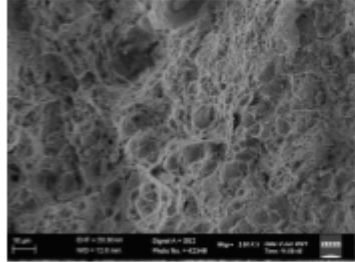
Fractograph 4: Fracture A, surface morphology (2000X, SE, 20kV, FEGSEM)

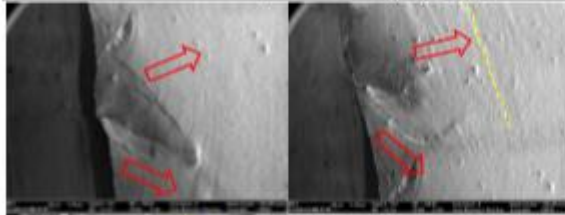
The fracture surface analysis at **Fracture B** revealed multiple initiation positions (Fractographs 5 and 6) and planes. Selective initiation points correspond with the noted micro-fractures (Fractographs 6, 7 and 8, green arrows; Photo 10, red circle). Clear signs of typical fatigue 'beachmarks' (Fractograph 5, yellow dashed lines) and progression directions were noted (red arrows). The absence of clear striations within the morphology at higher magnifications suggest that **Fracture B** progressed under repeated overload conditions (low-frequency, high stress) supporting the notion that **Fracture A** initiated first in the sequence and/or progressed at a higher rate.

Fractograph 5: Fracture B, surface morphology (SE, 20kV, FEGSEM)

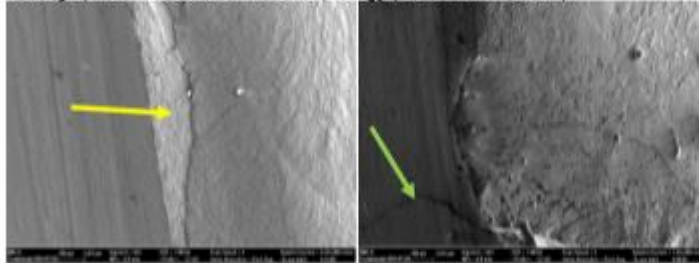
Fractograph 6: Fracture B, surface morphology (SE, 20kV, FEGSEM)

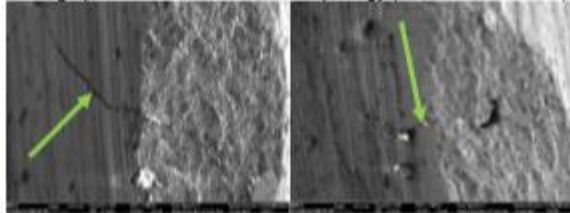
Fractograph 7: Fracture B, surface morphology (SE, 20kV, FEGSEM)
