AIRCRAFT ACCIDENT REPORT AND EXECUTIVE SUMMARY

Reference:		CA18/2/3/10017	
Aircraft Registration	ZS-MZV	Date of Accident	28 June 2021		Time of Accident	0925Z	
Type of Aircraft	Cessna 182P (Serial No. 182-61343)		Type of Operation		Private (Part 91)		
Pilot-in-command Licence Type	Private Pilot Licence		Age	31	Licence Valid	Yes	
Pilot-in-command Flying Experience	Total Flying Hours		115.5		Hours on Type	42.7	
Last Point of Departure	Hoedspruit Civil Aerodrome (FAHT), Limpopo Province						
Next Point of Intended Landing	Rand Aerodrome (FAGM), Gauteng Province						
Damage to Aircraft	Substantial						
Location of the accident site with reference to easily defined geographical points (GPS readings if possible)							
Swampland in Wadeville (GPS position: 26°17'18.20" South 028°10'19.40" East), elevation 5 047 feet (ft)							
Meteorological Information	Surface wind; 350°/16kts, temperature; 17°C, dew point; -1°, CAVOK						
Number of People On-board	1 + 3	Number of People Injured	0	Number of People Killed	0	Other (On Ground)	0

Probable Cause							
The pilot's fuel management practise resulted in a complete loss of engine power due to fuel exhaustion; the pilot had no choice but to

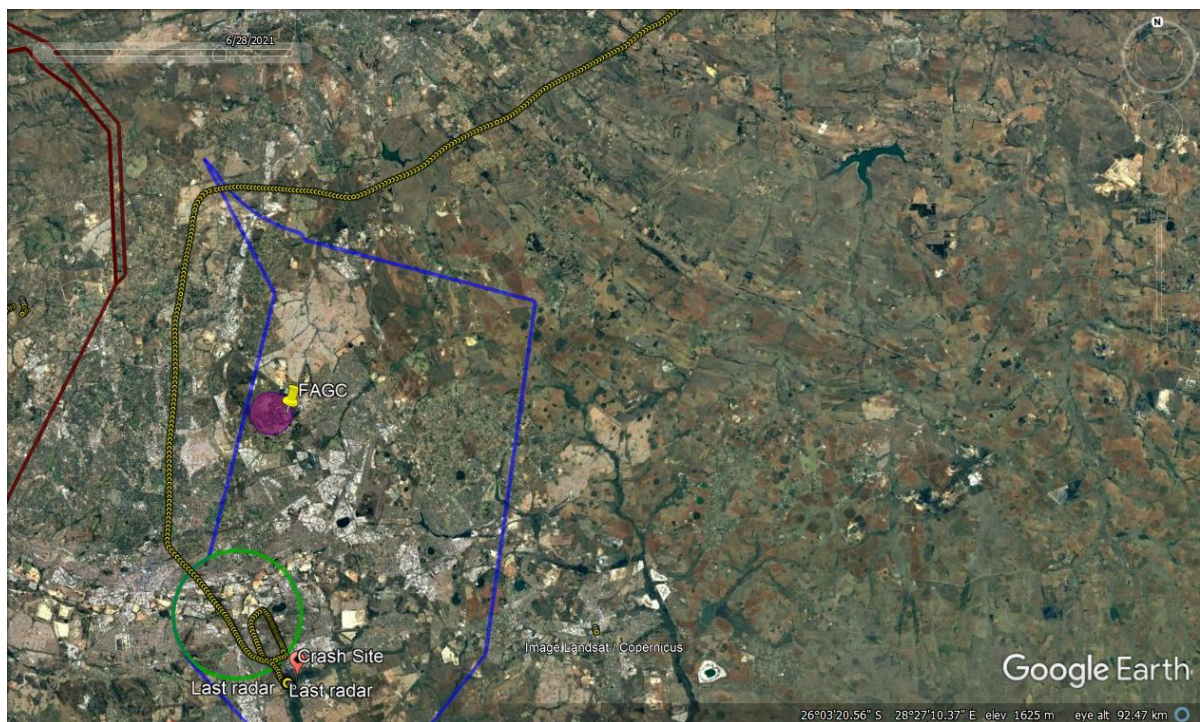
Figure 1: Overlay with the yellow dots indicating the radar track flown by ZS-MZV.
(Source: Google Earth)

The pilot had not incorporated any reserve or deviation fuel for the flight, nor had he opted to divert, land and refuel at any stage. From the radar data, the pilot flew past FAGC within 1nm from the aerodrome (see Figure 1) and continued with the flight to FAGM, stretching the fuel supply. The reason the pilot did not opt to divert to another aerodrome could have been attributed to the fact that he was obliged to adhere to Part 91.03.4 (Air traffic service flight plan and associated procedures) of the CAR 2011, as he had filed a flight plan, which was active for the flight. Part 91.03.4(11), however, does make provisions for a pilot to deviate from a flight plan when an emergency arises that necessitates immediate action, in which event, the responsible Air Traffic Service Unit (ATSU) shall, as soon as possible, be advised of the action taken.

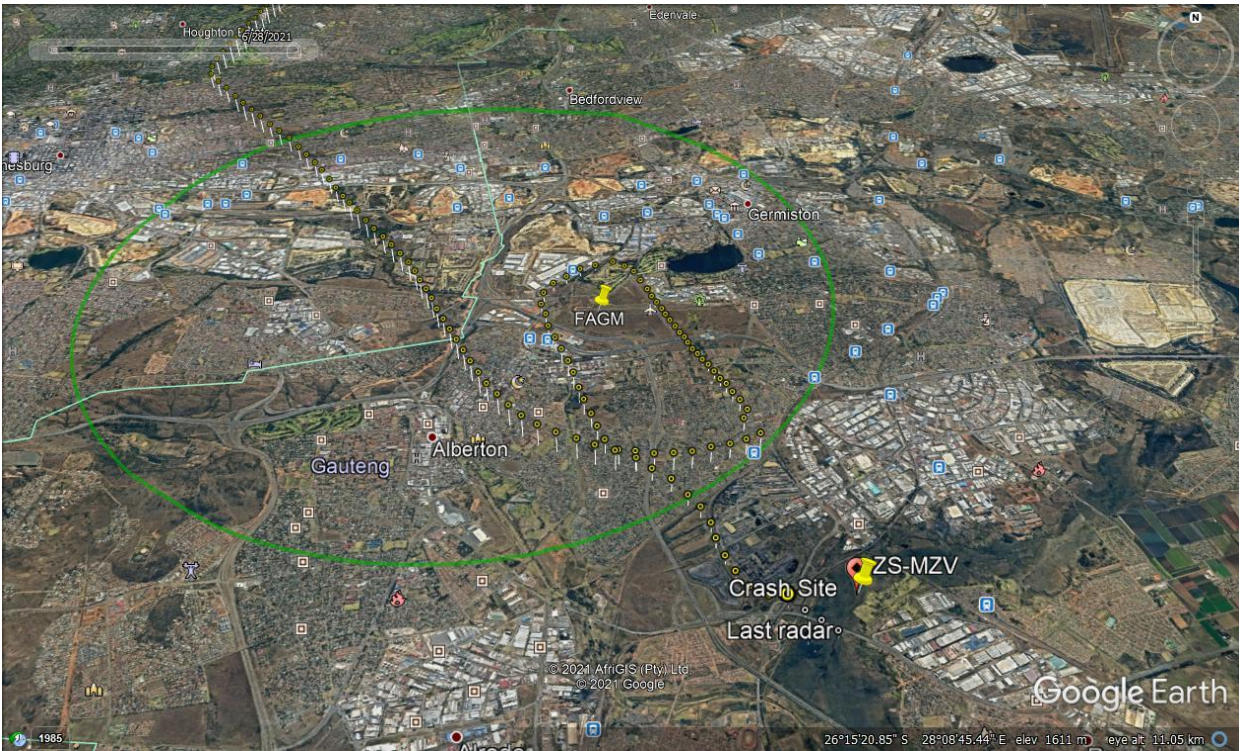
Figure 2: A close-up overlay with the yellow dots indicating the radar track flown by ZS-MZV. (Google Earth)

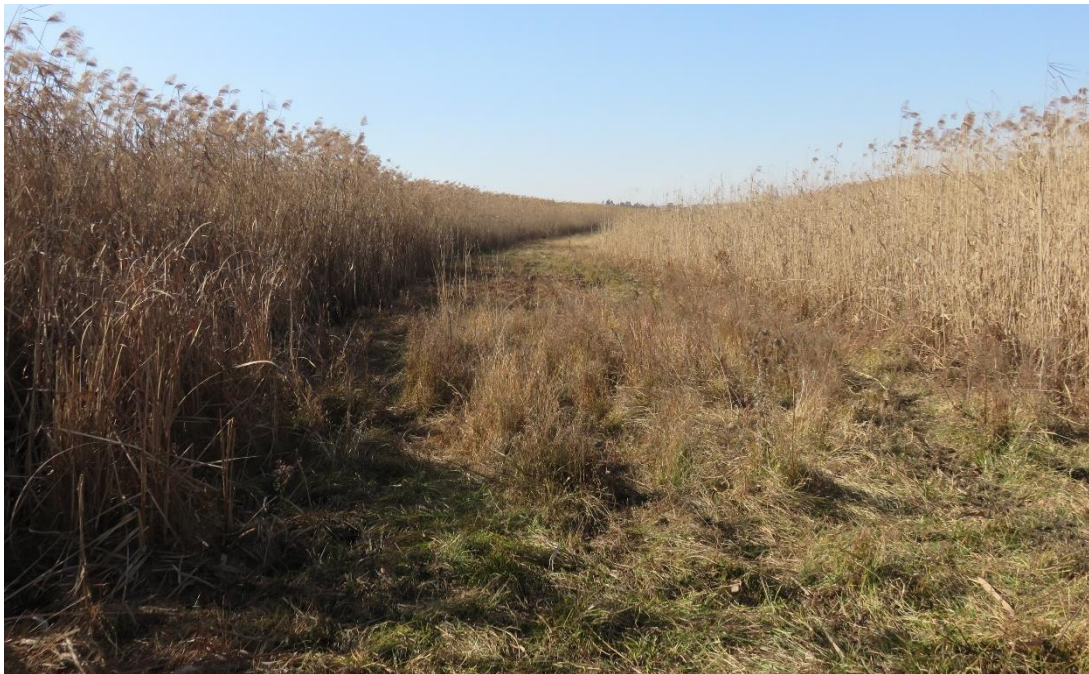
Figure 7: The open area view beyond the accident site.
