**AIRCRAFT ACCIDENT REPORT AND EXECUTIVE SUMMARY**

| | | | | <b>Reference:</b> | | CA18/2/3/10022 | |
| <b>Aircraft Registration</b> | ZU-FZZ | <b>Date of Accident</b> | 9 July 2021 | | <b>Time of Accident</b> | 0720Z | |
| <b>Type of Aircraft</b> | Sling 2 | | | <b>Type of Operation</b> | Training (Part 141) | | |

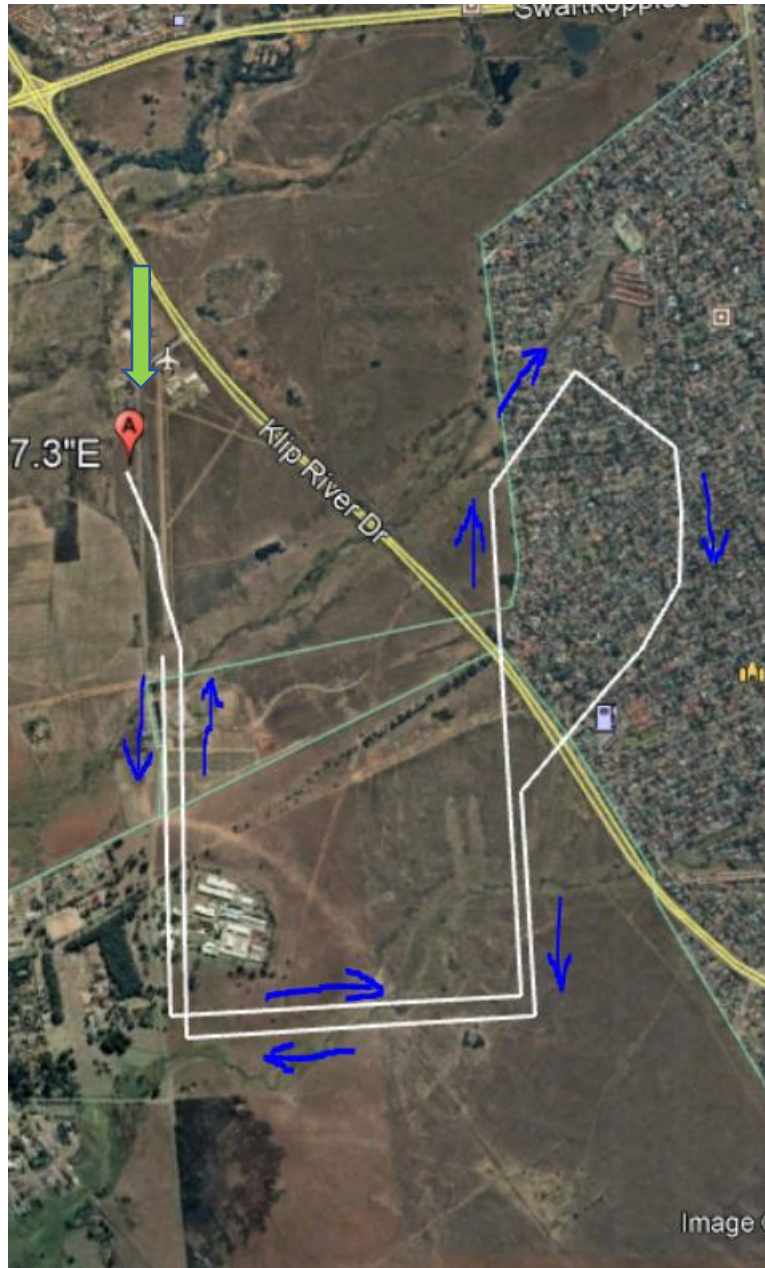
- 1.1.4. According to an eyewitness who was standing next to Kromvlei Road which runs parallel to the runway, the aircraft lifted off and then made a descent, flying low over Kromvlei Road in a left-wing low attitude. He then witnessed the aircraft hit the ground with the left-wing first; thereafter, it flipped over, and the propeller struck the ground. The aircraft came to rest in an inverted attitude. Moments later, he saw the aircraft catch fire (see Figure 2).

**Figure 2:** The student pilot changed the circuit pattern to land RWY 02. The green arrow shows the position of the witness. (Source: Google Earth)

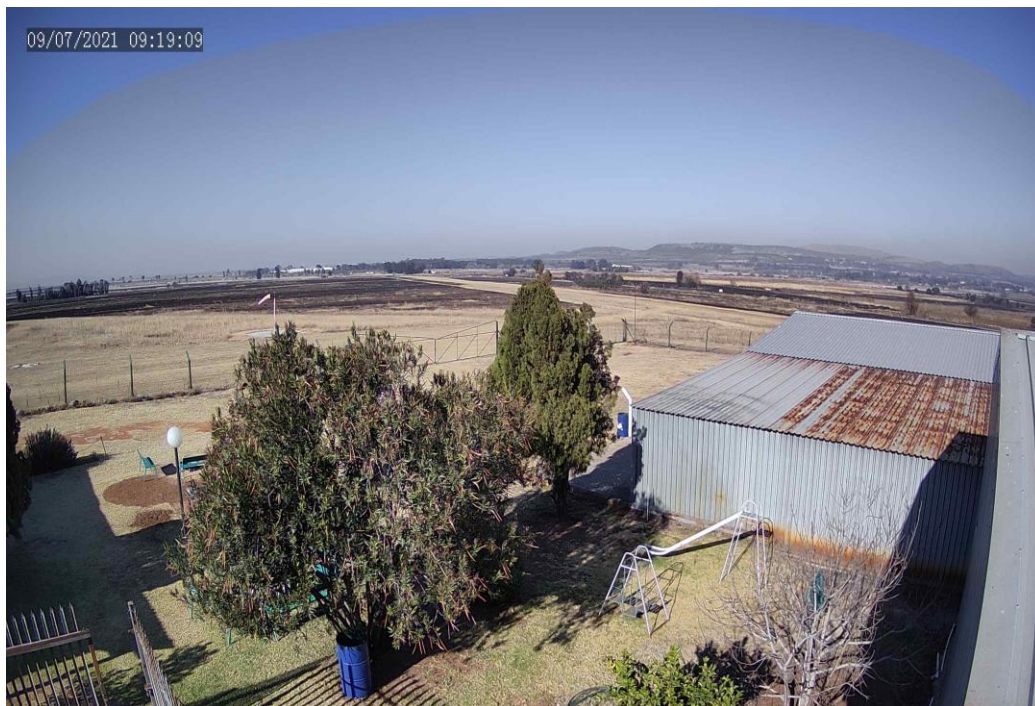
- 1.1.2. The student pilot carried out three circuit-and-landing exercises with the flight instructor on-board. Thereafter, the student pilot landed the aircraft and the flight instructor disembarked, allowing the student pilot to continue to conduct a solo consolidation flight which consisted of circuit-and-landing exercises. The student pilot carried out five solo circuit-and-landing exercises on RWY 20 without incident (see Figure 1). However, during the sixth circuit, the student pilot decided to change from landing RWY 20 to RWY 02 after observing the windsock and noticing that the wind had changed direction from a south-westerly to a north-westerly.

**Figure 6:** The windssock showing a north-westerly wind direction at 0719Z (0919LT).  
(Source: Aviation Webcams)

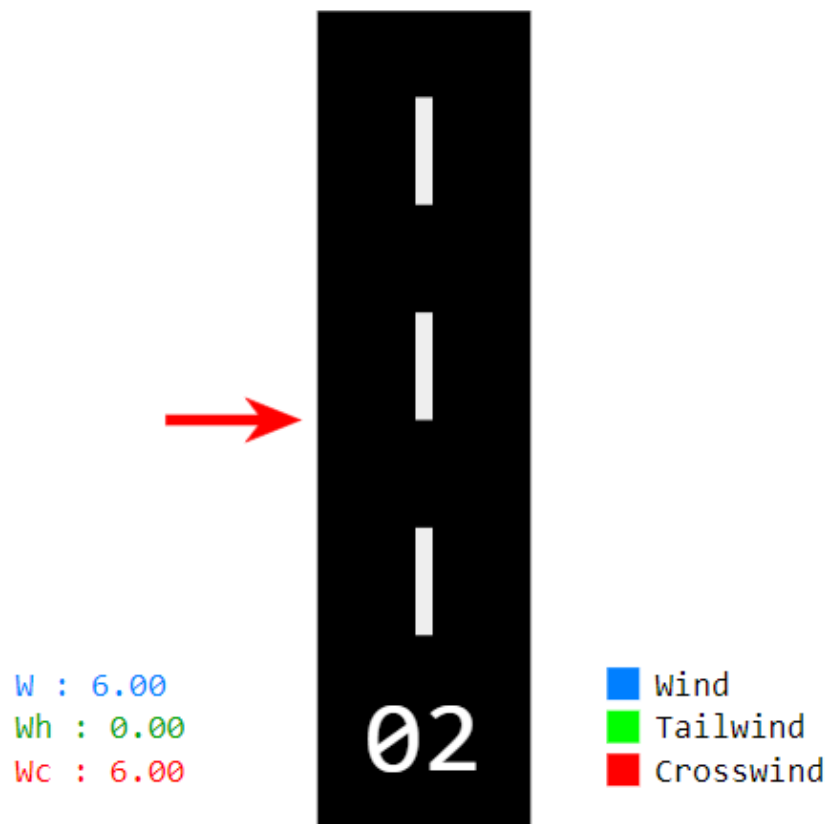
**Figure 7:** Indication of the wind values. (Source: [www.e6bx.com/wind-components/](http://www.e6bx.com/wind-components/))
