LIMITED ACCIDENT INVESTIGATION REPORT

Reference Number	CA18/2/3/10037					
Classification	Accident	Date	9 September 2021	Time	1224Z	
Type of Operation	Private (Part 91)					
Location						
Place of Departure	Rand Aerodrome (FAGM), Gauteng Province	Place of Intended Landing	Rand Aerodrome (FAGM), Gauteng Province			
Place of Occurrence	Runway 11 at FAGM, Gauteng Province.					
GPS Co-ordinates	Latitude	S25° 56.' 19"	Longitude	E027°55.'34	Elevation	4520 feet
Aircraft Information						
Registration	ZS-EFF					
Model/Make	Piper PA-24-260 Comanche (Serial No: 24-4045)					
Damage to Aircraft	Substantial	Total Aircraft Hours	2336.9			
Pilot-in-command						
Licence Valid	Yes	Gender	Male	Age	43	
Licence Type	Airline Transport Pilot Licence (ATPL)					
Total Hours on Type	65.9		Total Flying Hours	13022.5		
People On-board	1 + 1	Injuries	0	Fatalities	0	Other (On Ground) 0
What Happened						
<p>On 9 September 2021, a pilot accompanied by an aircraft maintenance engineer (AME) on-board a Piper PA-24-260 Comanche tricycle retractable landing gear aircraft with registration ZS-EFF took-off on a private flight from Rand Aerodrome (FAGM) Runway 11, situated in Germiston, Gauteng Province, with

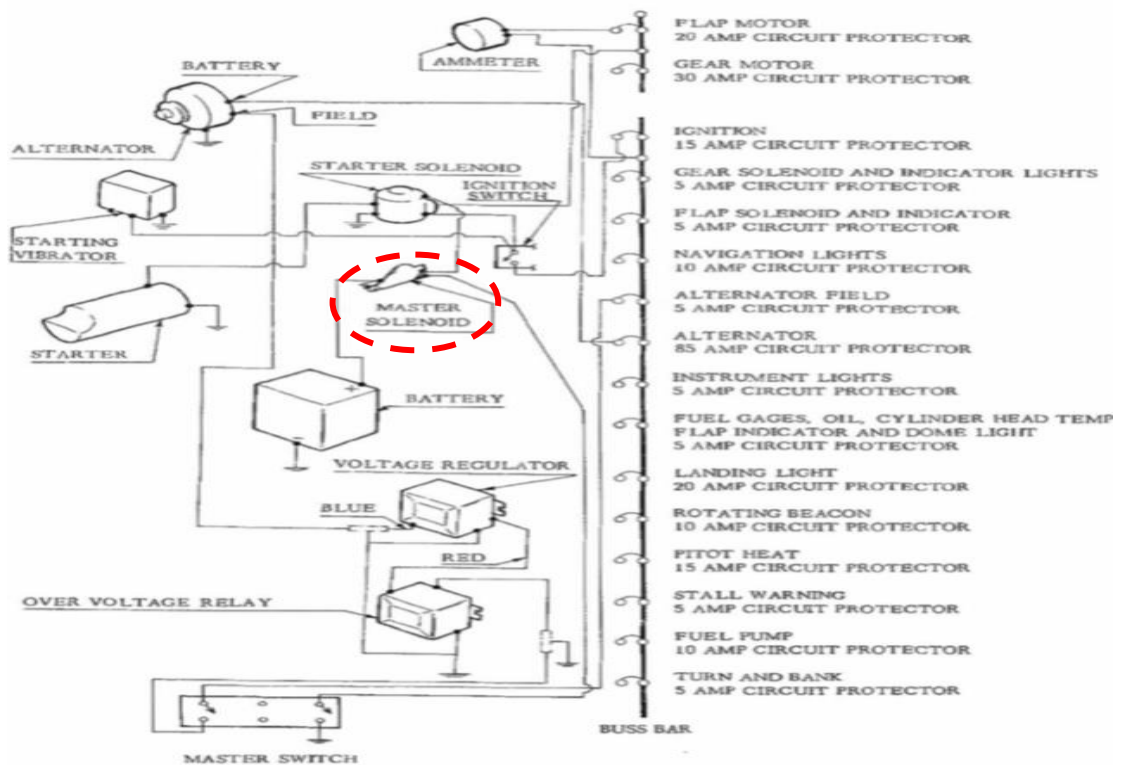
Figure 7: The wiring diagram of a PA-25-260 Comanche aircraft. (Source: AMM)

On 13 September 2021, the aircraft maintenance organisation (AMO) with a valid approval certificate was contracted by the operator to assist with the electrical system defect investigation. The engineer who assisted with the investigation had both Category W and X ratings. Inspection was carried out on the battery and connection to the master solenoid, making sure that the fasteners were properly secured; nothing abnormal was noted. The wiring under the floor panels was inspected and found undisturbed. After the AMO's engineer had opened a panel situated on the left of the pilot's side, he noticed that the screw securing the cable ring lug to the master switch was loose. The cable was found to have detached from the master switch body. The cable in question controls the aircraft's charging system and the defect was directly linked to electronic failure as the charging system was not sufficiently keeping buss and battery voltage at operating levels. The buss voltage dropped too low that the master solenoid switched off.

The electrical failure on the aircraft was caused by a disconnected master switch cable which controls the charging system, and the defect was directly linked to the electrical failure as the charging system was not sufficiently keeping buss and battery voltage at operating levels.
