| AIRCRAFT ACCIDENT REPORT AND EXECUTIVE SUMMARY |

| | | | | Reference | | CA18/2/3/10054 | |
| Aircraft Registration | 9H-VJM | Date of Accident | 13 October 2021 | | Time of Accident | 0518Z | |
| Type of Aircraft | BD-700-1A10 (Global 6000) | | Type of Operation | | Private (Part 91) | | |

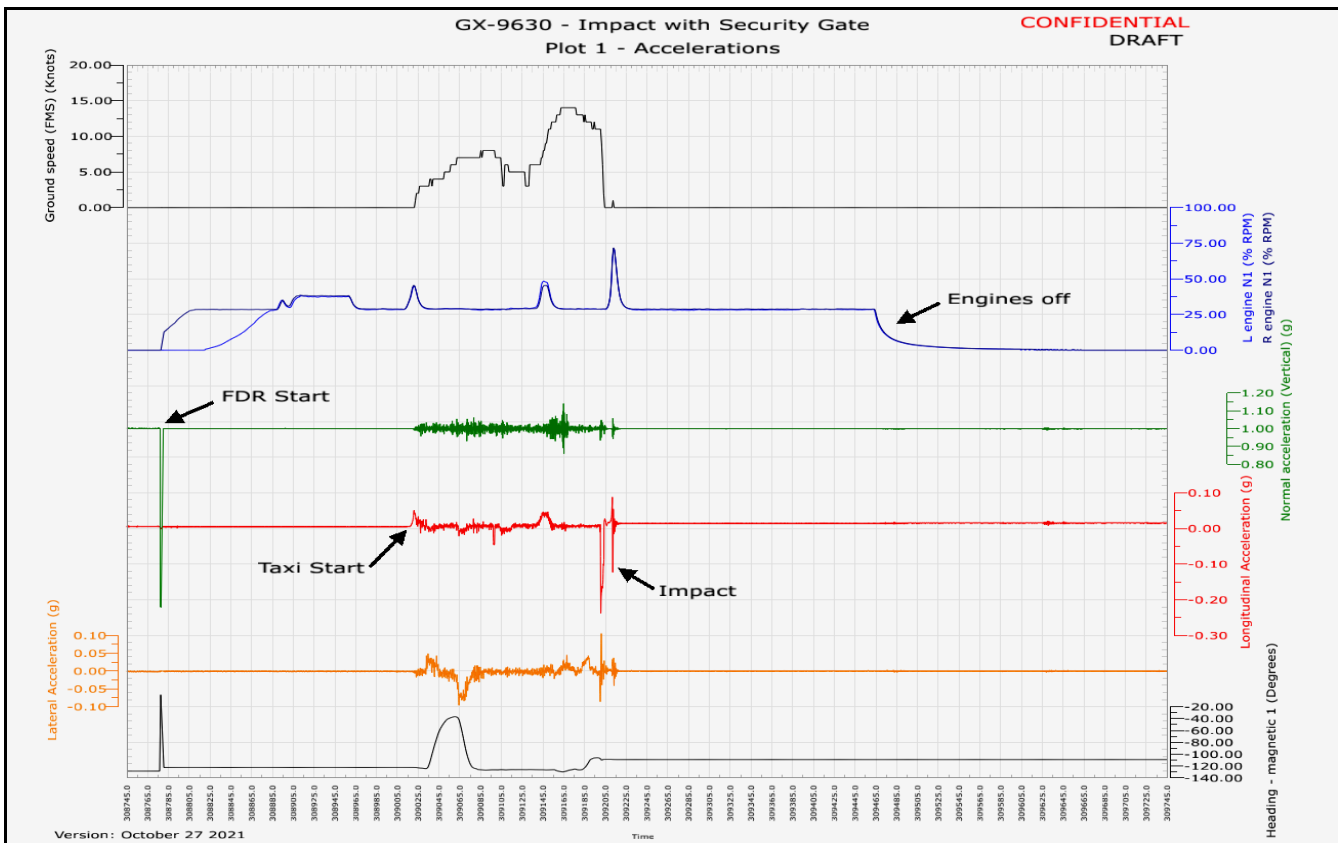
Graph 1: FDR data shows no abnormalities with the operation of the aircraft.

1.11.5 The downloaded FDR parameters showed that the aircraft and all its systems were serviceable at the time and could not have contributed or caused the accident. The FDR data graph (below) displays no abnormalities with the operation of the aircraft.

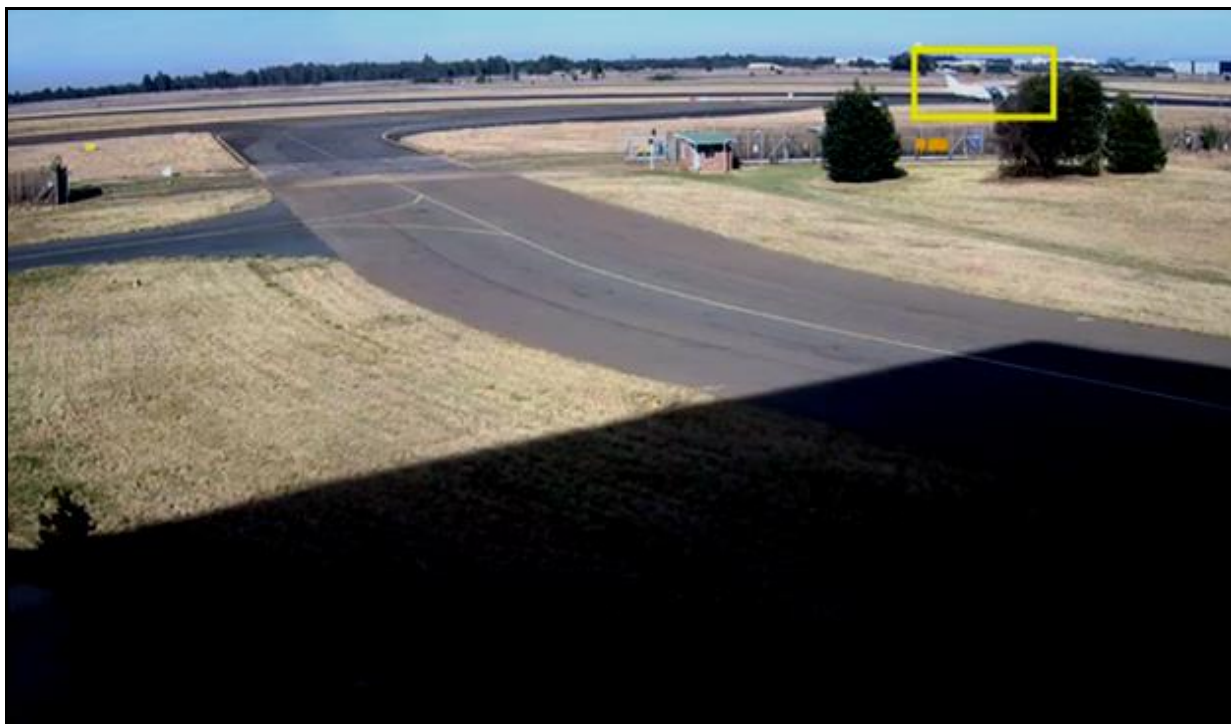
Figure 6: In this screenshot, the ZS-AAK aircraft exits the gate as shown in the yellow window.

The total video footage duration is 1 minute and 19 seconds. The event leading to the accident was approximately 53 seconds. The footage starts with the ZS-AAK aircraft already passing through the Echo gate into FAOR airside (seen between the two large trees and moves out of frame 9 seconds later, see Figure 6). The gate moves towards the close position 6 seconds later after the ZS-AAK is out of frame. Thereafter, the 9H-VJM aircraft appears 7 seconds later on the Denel CCTV camera which was 120 metres away from the gate; the gate is still moving towards close position.

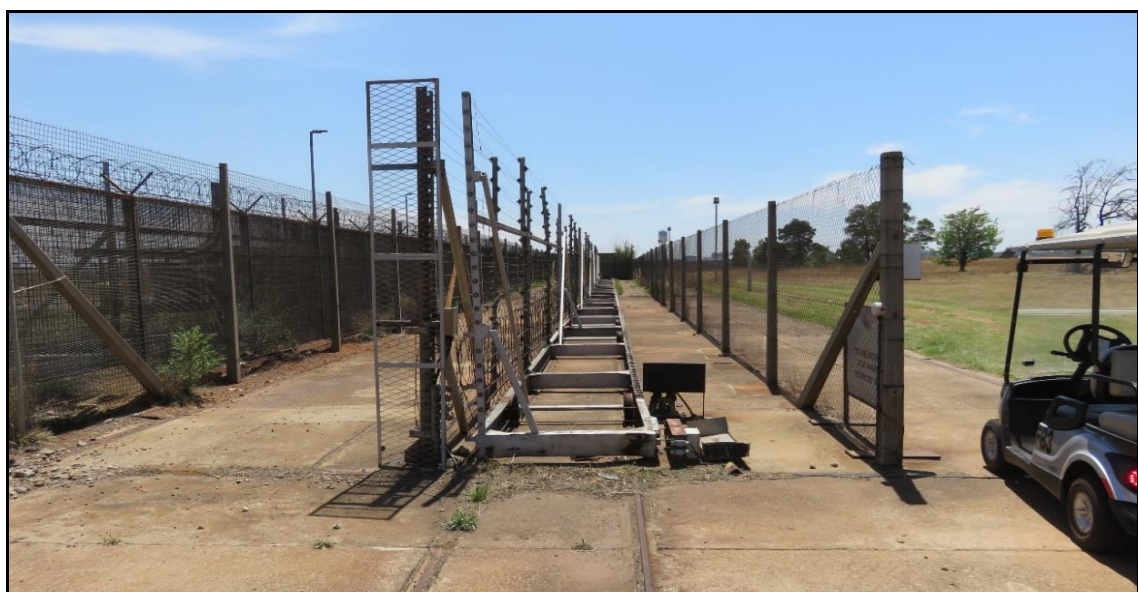
There are two gates at this location, namely ACSA (Echo gate) on the airport side and Denel gate on the Denel Campus side. The gates are approximately 2 metres (m) apart. The Denel Campus gate (see Figure 12) has been decommissioned several years ago and currently stands in the fully open position, however, its traffic lights on each side of the Apron (taxiways) are still functional and are always illuminating green as they stand open. There are security guards and guard facilities (guard houses) on both FAOR airside and Denel Campus side. The function of the guards is to prohibit any unauthorised movement of vehicles and personnel on either side of the gate.

Figure 12: The Denel Campus gate remains in the fully open position.

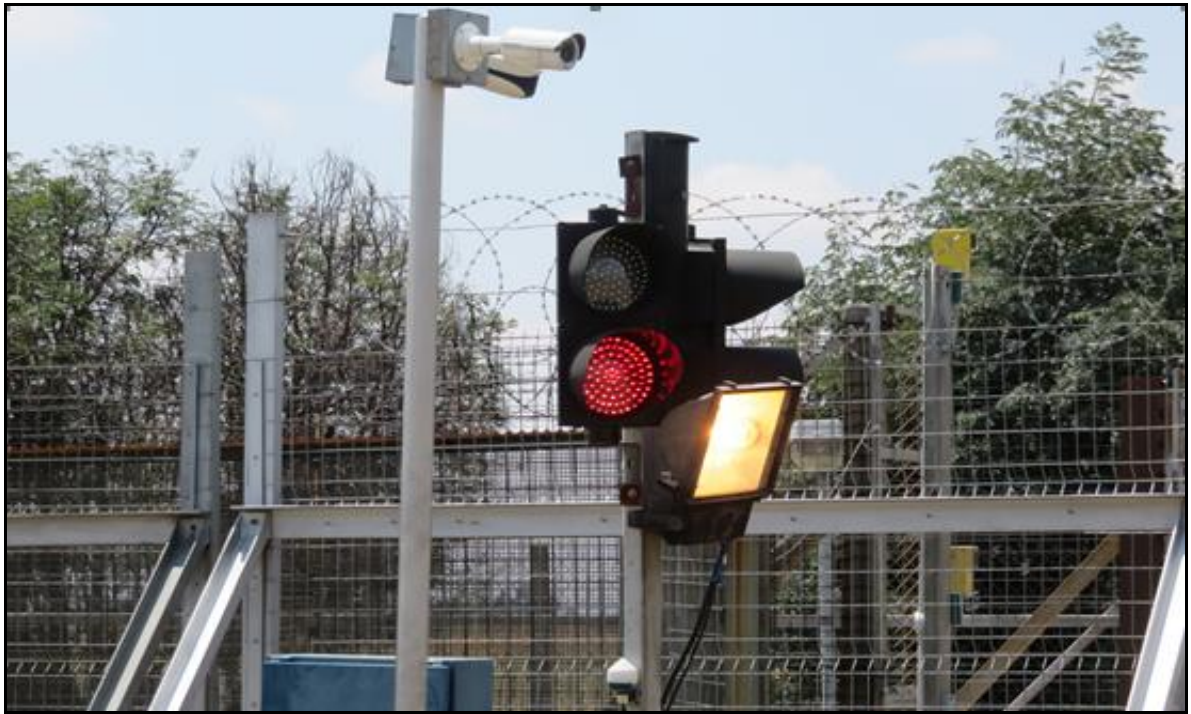
A traffic light is located on both sides of the Echo gate, one near the guard house (gate open side) and the other, on the 'gate close' side. These lights were working at the time as the traffic light on the 'gate close side' was visible on the CCTV footage. The light was green while the gate was in the open position; as soon as the gate started to move towards 'close' position, the green light immediately switched off. Pictures in Figures 18 and 19 were taken on 19 October 2021 by the investigator. These traffic lights were not working on 13 October 2021 when the investigation team inspected the gate.

Figure 18: The traffic light at the gate open position.

However, these lights were working at the time of the accident, as the traffic light on the 'gate close side' was visible on the CCTV footage. The light was green while the gate was in open position; as soon as the gate started to move towards 'close' position, the green light switched off.

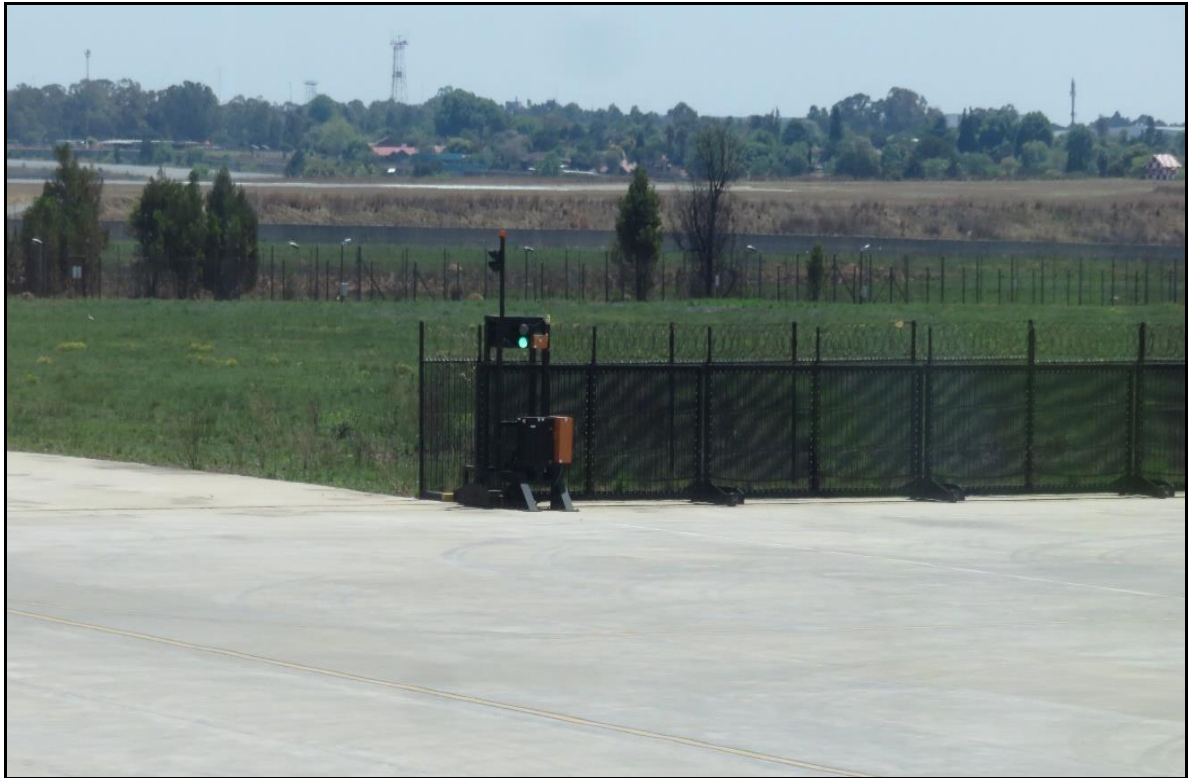
Figure 22: The FBO apron gate and the visible traffic light (illuminating green).
